the **play inspection** company

## Annual Inspection

Frodsham Town Council

Churchfields

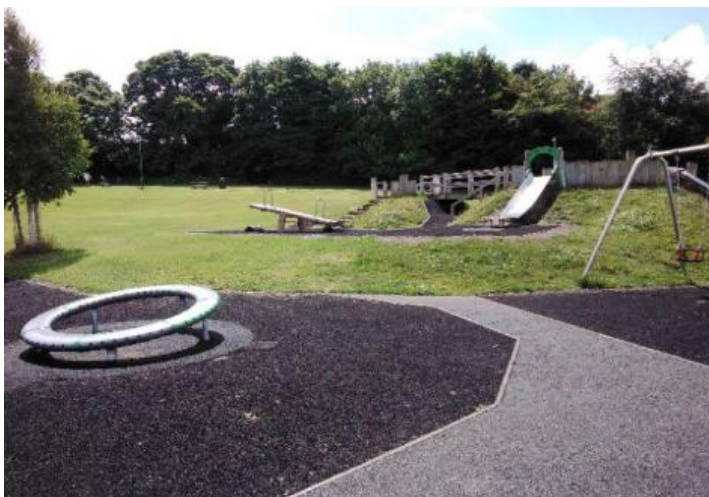
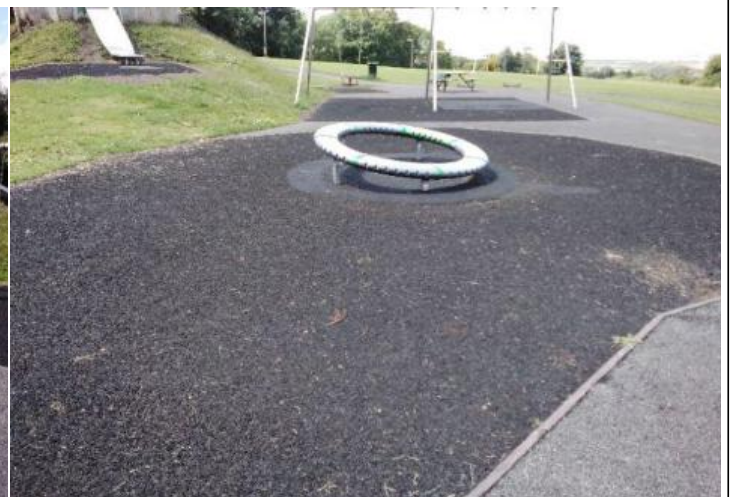
**Item:** Ancillary Items - Site General  
**Manufacturer:** Owner/Operator

**Finding:** The wetpour is crumbling in areas

**Action:** Monitor for any further deterioration and repair as required

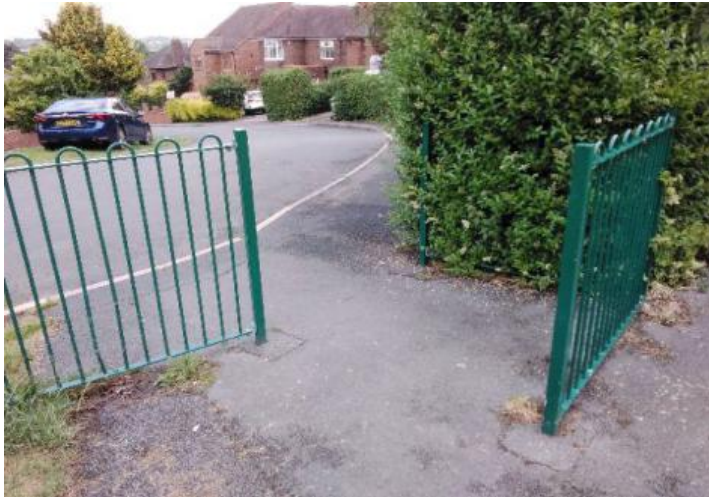
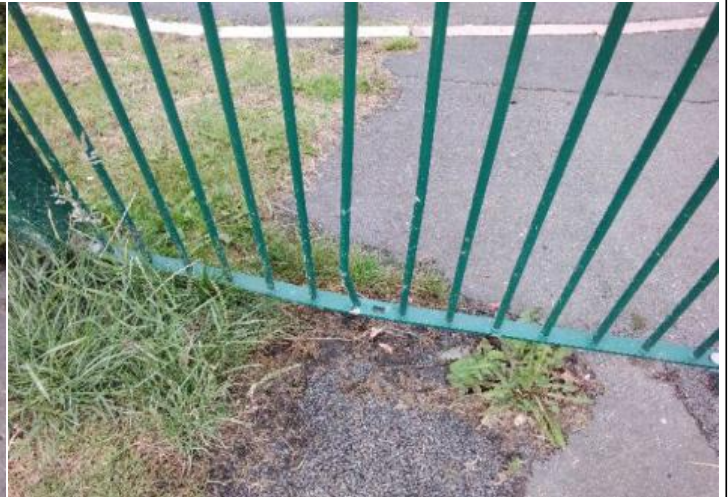
**Item:** Ancillary Items - Entrance Feature  
**Manufacturer:** Owner/Operator

**Finding:** There is some damage to the fence sections

**Action:** Monitor for any further deterioration and repair as required

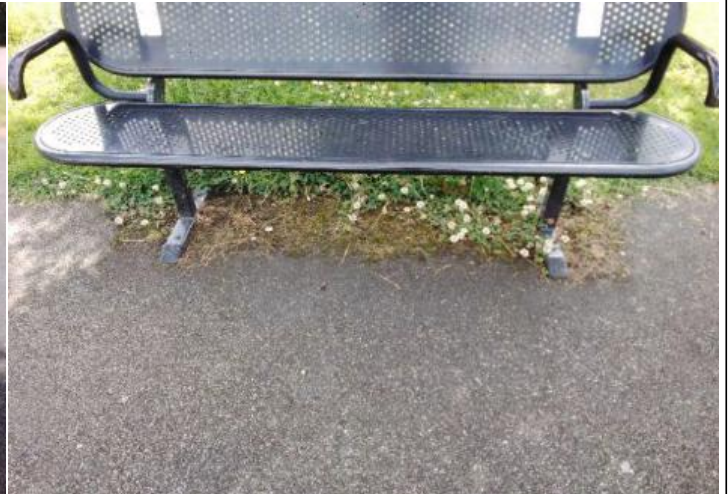
**Item:** Ancillary Items - Bench  
**Manufacturer:** Not Identified

**Finding:** Ground fixings are slightly loose

**Action:** Secure fixings

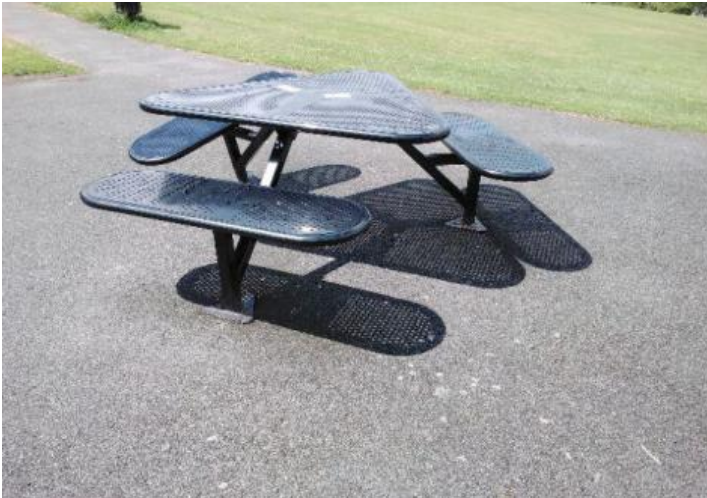
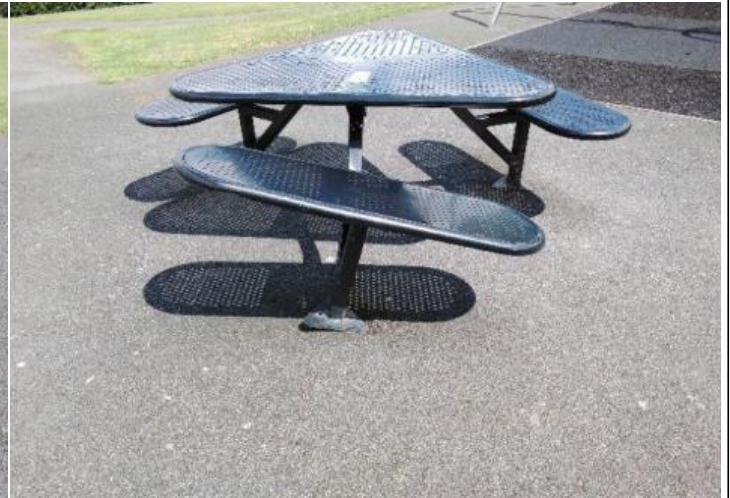
**Item:** Ancillary Items - Picnic Table  
**Manufacturer:** Not Identified

**Finding:** The bench seat has been distorted

**Action:** Repair

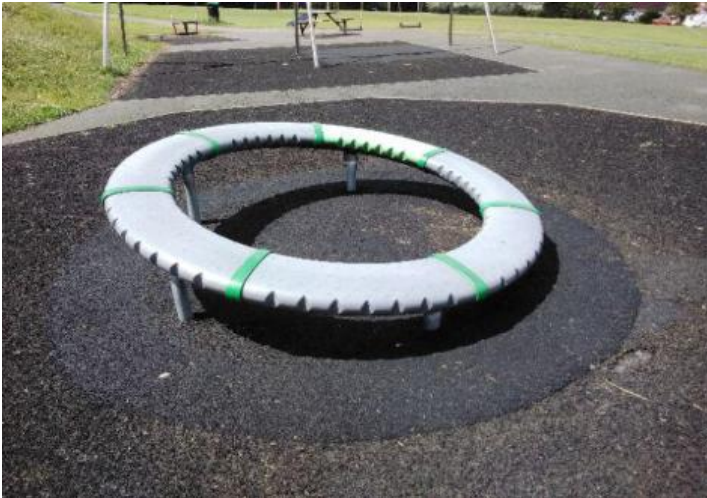
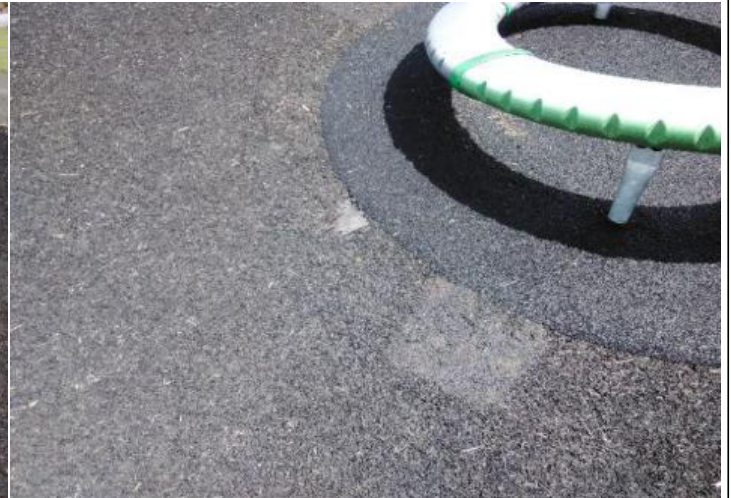
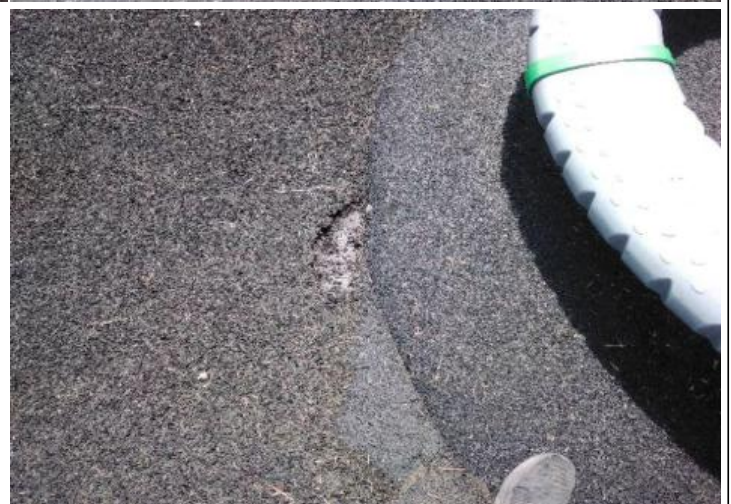
**Item:** Rotor Play - Supernova  
**Manufacturer:** Kompan Ltd

**Finding:** There is moderate damage to the surface creating potential trip hazards  
**Action:** Repair the damaged areas of surfacing

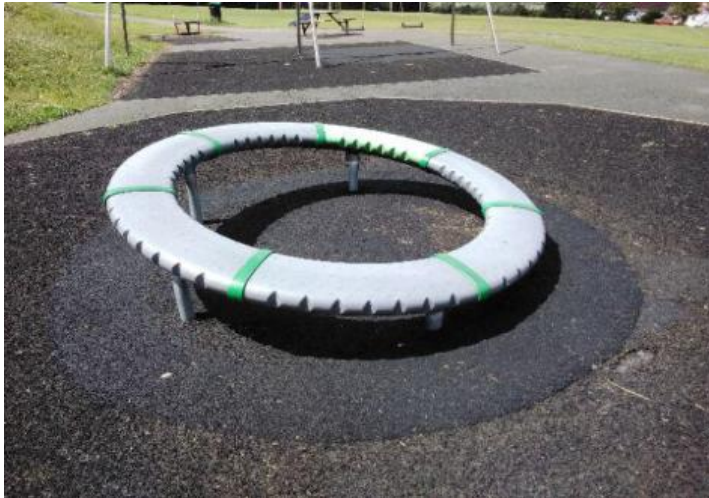
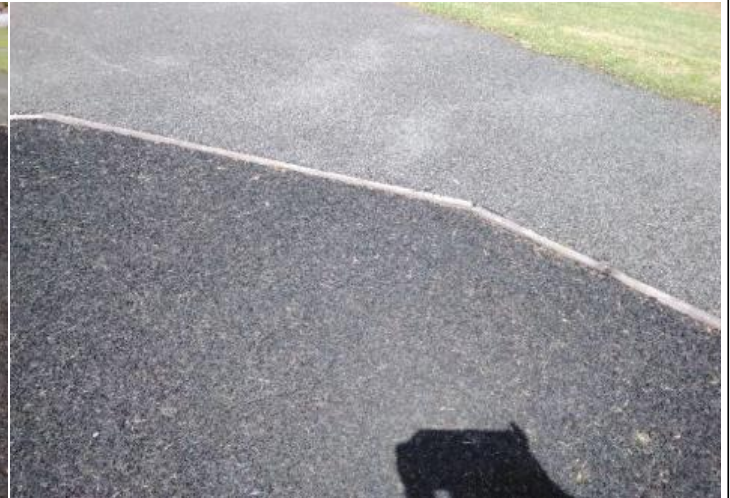
**Item:** Rotor Play - Supernova  
**Manufacturer:** Kompan Ltd

**Finding:** There are trip hazards at the edges of the surface

**Action:** Reinstate surrounding surface levels to remove the trip points

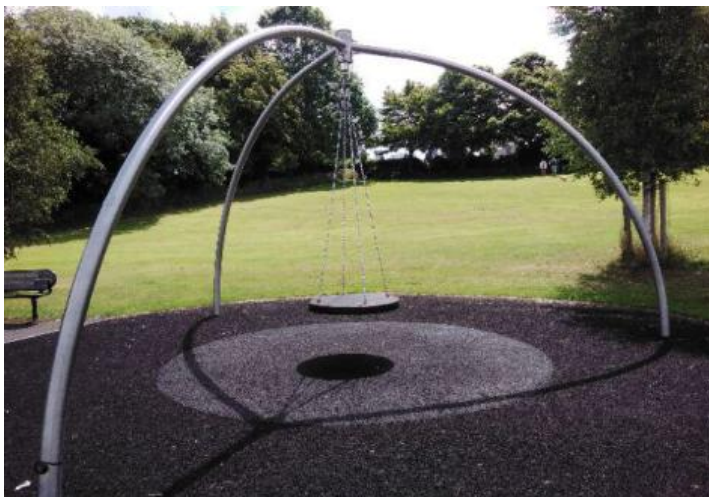
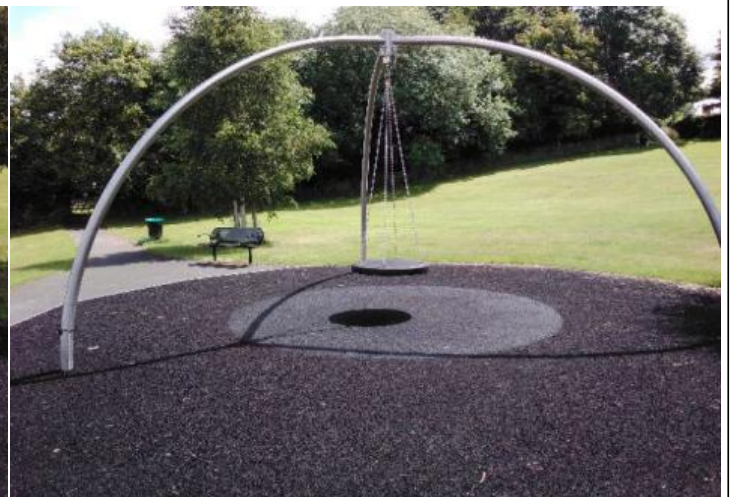
**Item:** Swings - Pendulum Swing  
**Manufacturer:** Playdale Playgrounds Ltd

**Finding:** The item is slightly loose in its foundations

**Action:** Monitor for any further deterioration and repair as required

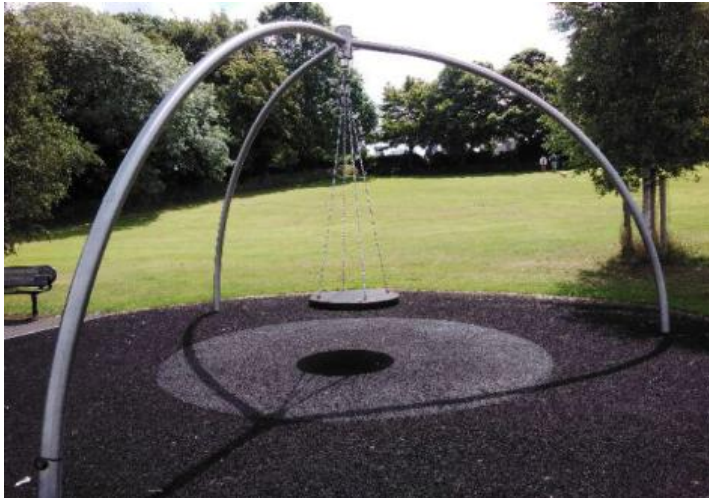
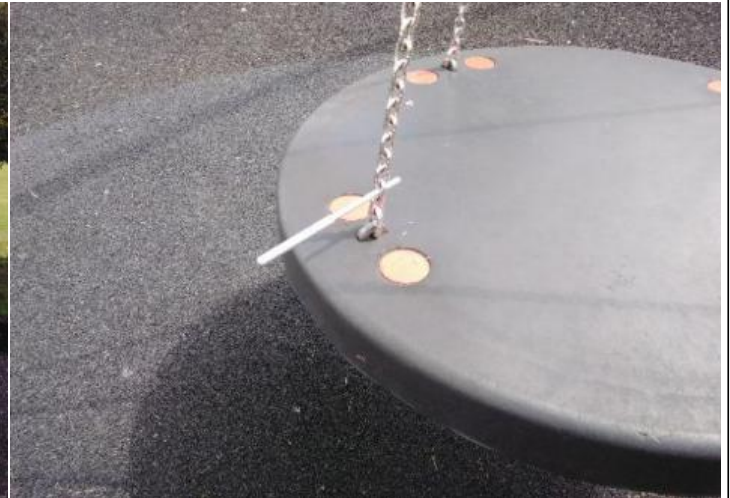
**Item:** Swings - Pendulum Swing  
**Manufacturer:** Playdale Playgrounds Ltd

**Finding:** The chain openings are in excess of the 8.6mm as recommended by BS EN 1176  
**Action:** Monitor - No remedial work recommended

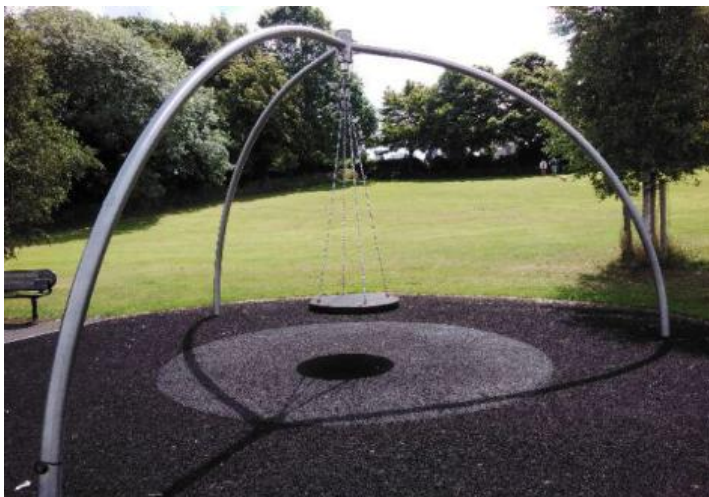
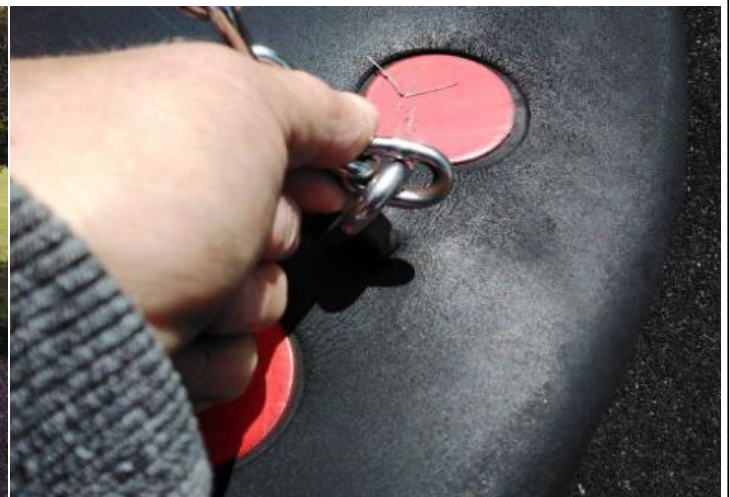
**Item:** Swings - Pendulum Swing  
**Manufacturer:** Playdale Playgrounds Ltd

**Finding:** There is some notable evidence of chain wear  
**Action:** Monitor for any further deterioration and replace when 40% worn

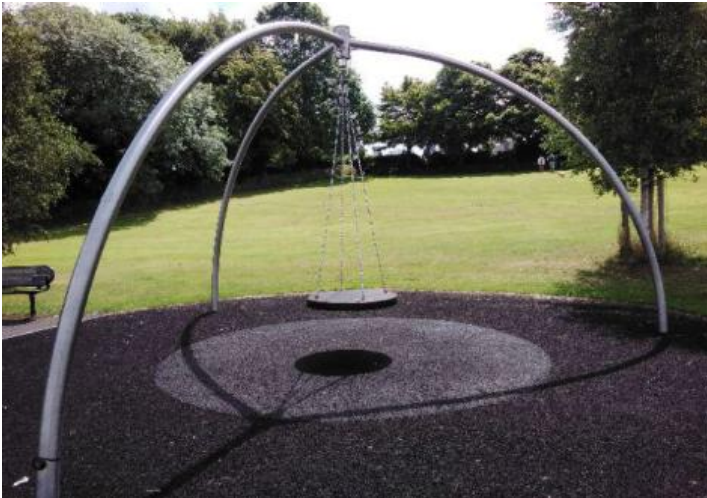
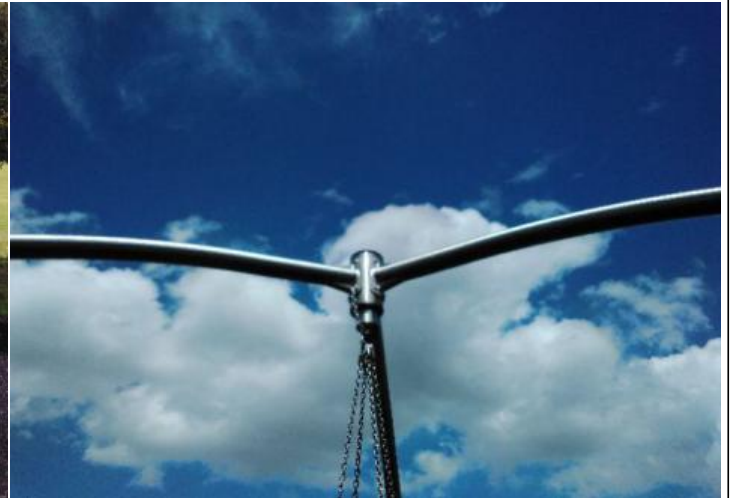
**Item:** Swings - Pendulum Swing  
**Manufacturer:** Playdale Playgrounds Ltd

**Finding:** The fixings or components for this item were in excess of 2.5m above the standing surface and could not be fully accessed by the inspector. We have completed a visual inspection of the fixings from ground level but a maintenance inspection should be undertaken to assess the condition, security and wear of the components at intervals in accordance with the manufacturers recommendations.

**Action:** Inspect in accordance with the manufacturers recommendations

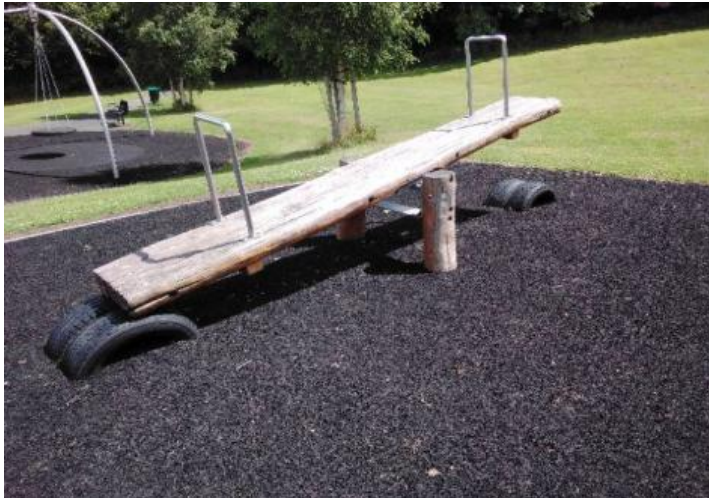
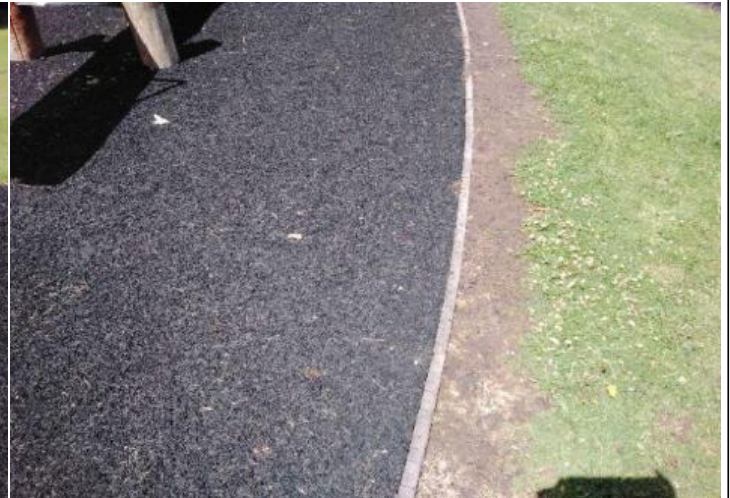
**Item:** Rocking Equipment - See Saw  
**Manufacturer:** Spiel Art

**Finding:** There are gaps opening between the surfacing and the edging surround or between the joints in the surfacing  
**Action:** Monitor for any further deterioration and repair as required

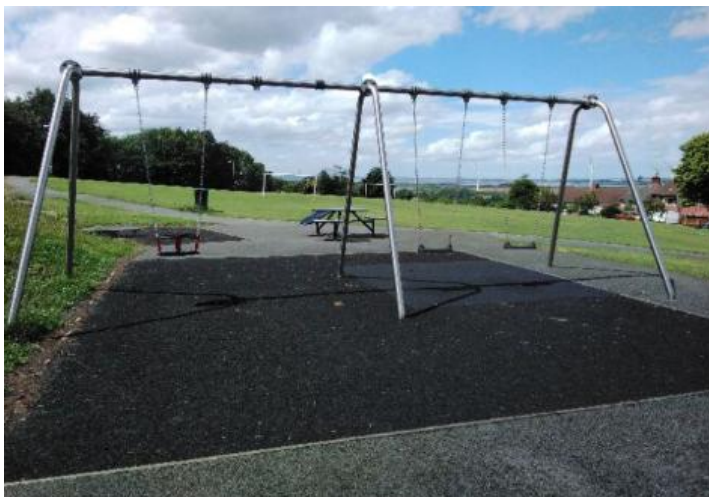
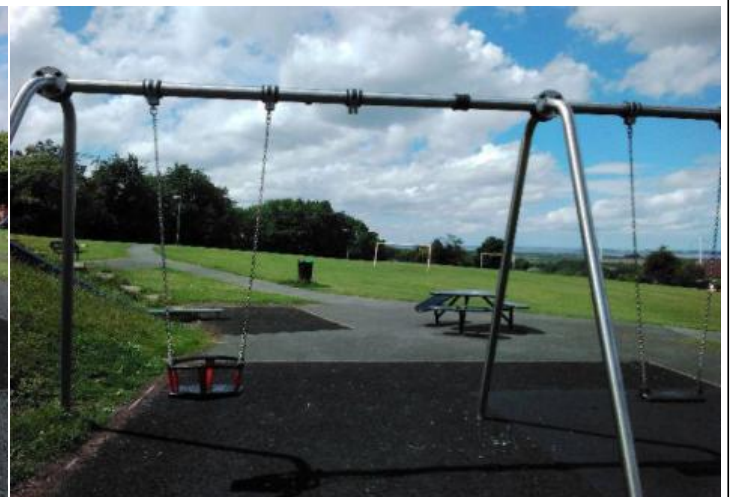
**Item:** Swings - 2 Bay (2 Flat, 2 Cradle)  
**Manufacturer:** Playdale Playgrounds Ltd

**Finding:** The seat(s) and suspension were missing at the time of inspection and the inspector was unable to make a full compliance assessment

**Action:** Replace missing seat(s) and suspension

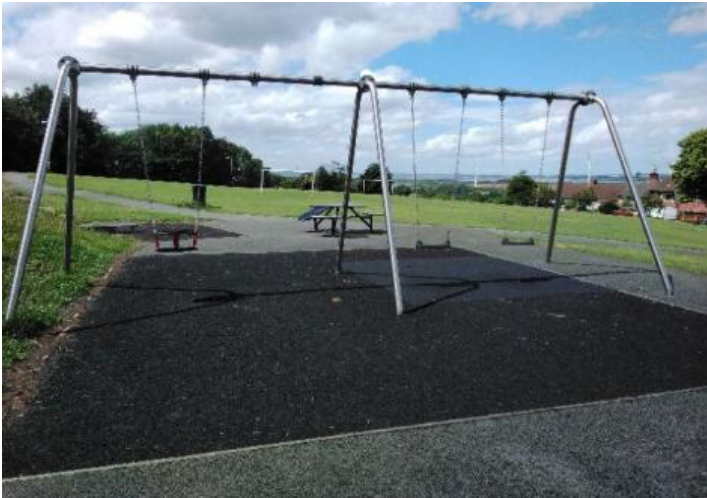
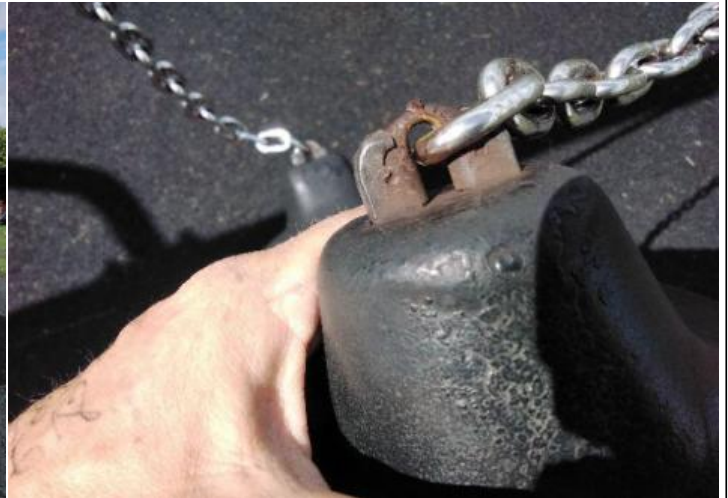
**Item:** Swings - 2 Bay (2 Flat, 2 Cradle)  
**Manufacturer:** Playdale Playgrounds Ltd

**Finding:** The swing seat connectors are worn more than 40% and require replacement

**Action:** Replace swing seat connectors if possible or replace seat

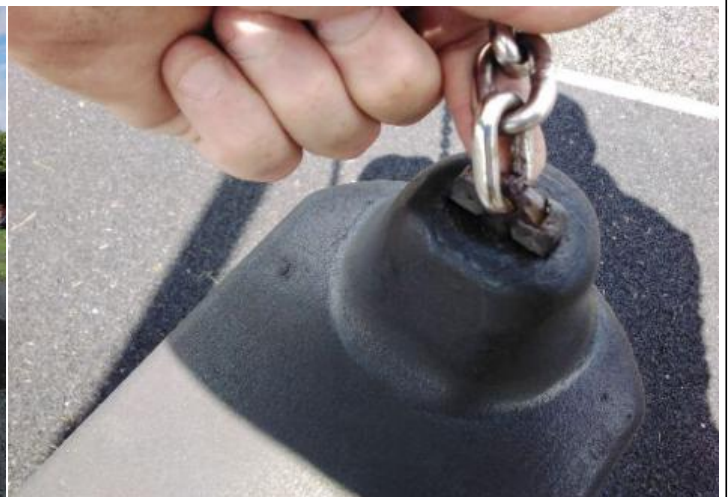
**Item:** Swings - 2 Bay (2 Flat, 2 Cradle)  
**Manufacturer:** Playdale Playgrounds Ltd

**Finding:** There is some notable evidence of chain wear

**Action:** Monitor for any further deterioration and replace when 40% worn

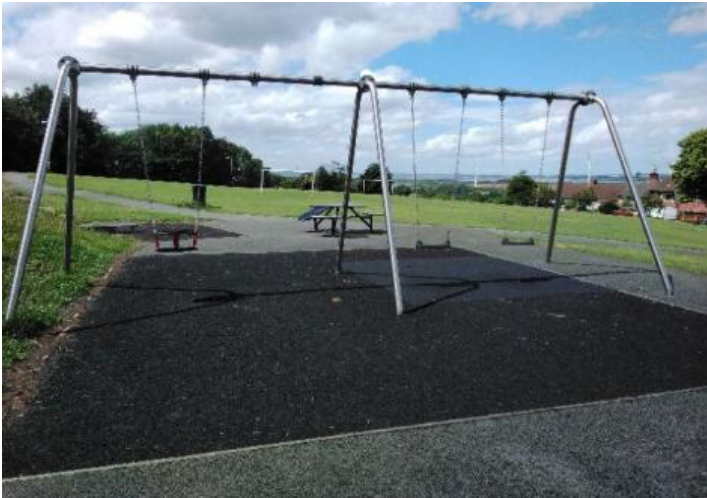
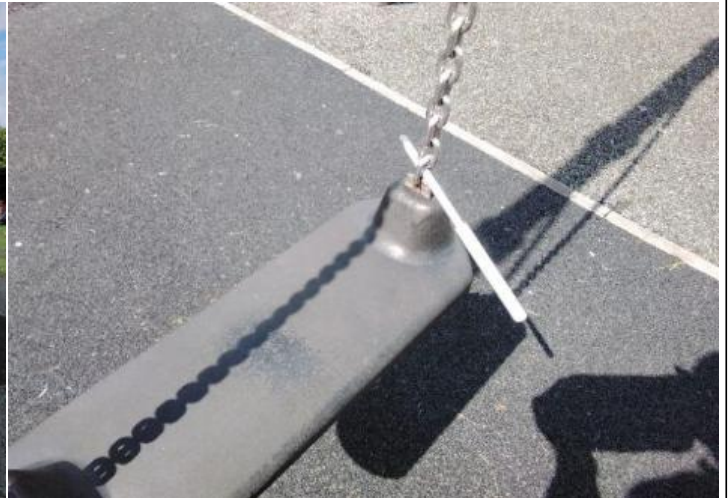
**Item:** Swings - 2 Bay (2 Flat, 2 Cradle)  
**Manufacturer:** Playdale Playgrounds Ltd

**Finding:** The chain openings are in excess of the 8.6mm as recommended by BS EN 1176  
**Action:** Monitor - No remedial work recommended

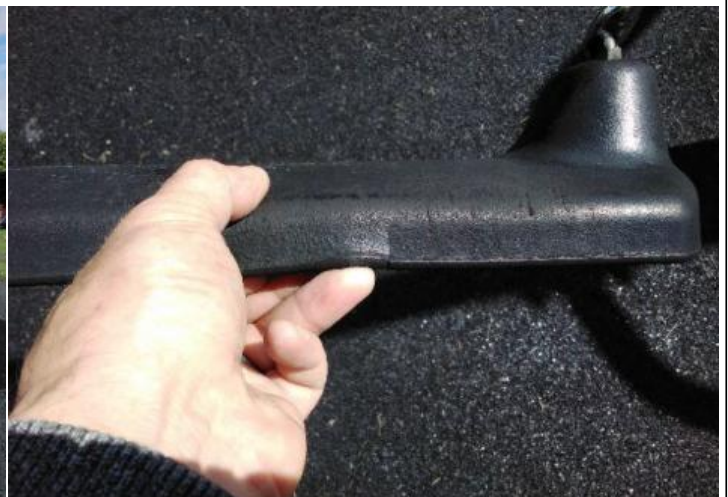
**Item:** Swings - 2 Bay (2 Flat, 2 Cradle)  
**Manufacturer:** Playdale Playgrounds Ltd

**Finding:** The seat has minor damage or wear  
**Action:** Monitor for any further deterioration and replace as required

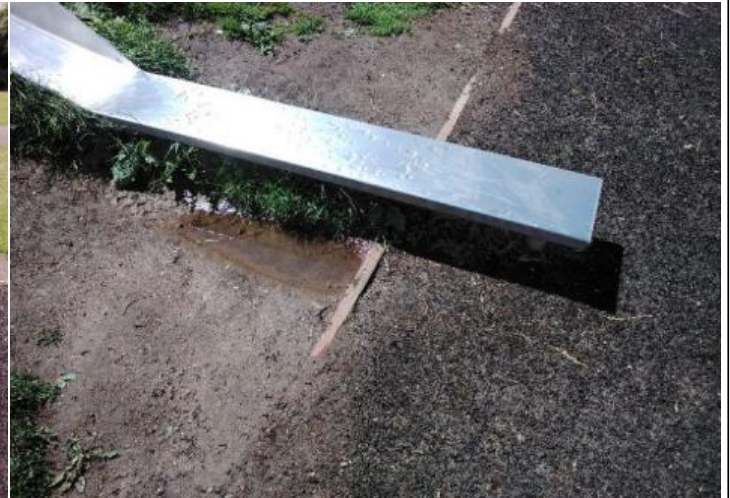
**Item:** Other - Embankment Slide  
**Manufacturer:** Not Identified

**Finding:** The timber edge forms a hard object within the falling space of the equipment in contravention of the requirements of BS EN 1176 Part 1

**Action:** Monitor - No remedial work recommended

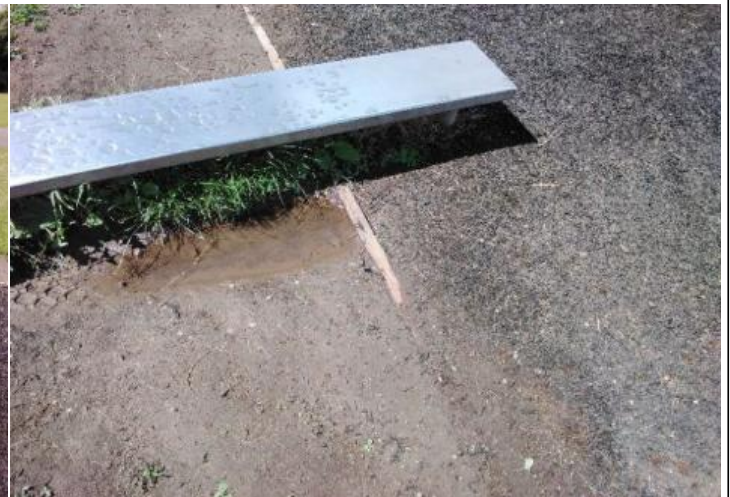
**Item:** Other - Embankment Slide  
**Manufacturer:** Not Identified

**Finding:** There are trip hazards present on the timber edge

**Action:** Reinstall surrounding surfaces to level to remove the trip points

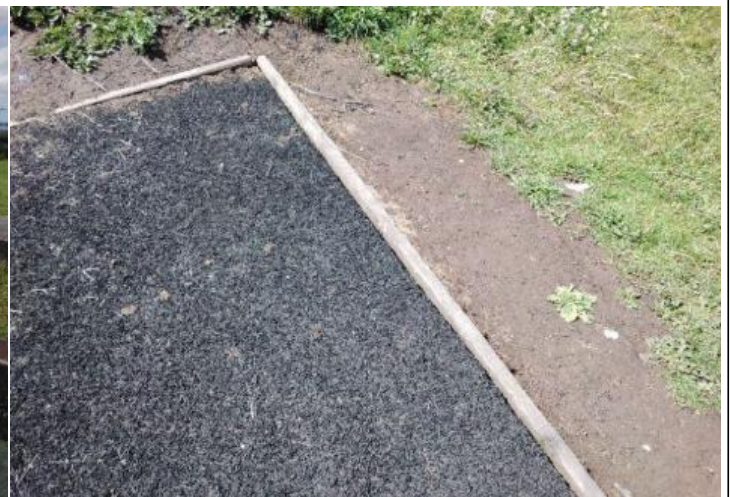
**Item:** Other - Embankment Slide  
**Manufacturer:** Playdale Playgrounds Ltd

**Finding:** There are significant gaps (over 30mm) between the surface and the edging or between the joints in the surface; these are large enough for a small foot to enter. **Action:** Repair surfacing

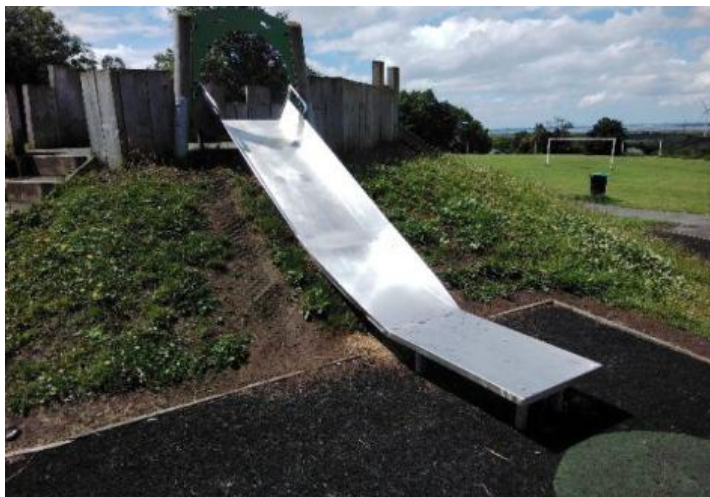
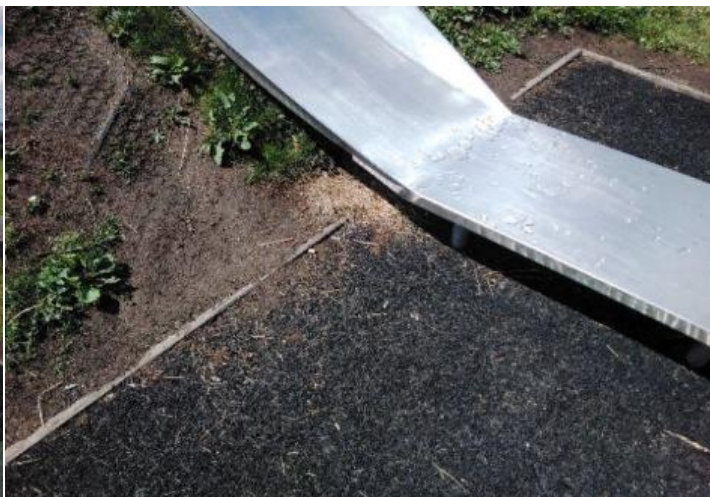
**Item:** Other - Embankment Slide  
**Manufacturer:** Playdale Playgrounds Ltd

**Finding:** The timber edge forms a hard object within the falling space of the equipment in contravention of the requirements of BS EN 1176 Part 1

**Action:** Monitor - No remedial work recommended

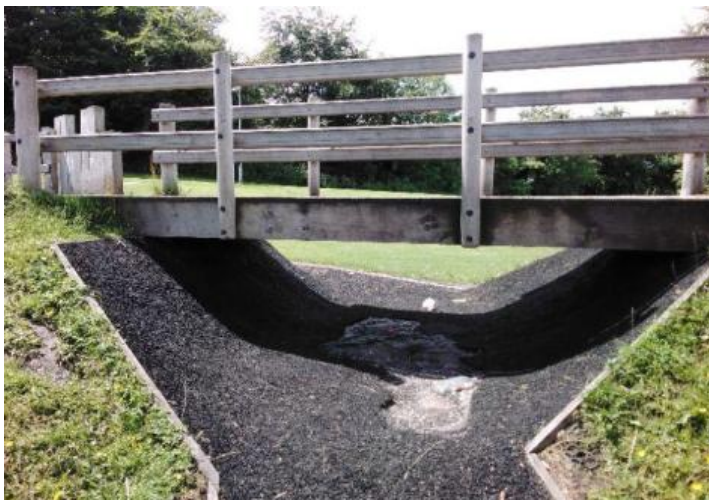
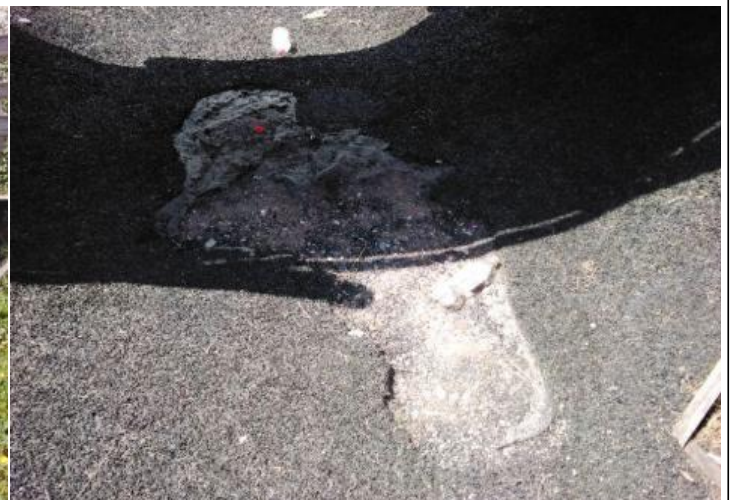
**Item:** Activity Equipment - Bridge  
**Manufacturer:** Playdale Playgrounds Ltd

**Finding:** The surfacing is severely damaged

**Action:** Repair damaged areas of surfacing

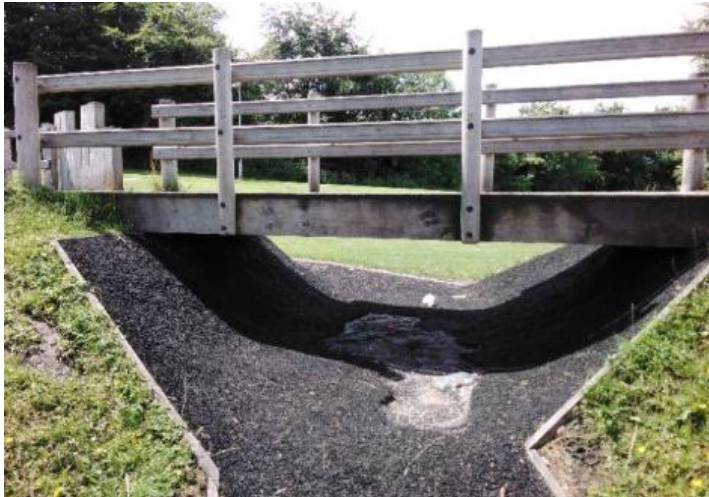
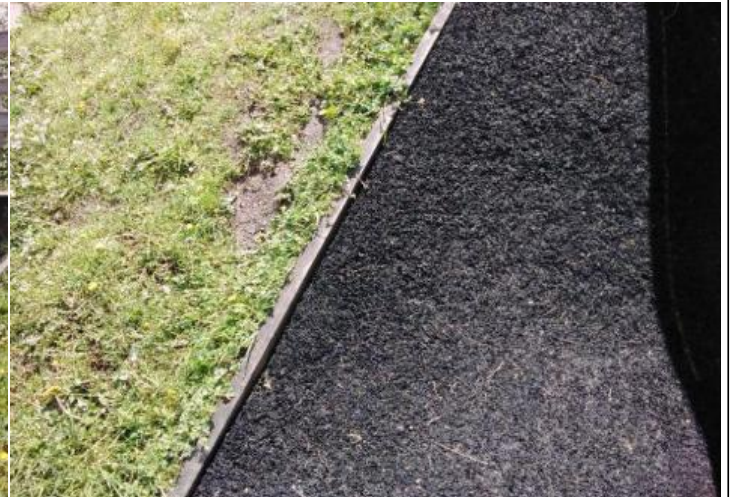
**Item:** Activity Equipment - Bridge  
**Manufacturer:** Playdale Playgrounds Ltd

**Finding:** There are gaps opening between the surfacing and the edging surround or between the joints in the surfacing

**Action:** Monitor for any further deterioration and repair as required

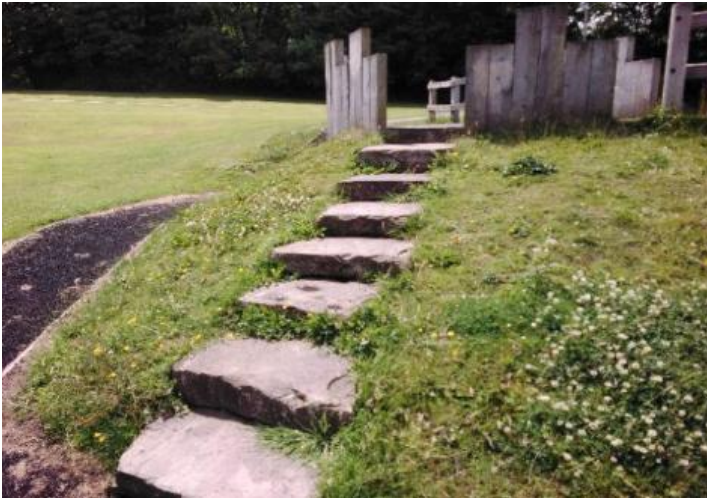
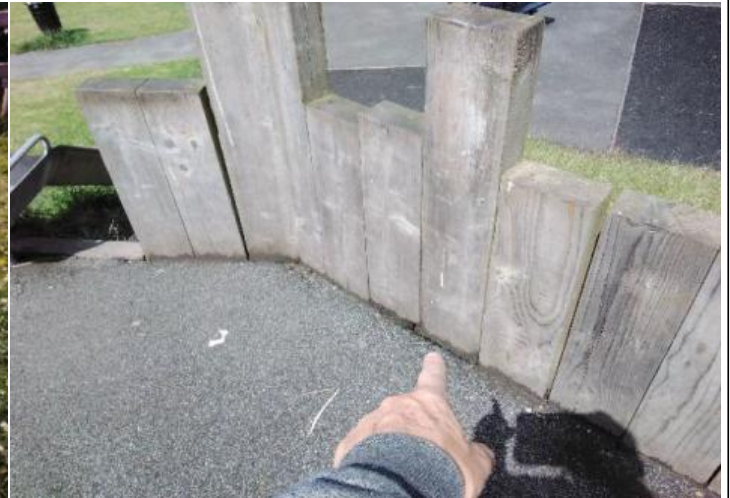
**Item:** Ancillary Items - Landscape Feature  
**Manufacturer:** Owner/Operator

**Finding:** There are areas or parts of the timber on the structure that have rotted

**Action:** Replace all affected timbers

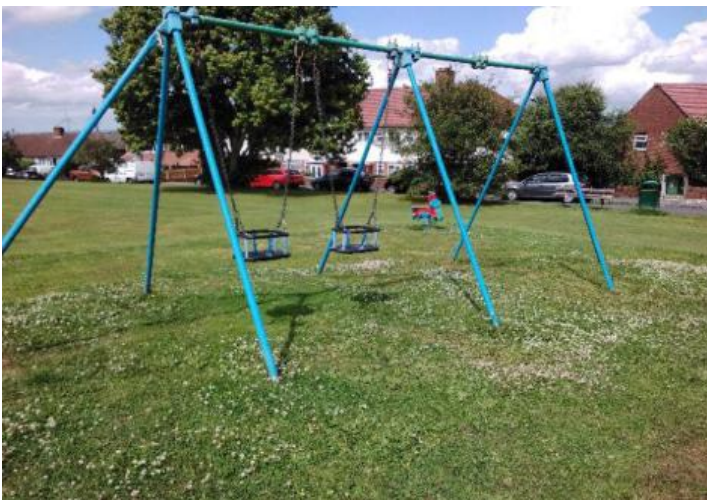
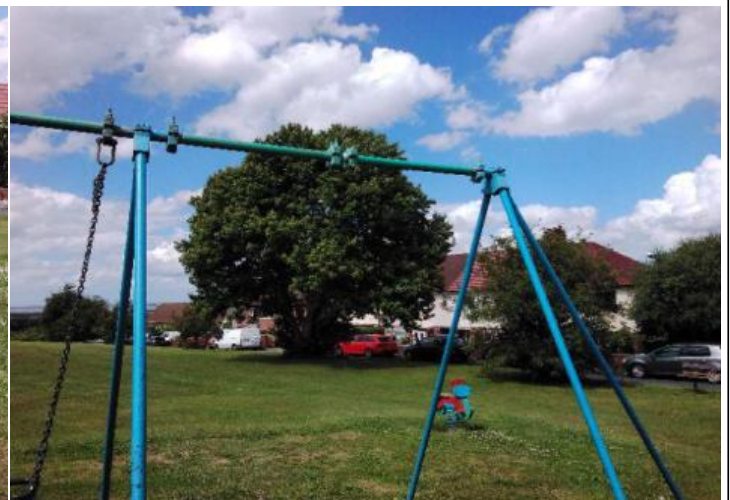
**Item:** Swings - 2 Bay 2 Cradle Swing  
**Manufacturer:** Wicksteed Playgrounds

**Finding:** The seat(s) and suspension were missing at the time of inspection and the inspector was unable to make a full compliance assessment

**Action:** Replace missing seat(s) and suspension

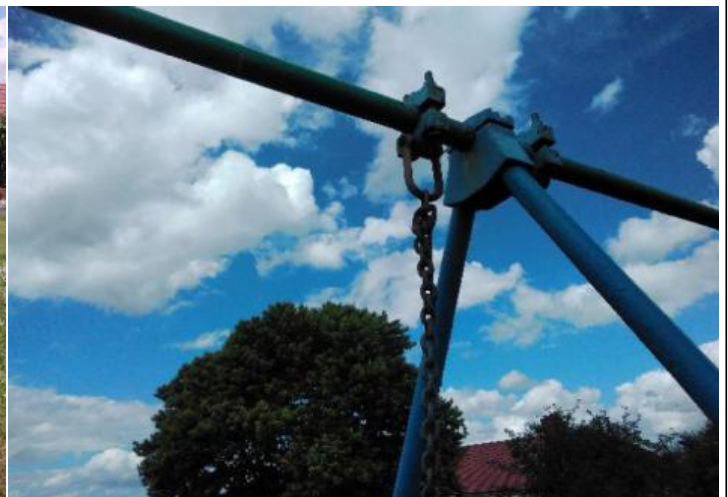
**Item:** Swings - 2 Bay 2 Cradle Swing  
**Manufacturer:** Wicksteed Playgrounds

**Finding:** There is some wear to the shackles.

**Action:** Monitor for any further deterioration and replace when 40% worn

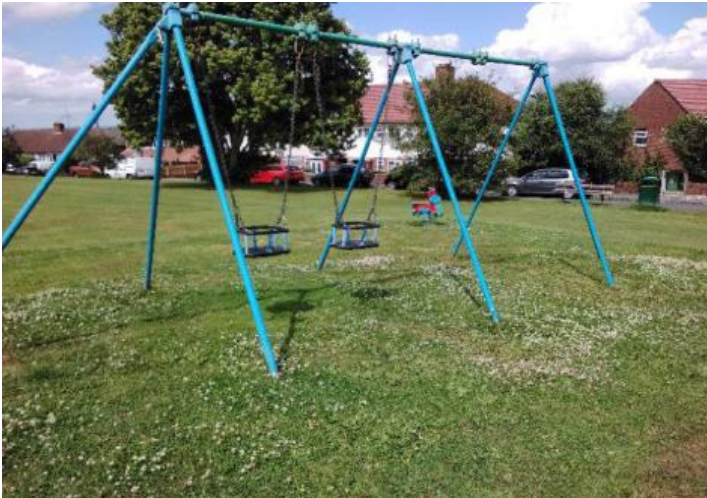
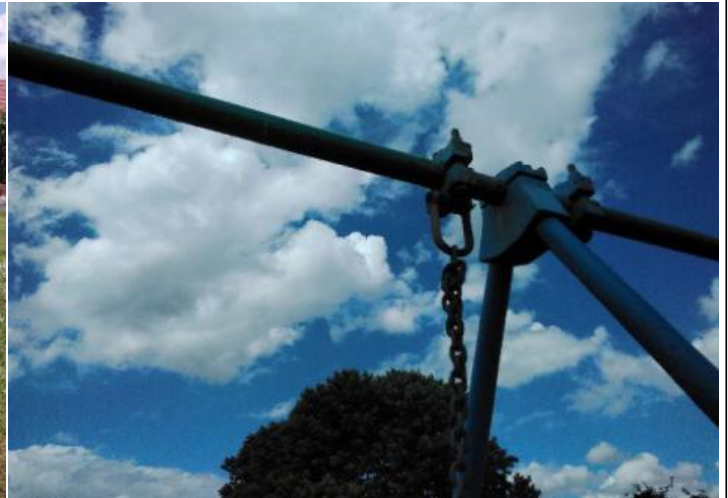
**Item:** Swings - 2 Bay 2 Cradle Swing  
**Manufacturer:** Wicksteed Playgrounds

**Finding:** The bushes are worn or missing

**Action:** Replace worn or missing bushes

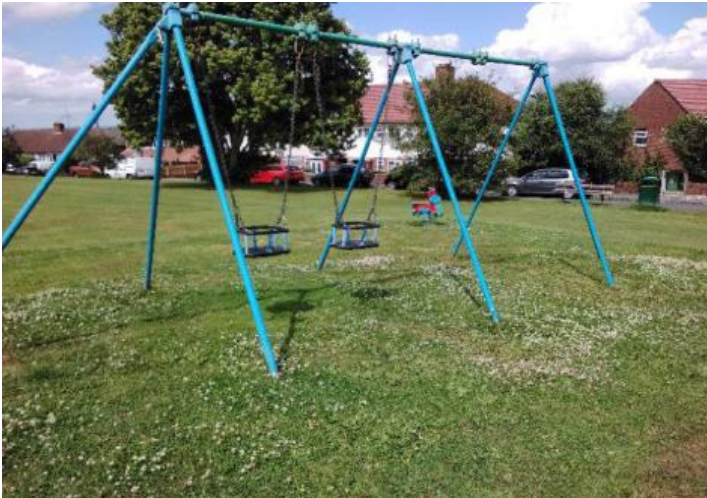
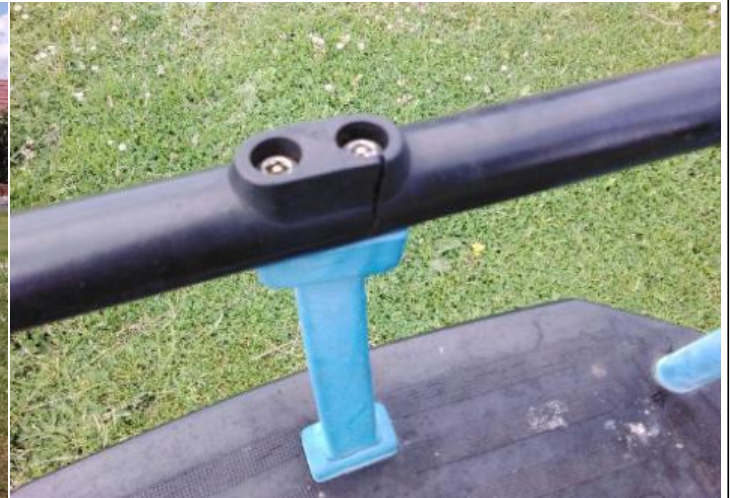
**Risk Level:** L - Low Risk  
**Surface:** Grass

**Finding:** The seat has minor damage or wear

**Action:** Monitor for any further deterioration and replace as required

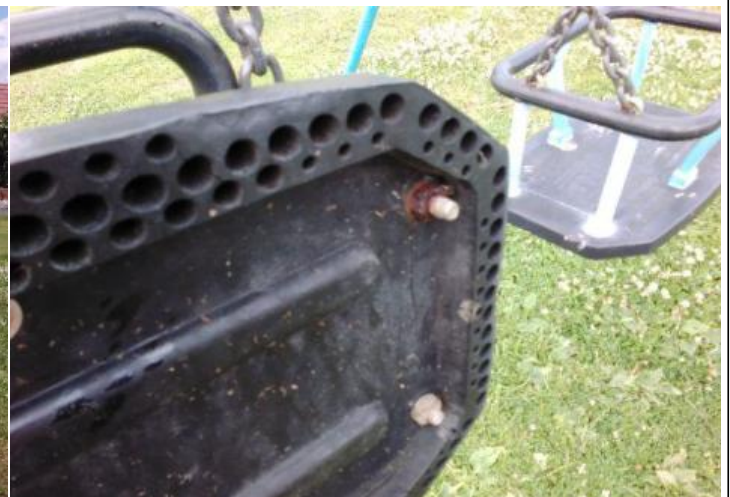
**Risk Level:** L - Low Risk  
**Surface:** Grass

**Finding:** The fixings have corroded excessively

**Action:** Replace all corroded fixings

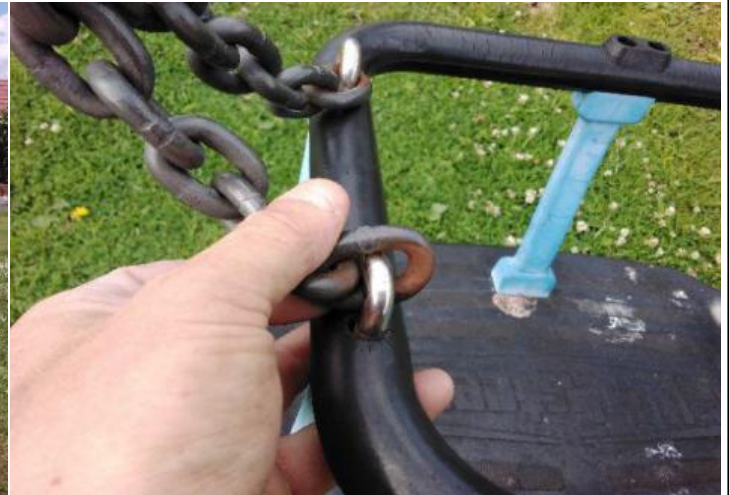
**Risk Level:** L - Low Risk  
**Surface:** Grass

**Finding:** There is some notable evidence of chain wear

**Action:** Monitor for any further deterioration and replace when 40% worn

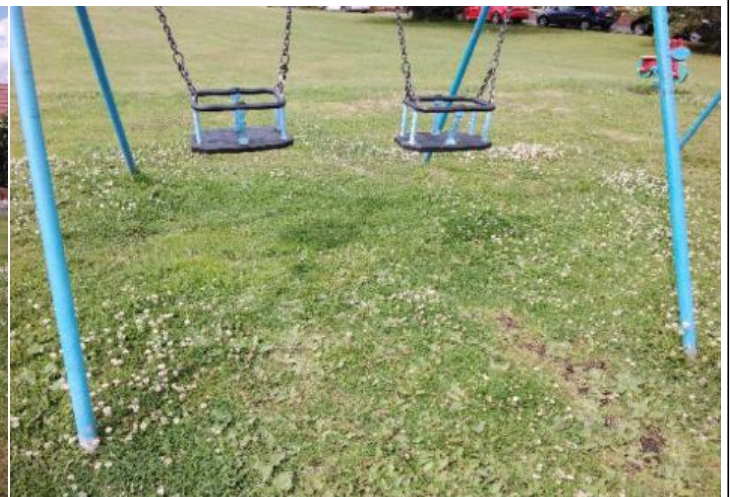
**Risk Level:** V - Very Low Risk  
**Surface:** Grass

**Finding:** The item of equipment has a fall height exceeding 1.50 metres and grass has been provided as a safety surface

**Action:** Monitor - no remedial action recommended

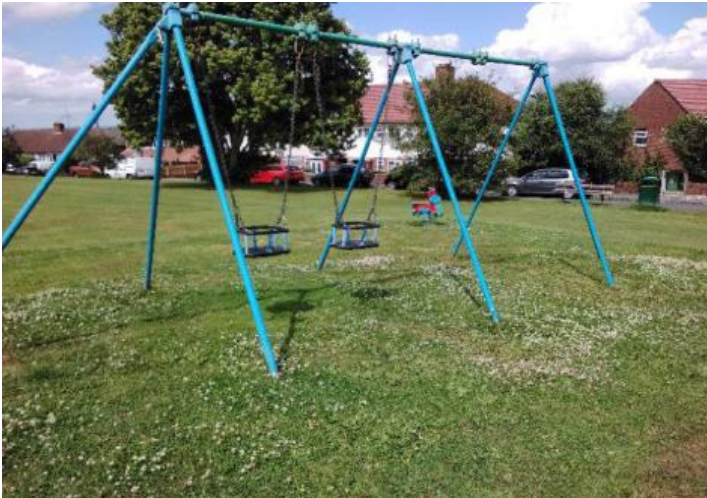
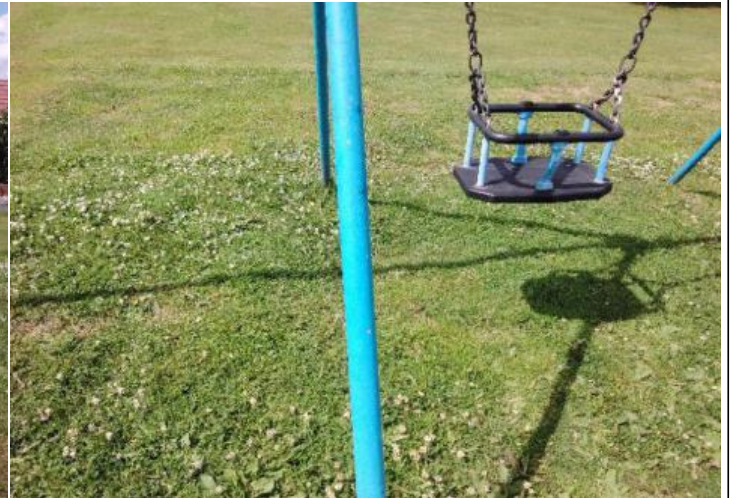
**Risk Level:** V - Very Low Risk  
**Surface:** Grass

**Finding:** The seats are too close to the frame as defined in BS EN 1176 Part 2; this is a low risk failure and no remedial action is required

**Action:** Monitor - No remedial work recommended

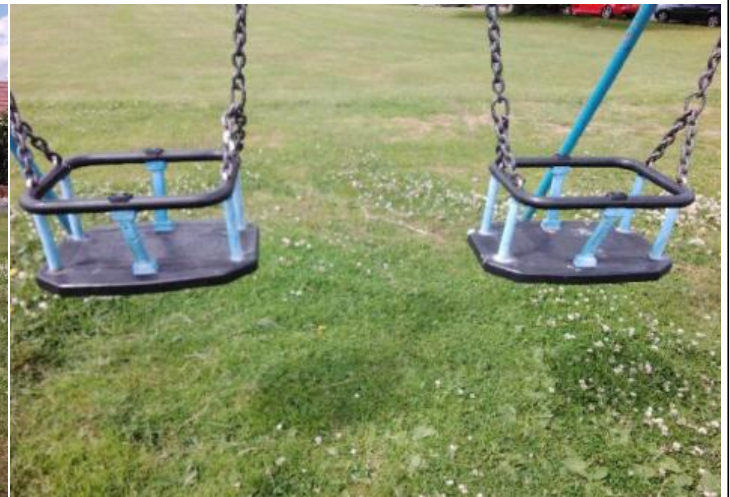
**Risk Level:** V - Very Low Risk  
**Surface:** Grass

**Finding:** The seats are too close to each other as defined in BS EN 1176 Part 2; this is a low risk failure and no remedial action is required

**Action:** Monitor - No remedial work recommended

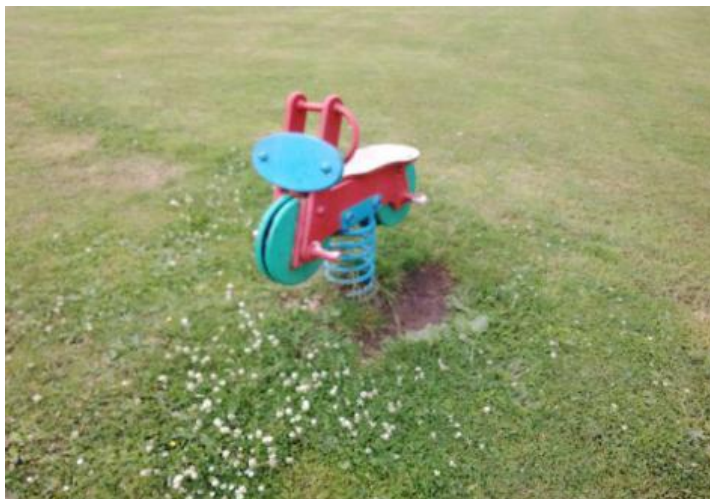
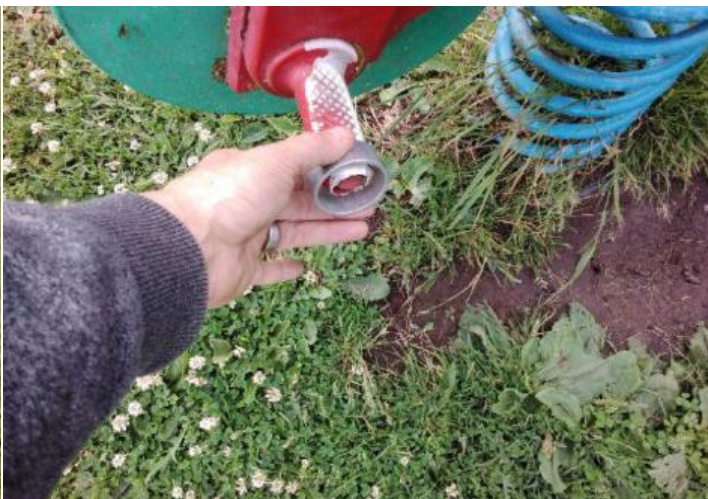
**Risk Level:** L - Low Risk  
**Surface:** Grass

**Finding:** The end of handgrips and/or footrests have a cross section of less than 15cm<sup>2</sup> and fail to meet the requirements of BS EN 1176 Part 6  
**Action:** Monitor - No remedial work recommended

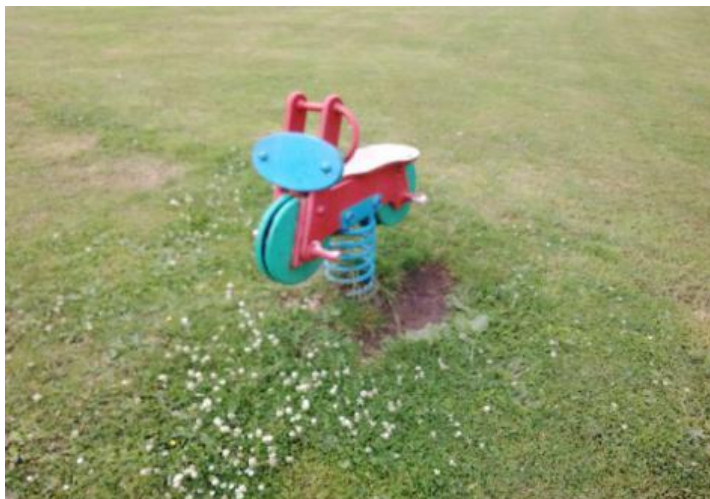
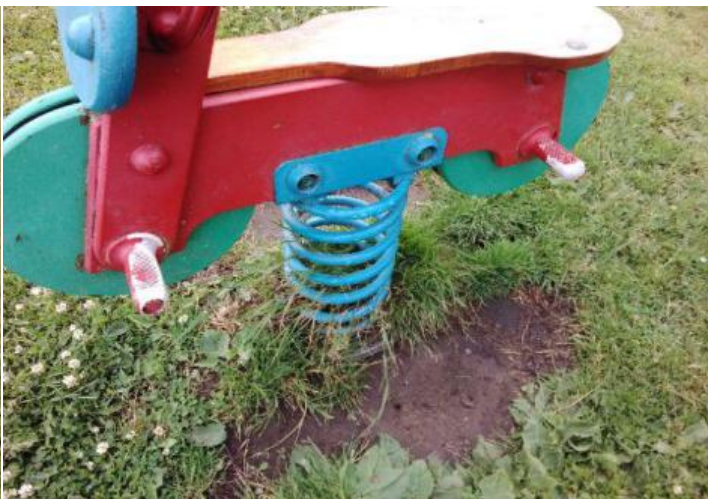
**Risk Level:** V - Very Low Risk  
**Surface:** Grass

**Finding:** There is/are bolt cap covers missing or damaged on the item  
**Action:** Replace missing or damaged bolt cap covers
