the **play inspection** company

## Annual Inspection

Frodsham Town Council

Churchfields

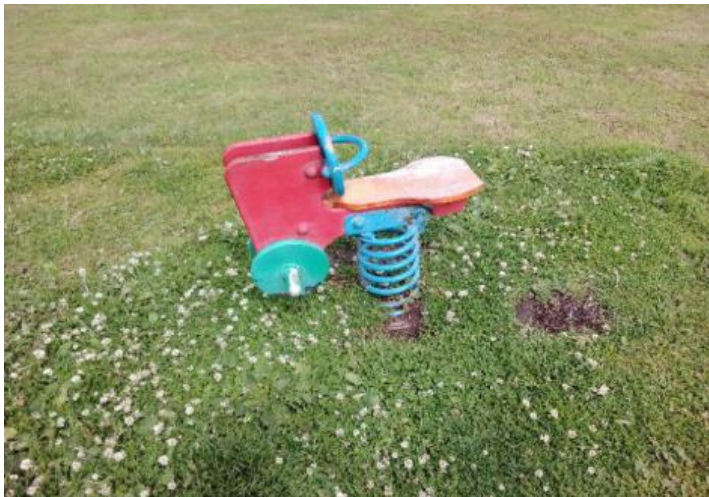
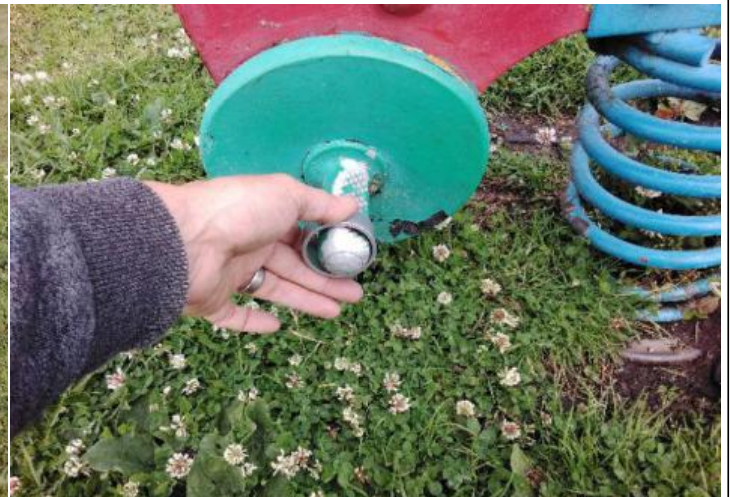
**Risk Level:** L - Low Risk  
**Surface:** Grass

**Finding:** The end of handgrips and/or footrests have a cross section of less than 15cm<sup>2</sup> and fail to meet the requirements of BS EN 1176 Part 6

**Action:** Monitor - No remedial work recommended

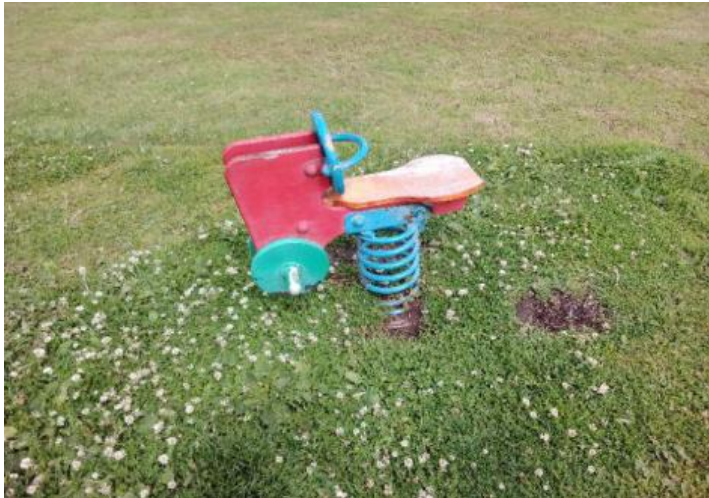
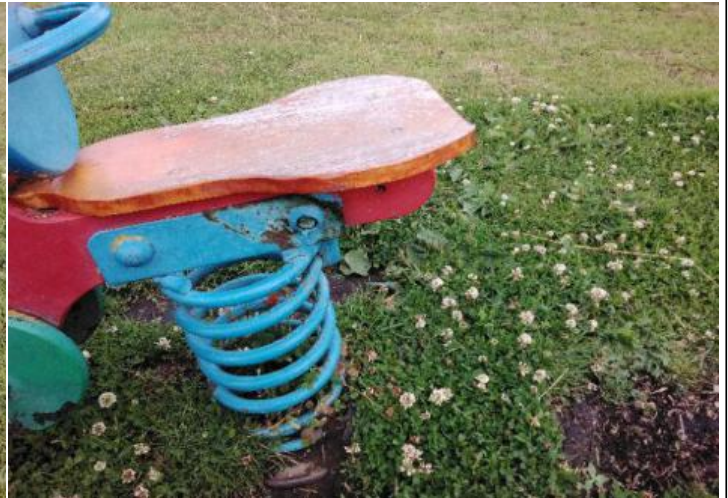
**Risk Level:** L - Low Risk  
**Surface:** Grass

**Finding:** The item has missing component(s)

**Action:** Consider replacing missing components

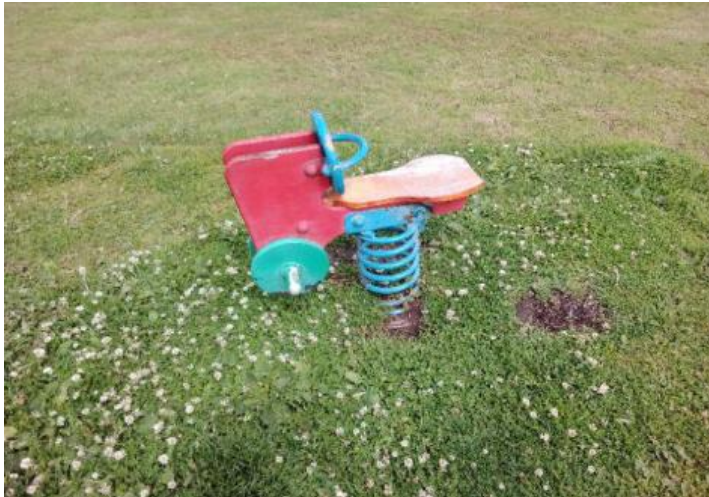
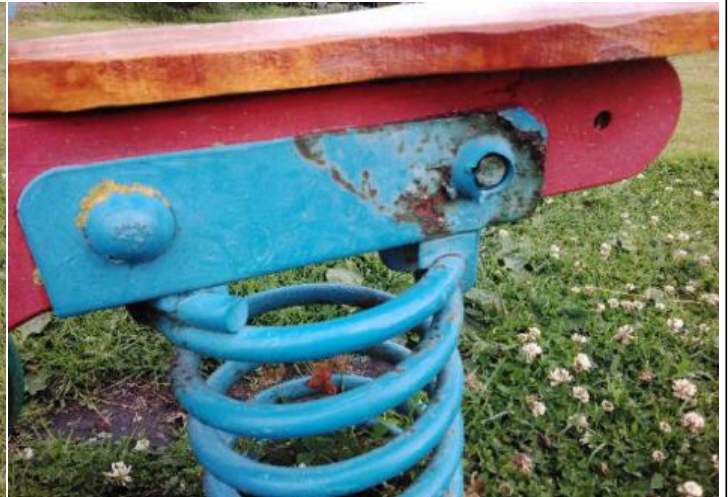
**Risk Level:** V - Very Low Risk  
**Surface:** Grass

**Finding:** There is/are bolt cap covers missing or damaged on the item

**Action:** Replace missing or damaged bolt cap covers

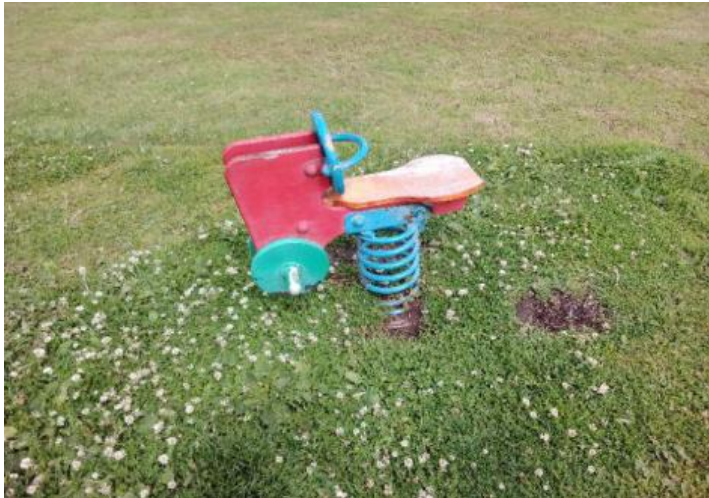
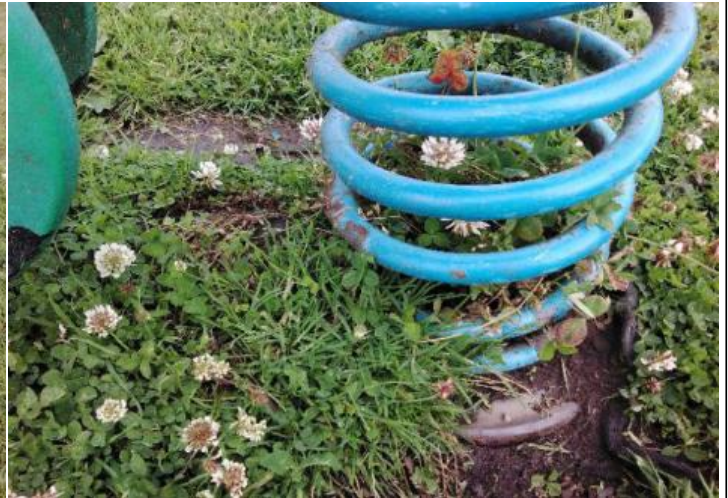
**Risk Level:** L - Low Risk  
**Surface:** Grass

**Finding:** The paintwork on the spring has been damaged or worn exposing the metal underneath which is rusting  
**Action:** Treat any rusting components and repaint

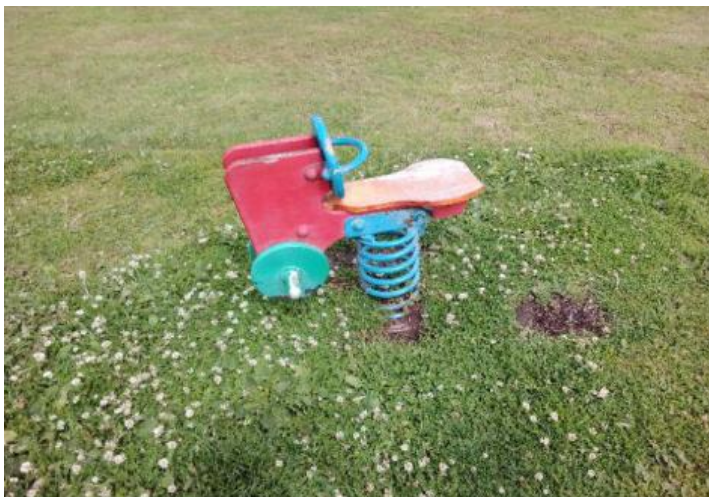
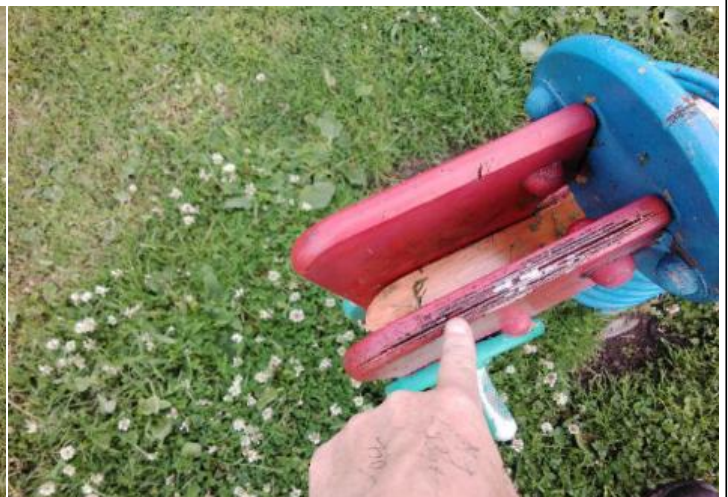
**Risk Level:** L - Low Risk  
**Surface:** Grass

**Finding:** There is some evidence of rot in the timber

**Action:** Monitor for any further deterioration and replace as required

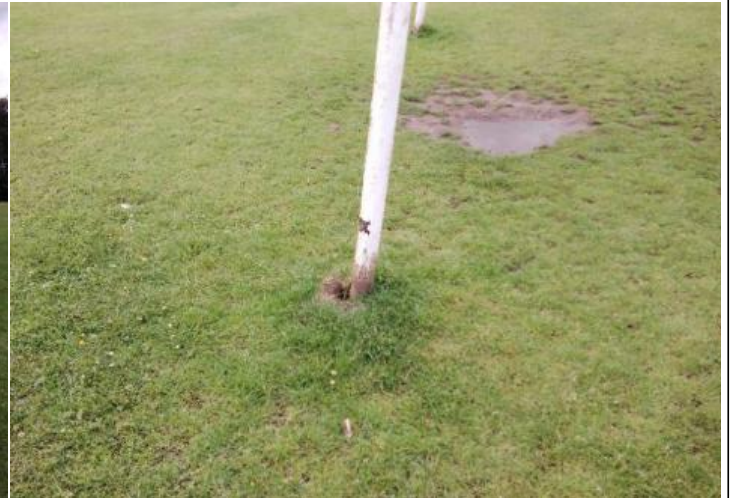
**Risk Level:** L - Low Risk  
**Surface:** Grass

**Finding:** The item is slightly loose in its foundations

**Action:** Monitor for any further deterioration and repair as required

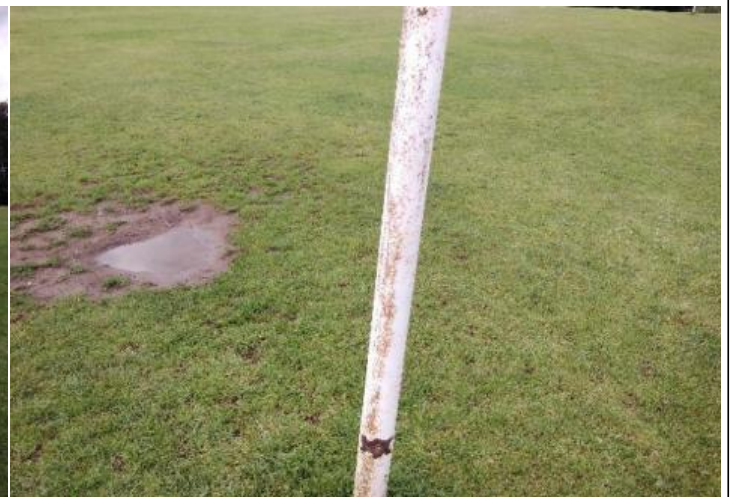
**Risk Level:** L - Low Risk  
**Surface:** Grass

**Finding:** There is surface corrosion present on the item

**Action:** Consider treating the item
