# the play inspection company

## **Annual Inspection**

Frodsham Town Council

## Top Road

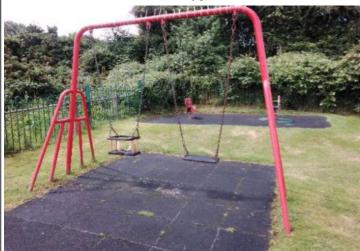
**Finding:** There is weed / vegetation growth on, between, or **Action:** Remove weed / vegetation growth around the edges of the surfacing

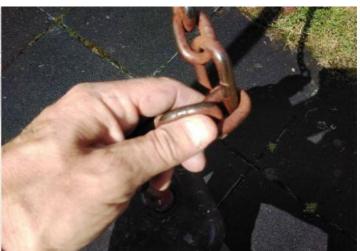
Finding: The split pins are missing from the shackles

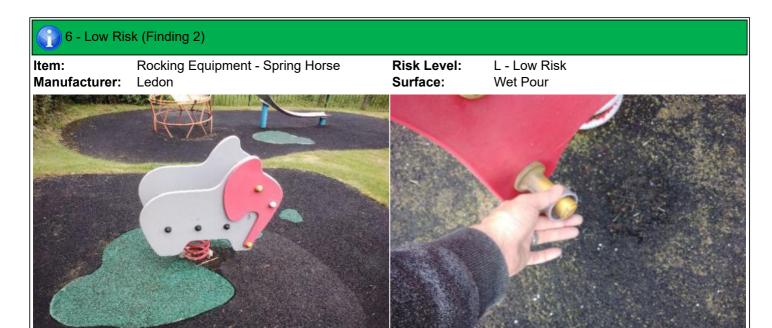
**Finding:** The end of handgrips and/or footrests have a cross **Action:** Monitor - No remedial work recommended section of less than 15cm2 and fail to meet the requirements of BS EN 1176 Part 6

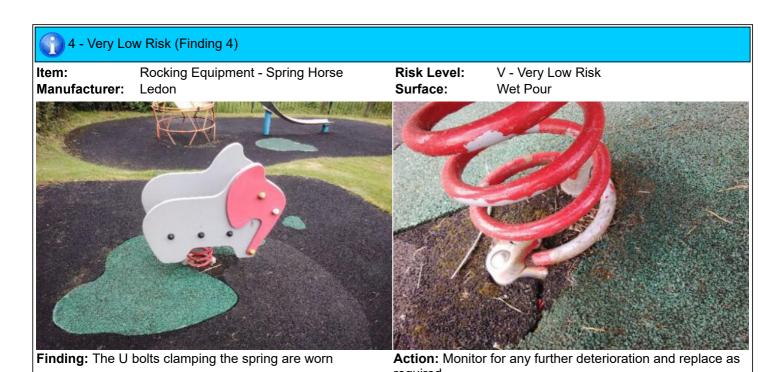
Finding: The U bolts clamping the spring are worn

**Action:** Monitor for any further deterioration and replace as required

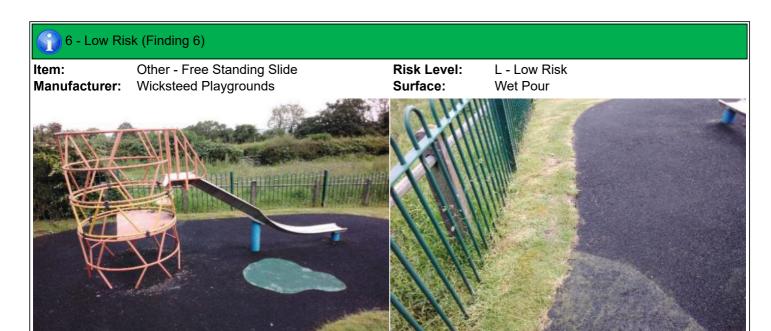
**Finding:** There is weed / vegetation growth on, between, or **Action:** Remove weed / vegetation growth around the edges of the surfacing

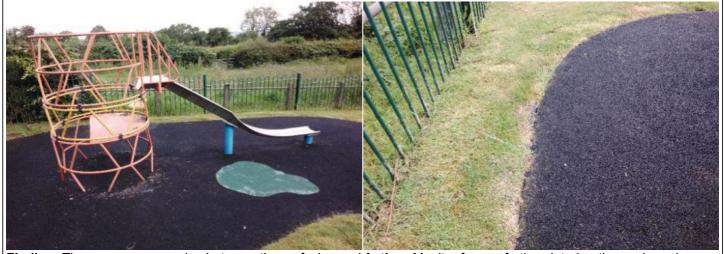
# 6 - Low Risk (Finding 7) Item: Other - Free

**Finding:** There are gaps opening between the surfacing and **Action:** Monitor for any further deterioration and repair as the edging surround or between the joints in the surfacing required

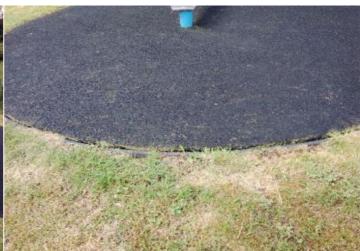
**Finding:** The surface is lifting at the edges and creating trip **Action:** Repair perimeter of surfacing to remove trip points points

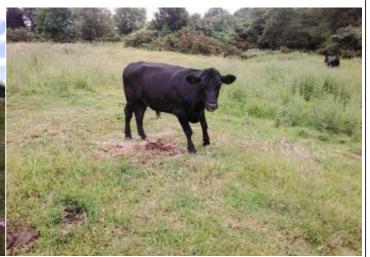
### 0 - Risk Assessment not Undertaken (Finding 1)

**Finding:** There is livestock is the access field to the play area

**Action:** Ensure there is an appropriate and up to date risk assessment in place

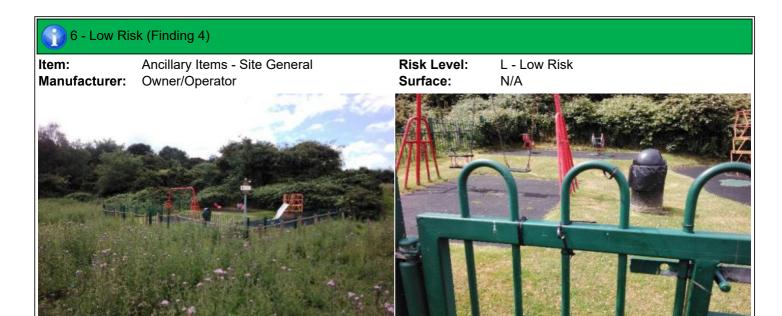
**Finding:** There are projecting ties on the equipment

**Action:** Remove ties

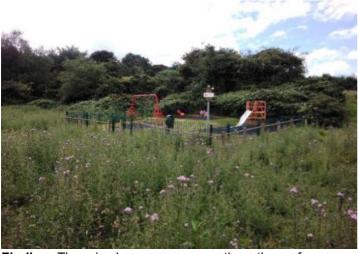
resulting in slippery conditions

Action: Clean and treat appropriately

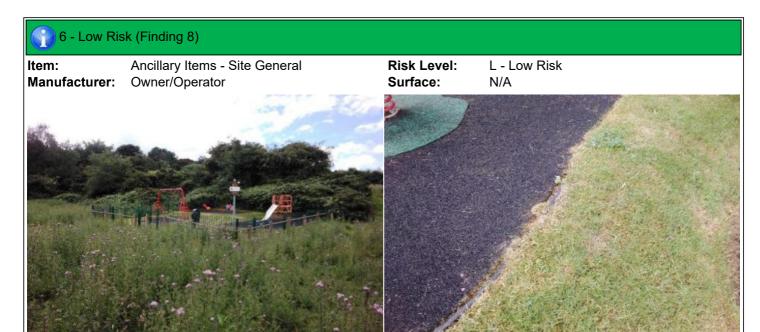
**Finding:** There is weed / vegetation growth on, between, or **Action:** Remove weed / vegetation growth around the edges of the surfacing
