Annual Inspection

Frodsham Town Council

Churchfields

Inspection Ref: 613981

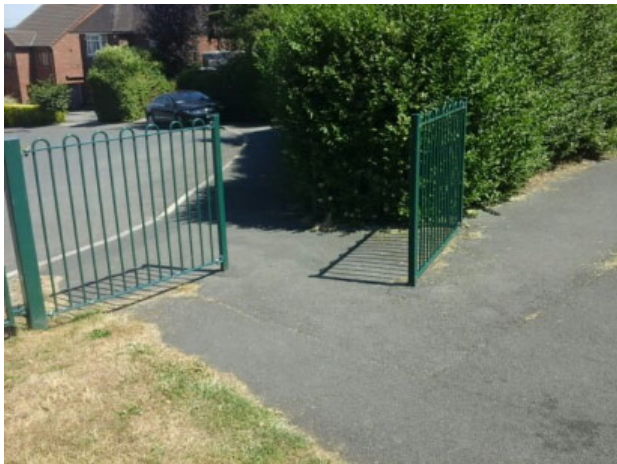
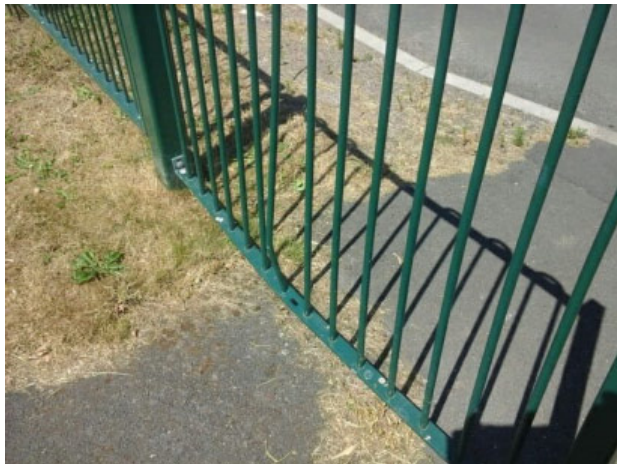
Finding:	There is slight damage to the feature		Action: Monitor for any further deterioration and repair as required

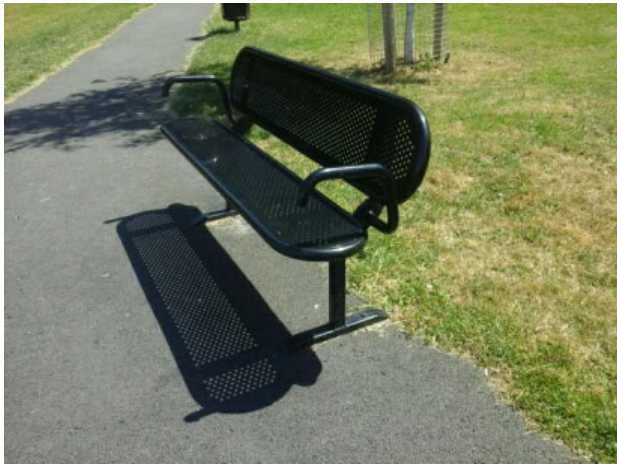
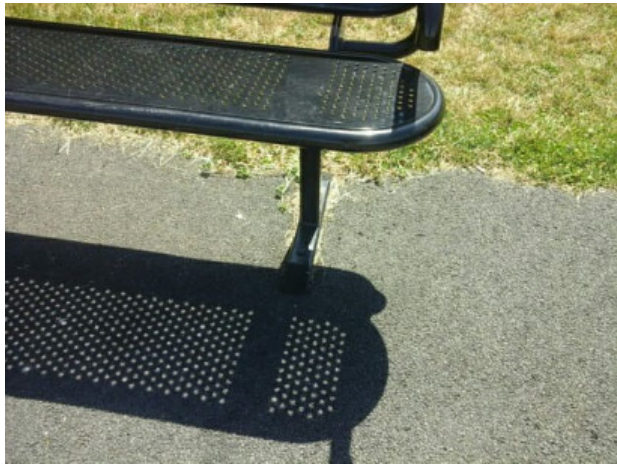
Finding:	The ground fixings are slightly loose		Action: Secure fixings

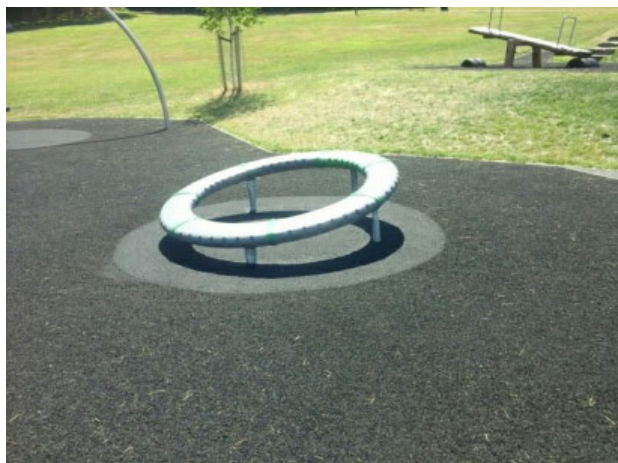
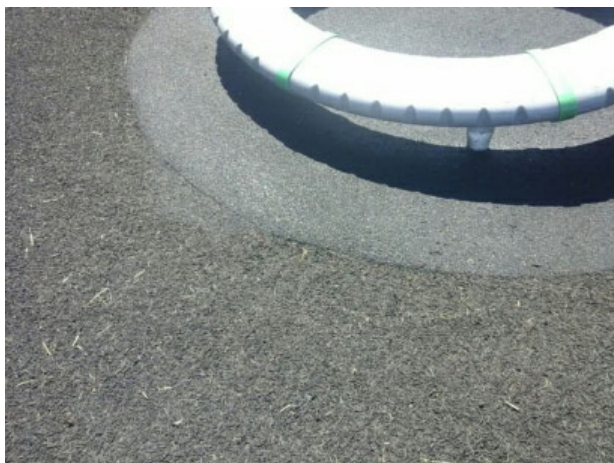
Finding: The wet pour is crumbling in areas

Action: Monitor for any further deterioration and repair as required

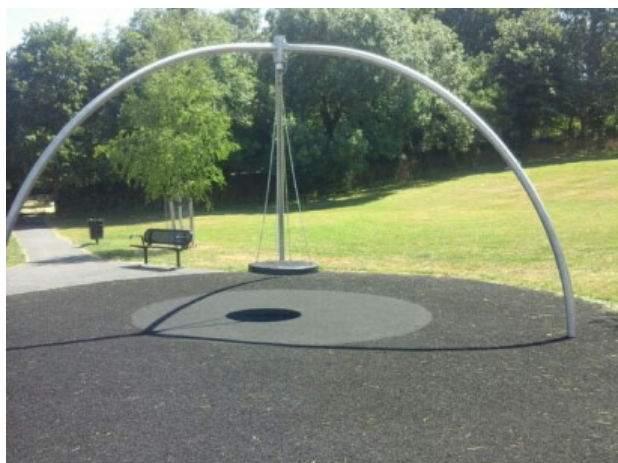
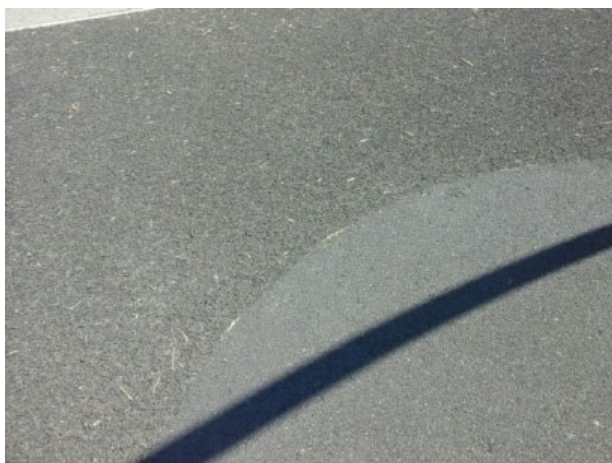
Finding: The wet pour is crumbling in areas

Action: Monitor for any further deterioration and repair as required

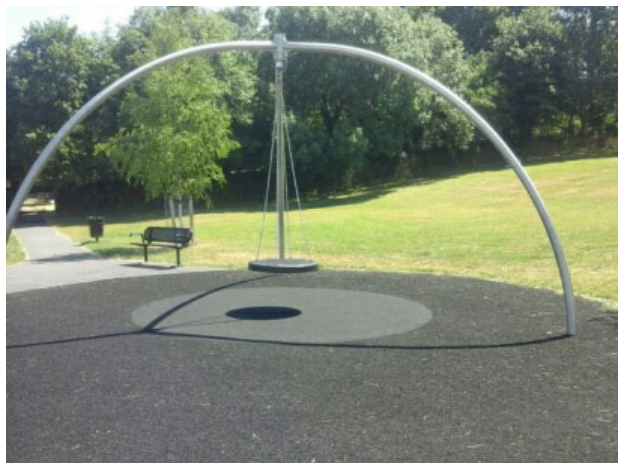
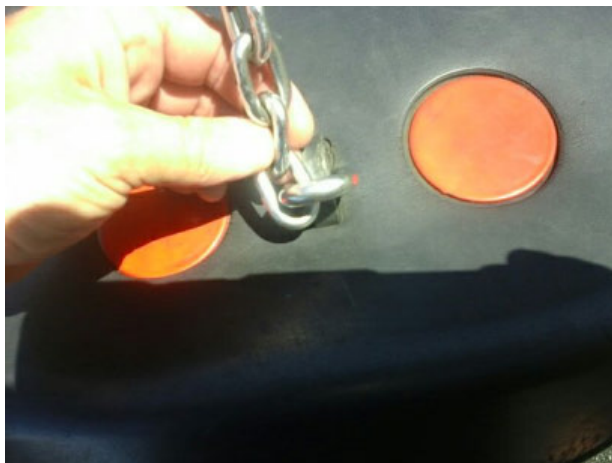
Finding: There is some notable evidence of chain wear

Action: Monitor for any further deterioration and replace when 40% worn

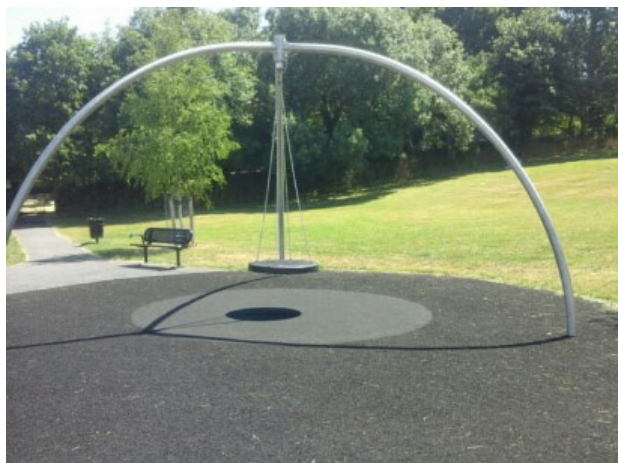
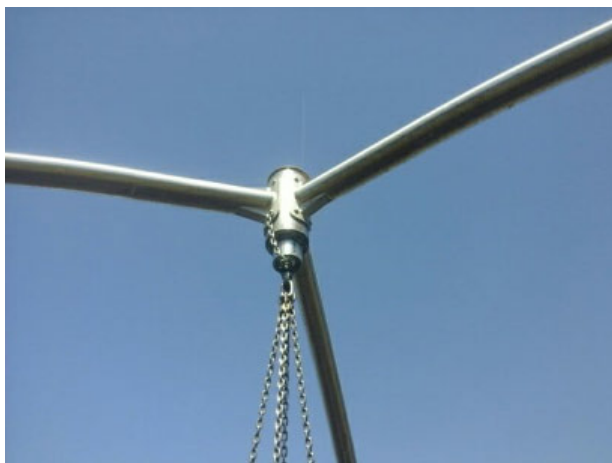
Finding: The fixings for this item were in excess of 2.5m above the standing surface and could not be fully accessed by the inspector, a maintenance inspection should be undertaken to assess wear and tear of the components

Action: Implement a maintenance inspection for this item

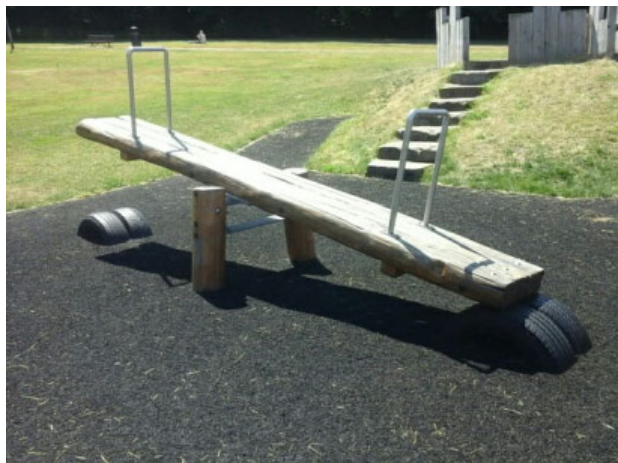
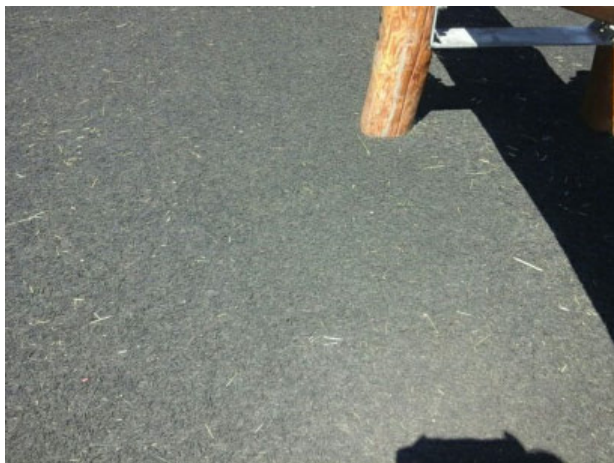
Finding: The wet pour is crumbling in areas

Action: Monitor for any further deterioration and repair as required

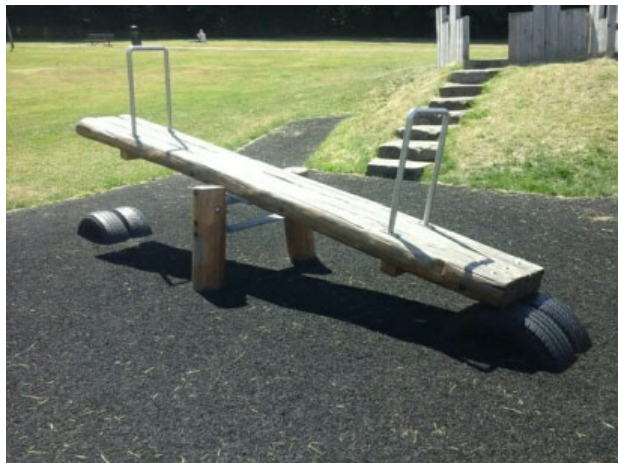
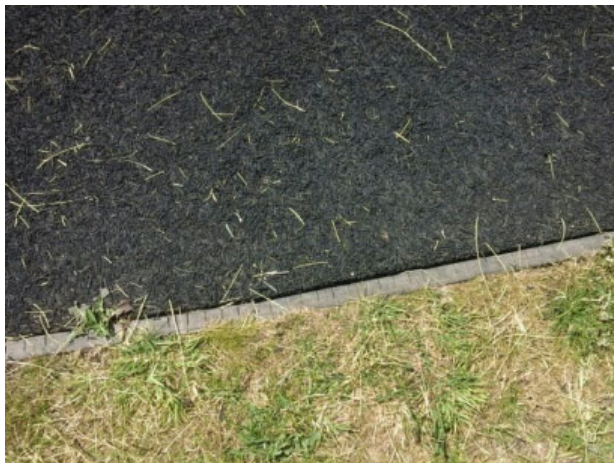
Finding: There are gaps opening between the surfacing and the edging surround or between the joints in the surfacing

Action: Monitor for any further deterioration and repair as required

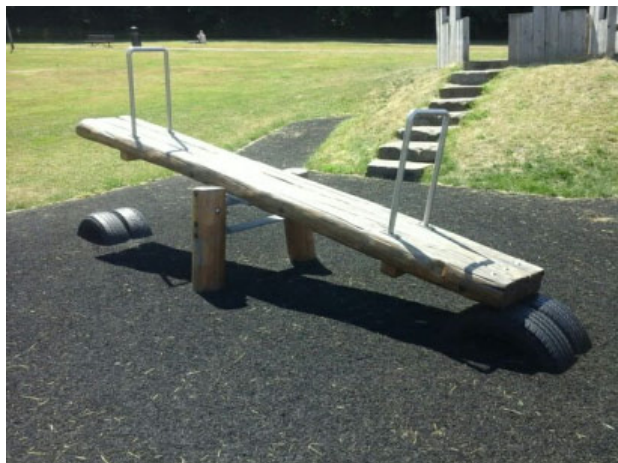
Finding: There are trip hazards at the edges of the surface

Action: Reinstate surrounding surface levels to remove the trip points

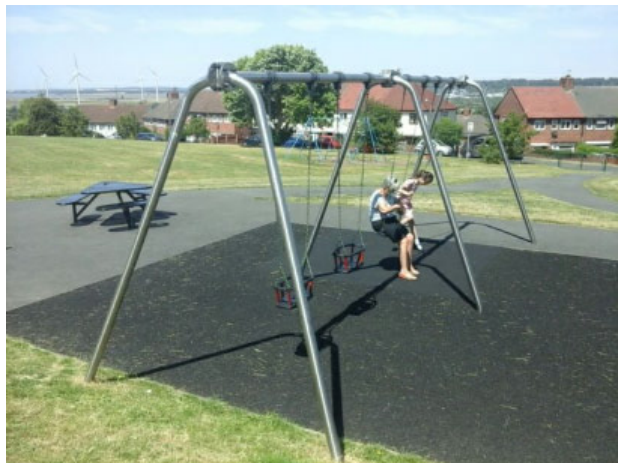
Finding: There are gaps opening between the surfacing and the edging surround or between the joints in the surfacing

Action: Monitor for any further deterioration and repair as required

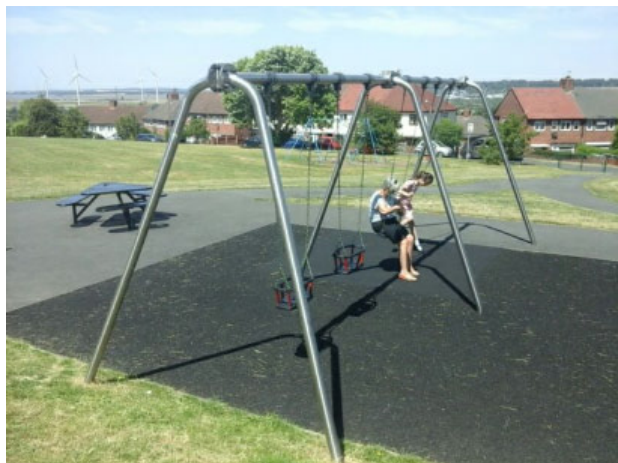
Finding: The wet pour is crumbing in areas

Action: Monitor for any further deterioration and repair as required

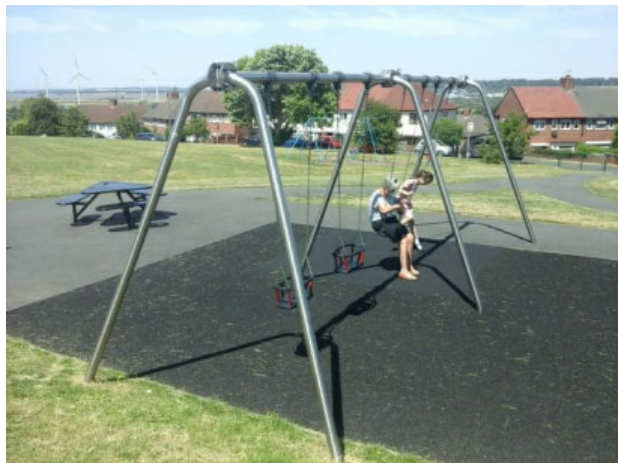
Finding: The seat has minor damage or wear

Action: Monitor for any further deterioration and replace as required

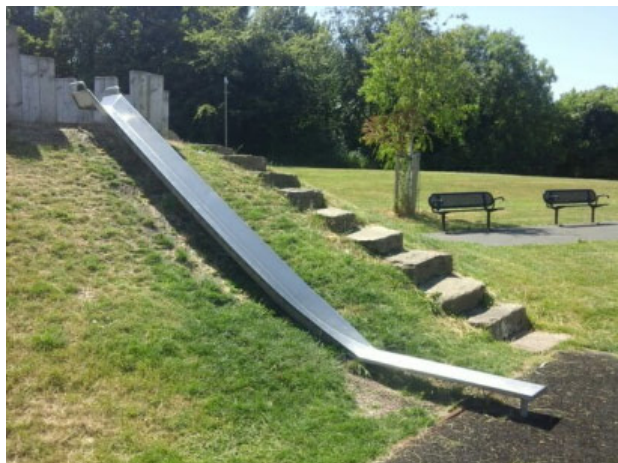
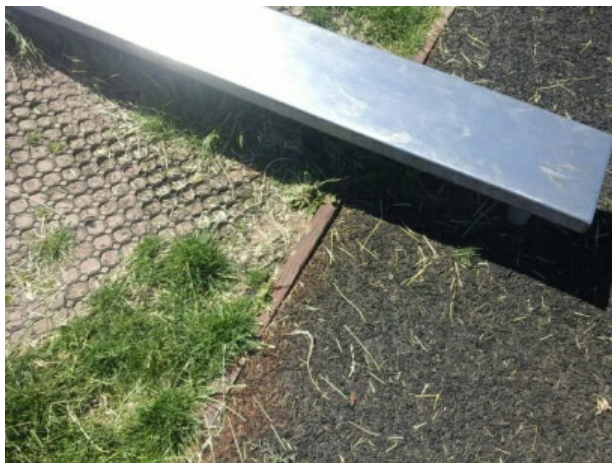
Finding: There are trip hazards at the edges of the surface

Action: Reinstate surrounding surface levels to remove the trip points

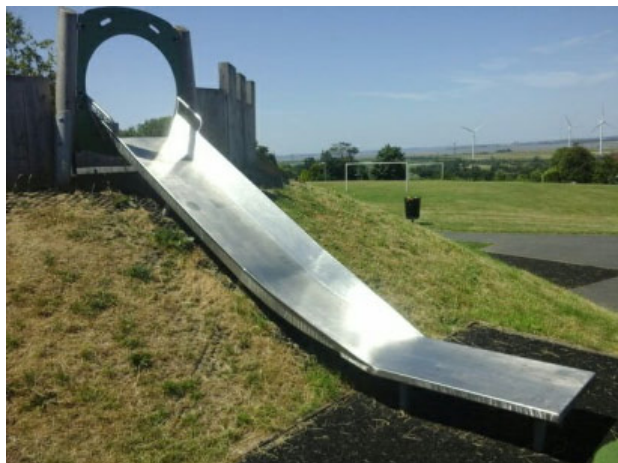
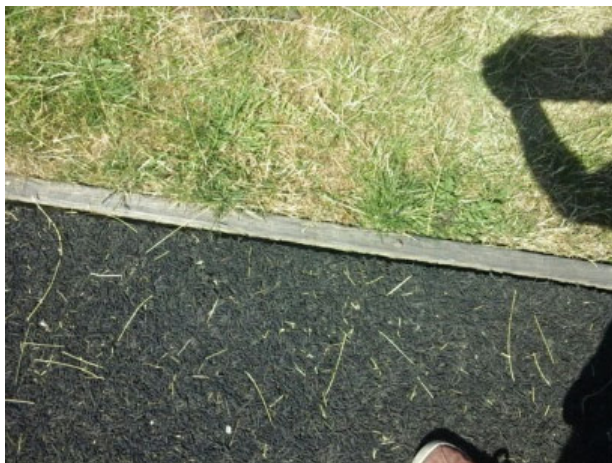
Finding: There are gaps opening between the surfacing and the edging surround or between the joints in the surfacing

Action: Monitor for any further deterioration and repair as required

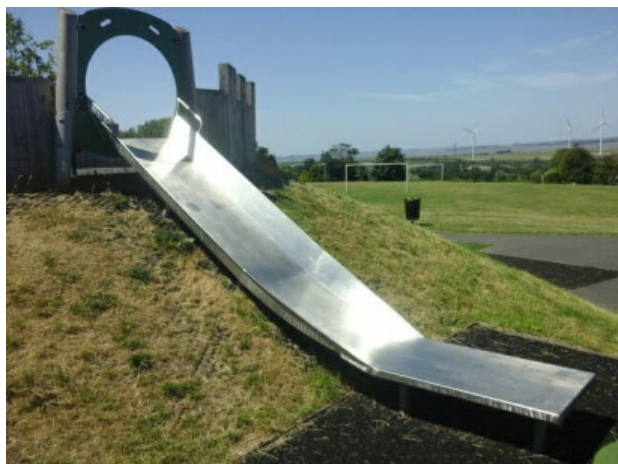
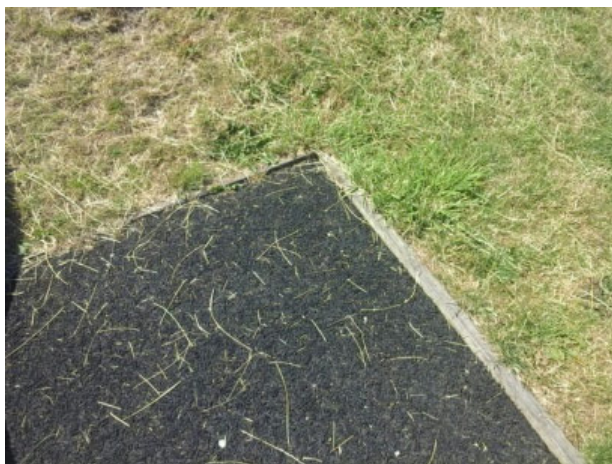
Finding: There are trip hazards at the edges of the surface

Action: Reinstate surrounding surface levels to remove the trip points

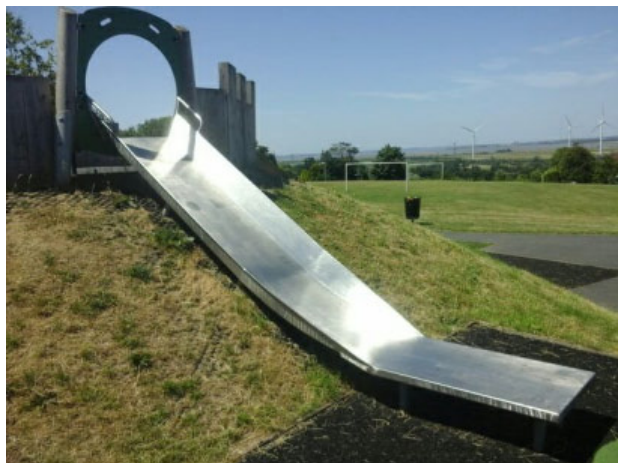
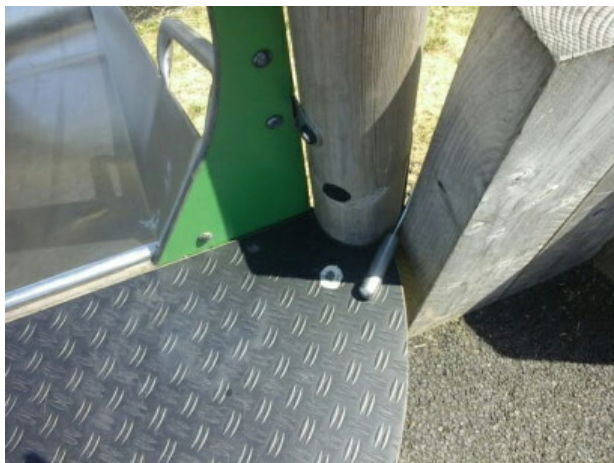
Finding: There is/are finger entrapment/s in the slide start and the item fails to meet the requirements of BS EN 1176:2008 Part 1 4.2.7.6 Entrapment of fingers

Action: Monitor use

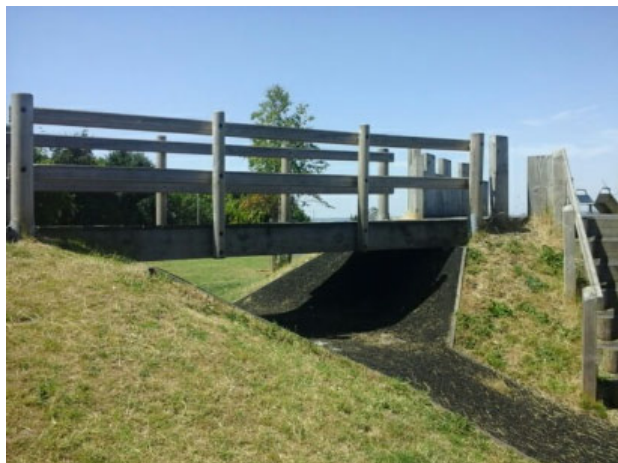
Finding: The surfacing around the item is damaged and is creating a potential trip hazard

Action: Repair the damaged areas of surfacing

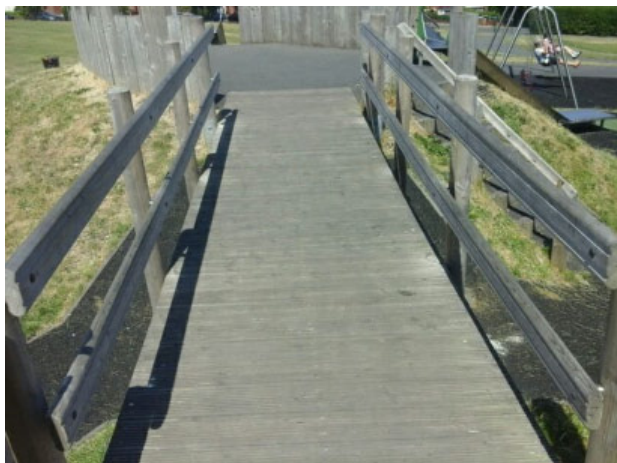
Finding: The timber has a number of air cracks apparent, the splits will have penetrated the preservative applied to the timber and allow water ingress to the unprotected areas

Action: Monitor for any deterioration (rot) and replace as required

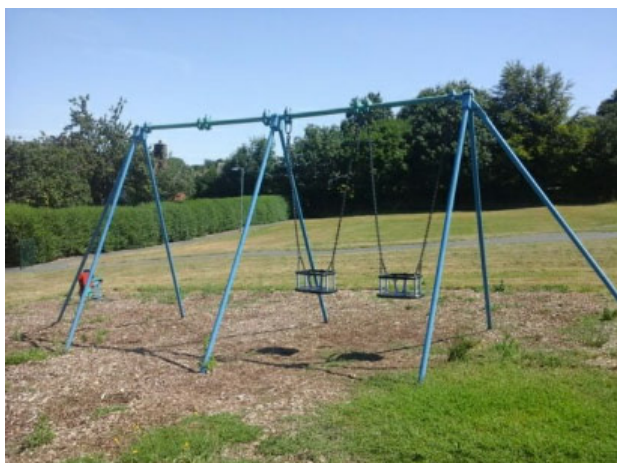
Finding: The loose fill safety surfacing has become compacted and degraded to mulch

Action: Rake and fork over to aerate the surface

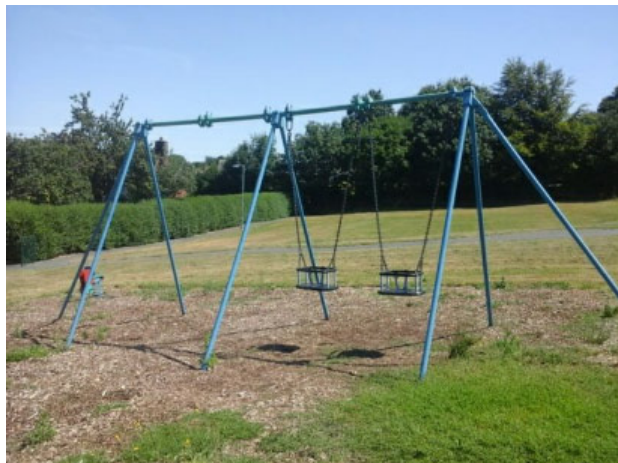
Finding: There are trip hazards at the edges of the surface

Action: Reinstate surrounding surface levels to remove the trip points

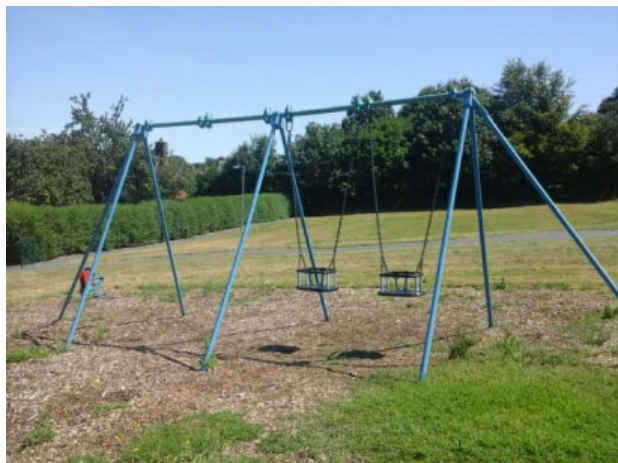
Finding: The edging timbers are damaged

Action: Repair

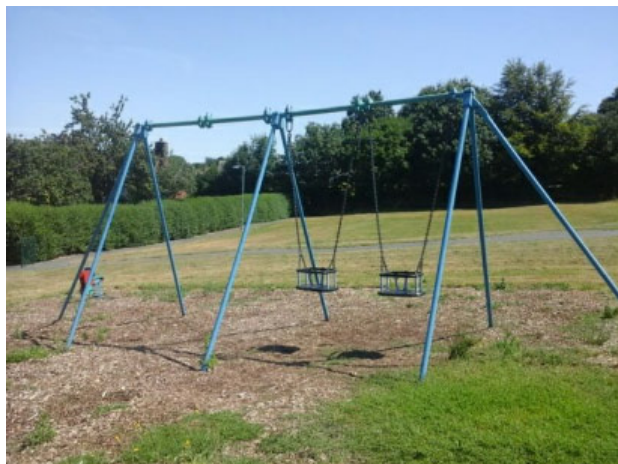
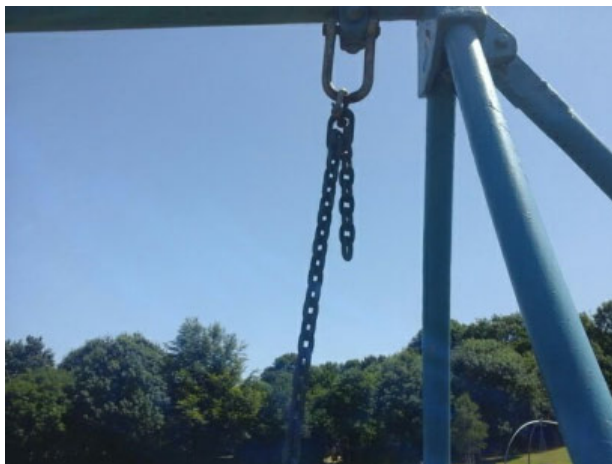
Finding: There are excessive chain tails

Action: Cut back excessive chain links (two links through the quick link connector are recommended)

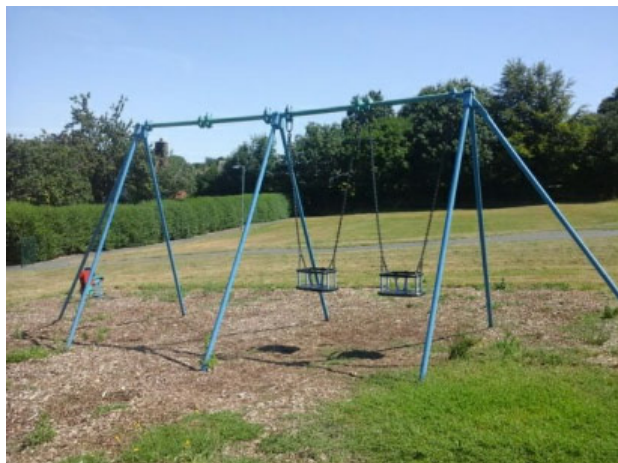
Finding: The bushes are worn or missing

Action: Replace worn or missing bushes

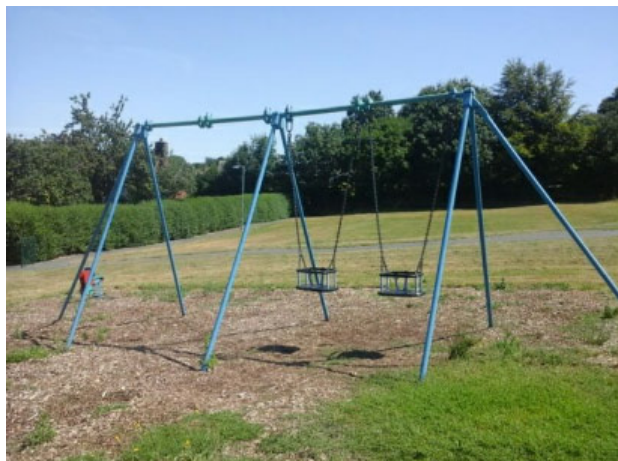
Finding: The level of loose fill surfacing has fallen significantly below the minimum 200mm recommended by BS EN 1176 Part 1

Action: Top up loose fill surfacing to recommended levels.

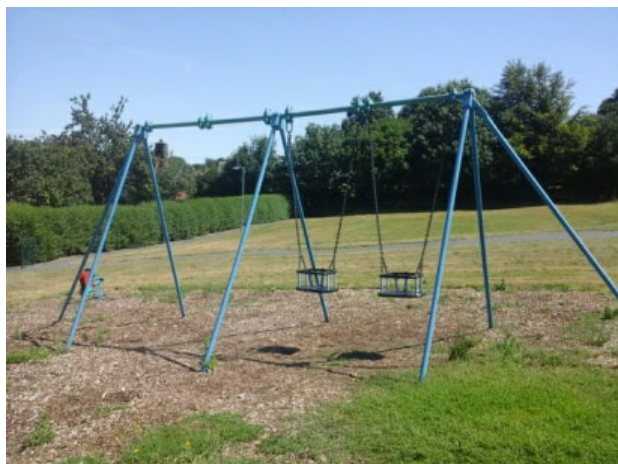
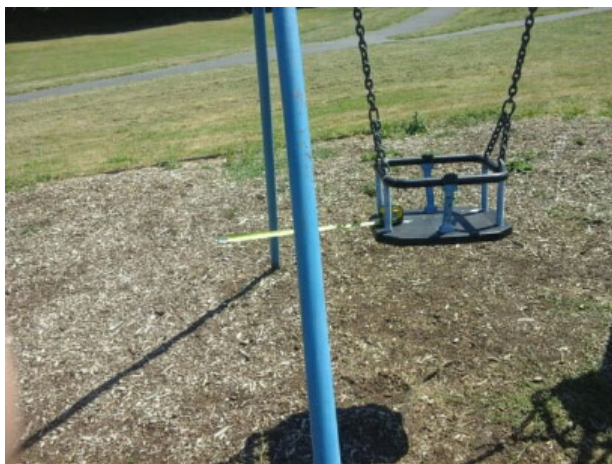
Finding: The seats are too close to the frame as defined in BS EN 1176 Part 2; this is a low risk failure and no remedial action is required

Action: Monitor use

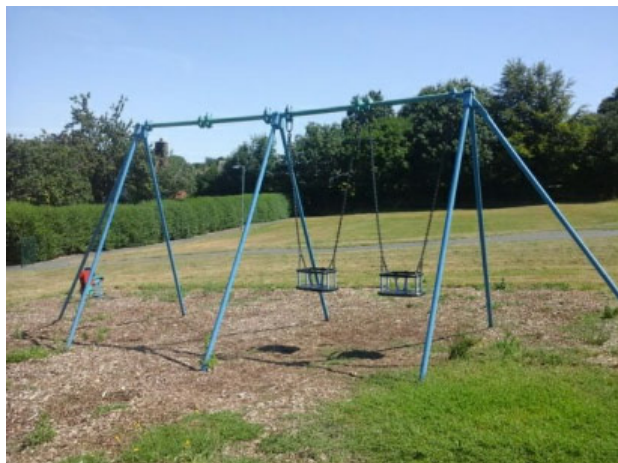
Finding: The seats are too close to each other as defined in BS EN 1176 Part 2; this is a low risk failure and no remedial action is required

Action: Monitor use

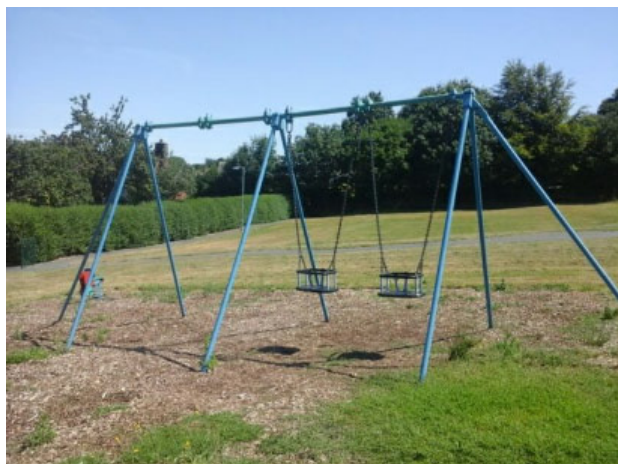
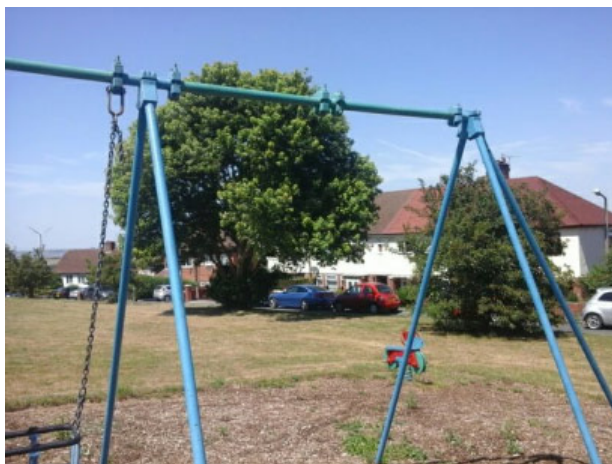
Finding: The seat(s) and suspension were missing at the time of inspection and the inspector was unable to make a full compliance assessment

Action: Replace missing seat(s) and suspension

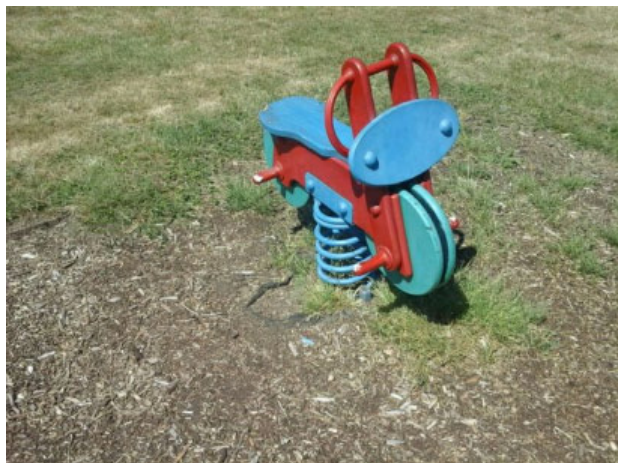
Finding: The loose fill safety surfacing has become compacted and degraded to mulch

Action: Rake and fork over to aerate the surface

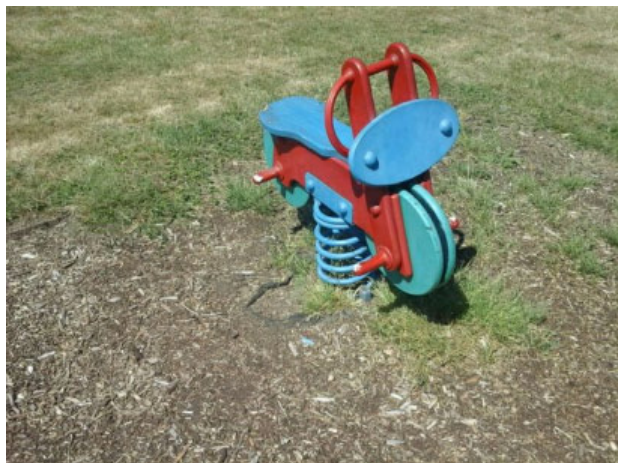
Finding: The level of loose fill surfacing has fallen significantly below the minimum 200mm recommended by BS EN 1176 Part 1

Action: Top up loose fill surfacing to recommended levels.

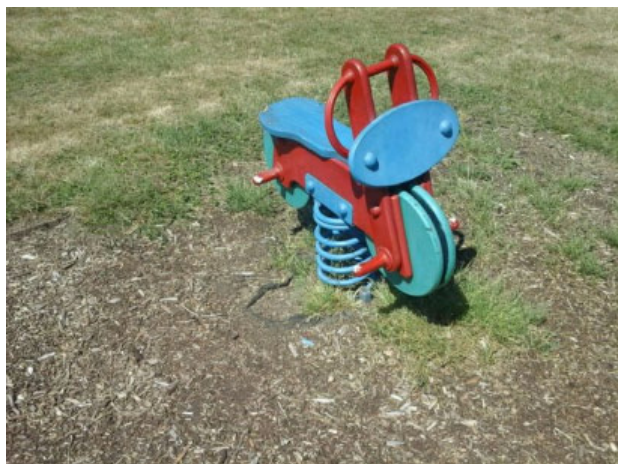
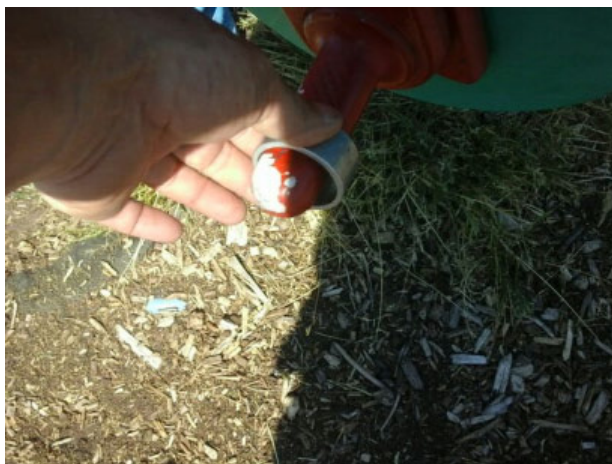
Finding: The end of handgrips and/or footrests have a cross section of less than 15cm² and fail to meet the requirements of BS EN 1176 Part 6

Action: This is a relatively low risk failure and no remedial action is recommended

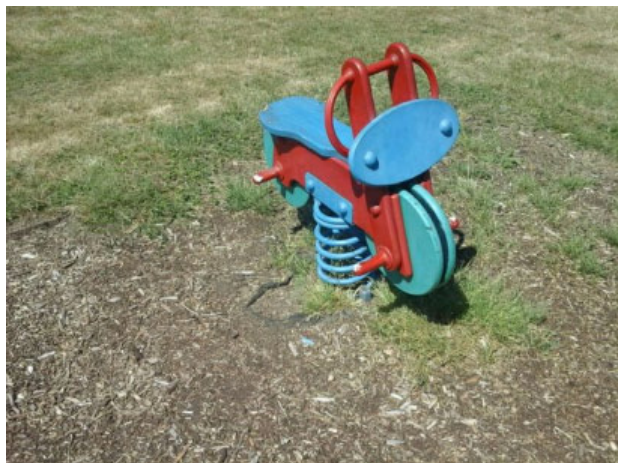
Finding: There is some evidence of rot in the timber

Action: Monitor for any further deterioration and replace as required

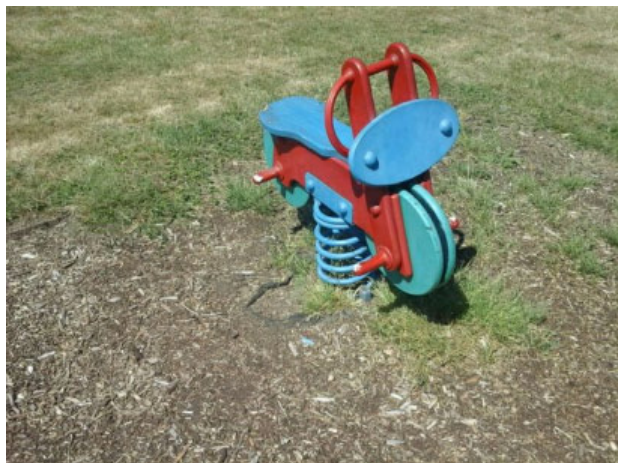
Finding: The item is slightly loose in its foundations

Action: Monitor for any further deterioration and repair as required

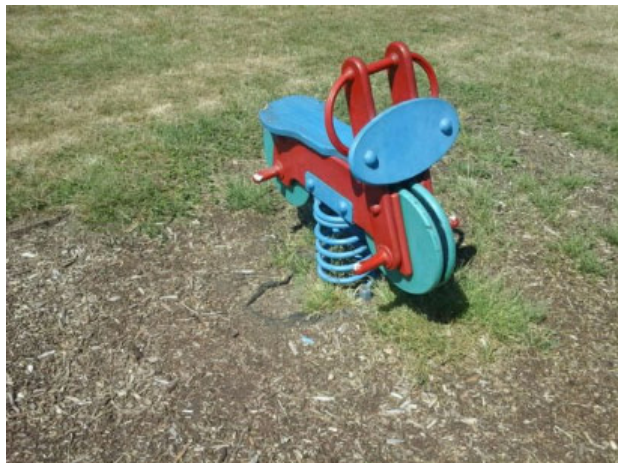
Finding: There is/are bolt cap covers missing or damaged on the item

Action: Replace missing or damaged bolt cap covers

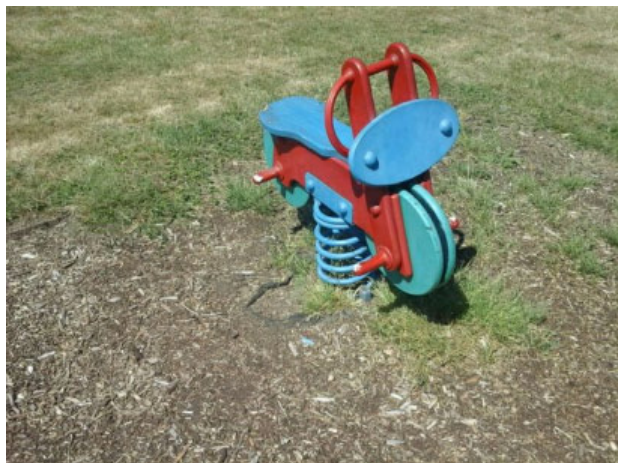
Finding: The seat is loose

Action: Re secure seat

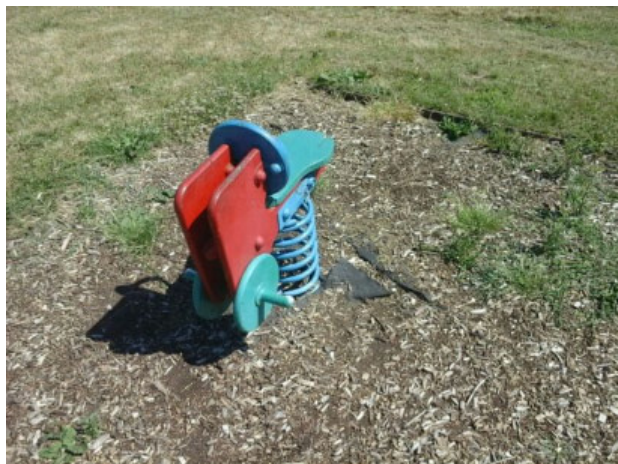
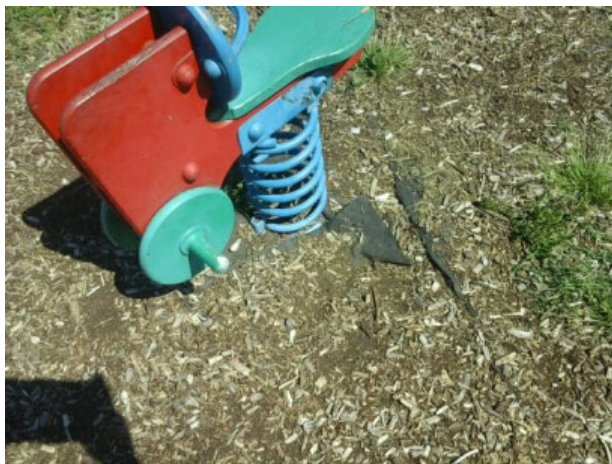
Finding: The loose fill safety surfacing has become compacted and degraded to mulch

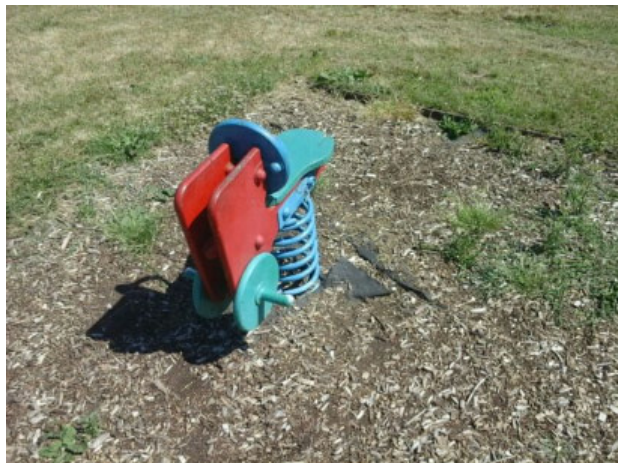
Finding: The level of loose fill surfacing has fallen significantly below the minimum 200mm recommended by BS EN 1176 Part 1

Action: Top up loose fill surfacing to recommended levels.

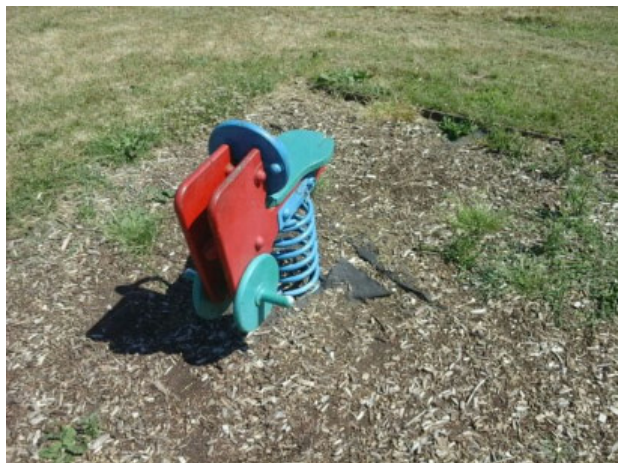
Finding: There is/are bolt cap covers missing or damaged on the item

Action: Replace missing or damaged bolt cap covers

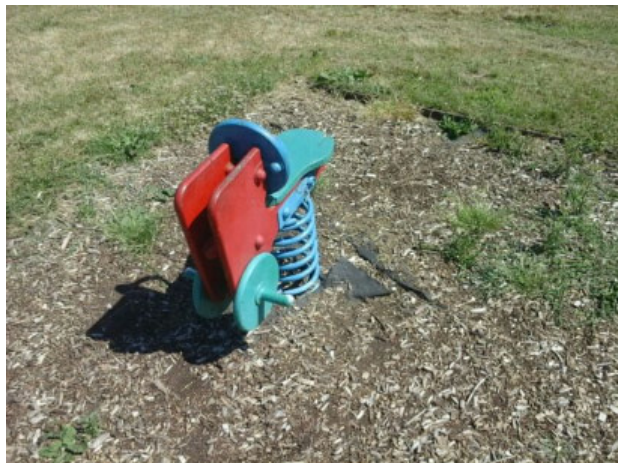
Finding: There is some evidence of rot in the timber

Action: Monitor for any further deterioration and replace as required

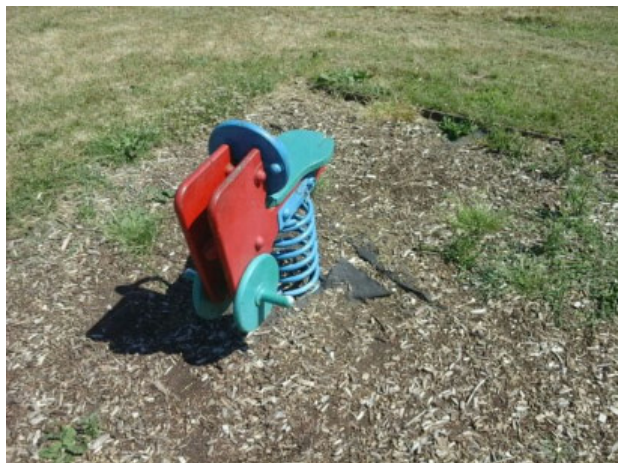
Finding: The item is slightly loose in its foundations

Action: Monitor for any further deterioration and repair as required

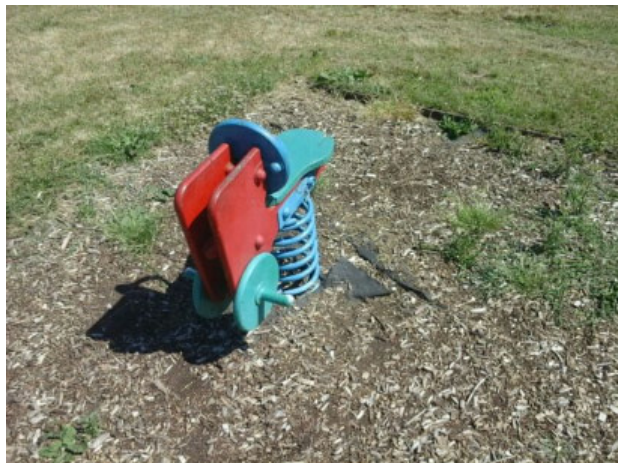
Finding: The item has missing component(s)

Action: Consider replacing missing components

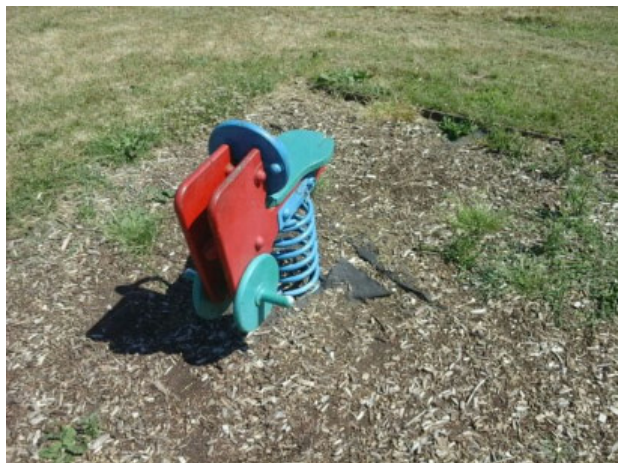
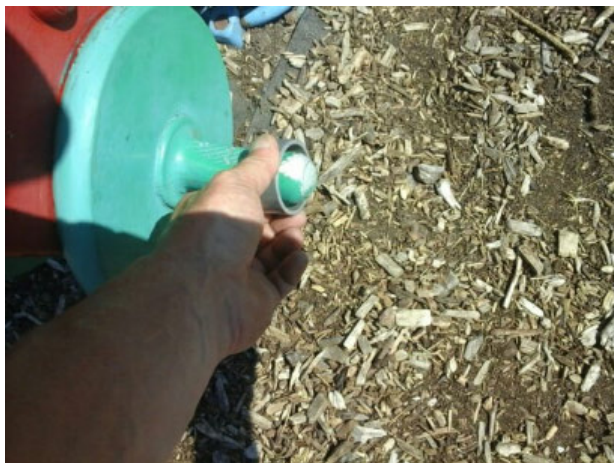
Finding: The end of handgrips and/or footrests have a cross section of less than 15cm² and fail to meet the requirements of BS EN 1176 Part 6

Action: This is a relatively low risk failure and no remedial action is recommended

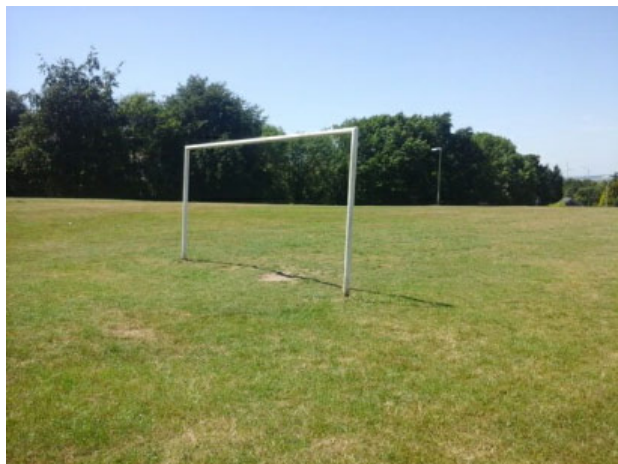
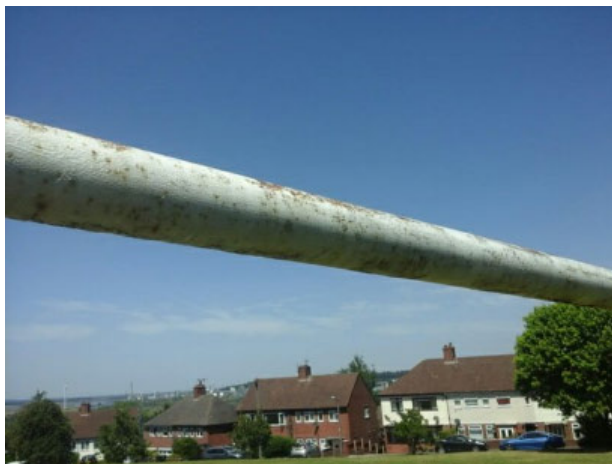
Finding: The paintwork on this item has been damaged or worn exposing the metal underneath which is rusting

Action: Treat any rusting components and repaint
