Annual Inspection

Frodsham Town Council

Townfield Lane

Annual Inspection - 02 July 2018 at 13:27 Inspector: Matt Hall RPII Annual Inspector (Outdoor)

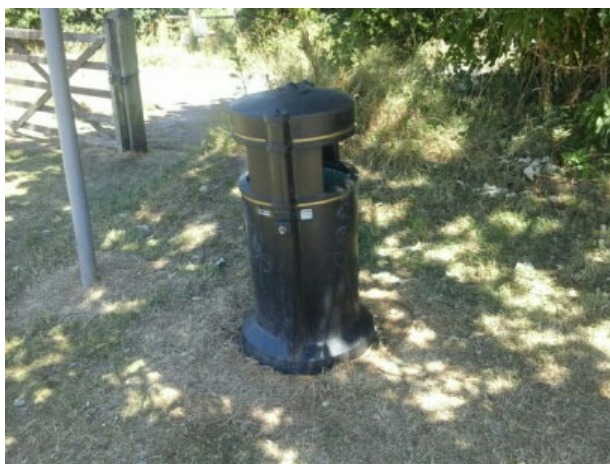
Item: Ancillary Items - Litter Bin
Manufacturer: Owner/Operator
Surface Type: N/A
Equipment Compliance: N/A
Surface Area Compliance: N/A
Ref/Part Number:
Total Findings: 2

There is some graffiti present - Remove the graffiti

The lid or door of the litter bin is not secured - Ensure the lid or door is kept locked

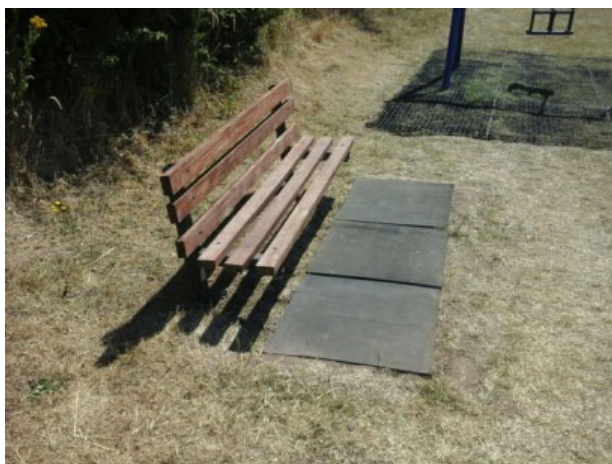
Item: Ancillary Items - Bench
Manufacturer: Owner/Operator
Surface Type: Grass
Equipment Compliance: N/A
Surface Area Compliance: N/A
Ref/Part Number:
Total Findings: 1

There are trip hazards present - Reinstate surrounding surfaces to level to remove the trip points

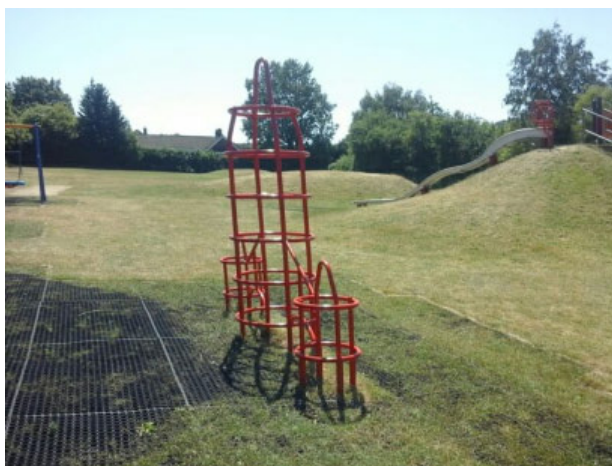
Item: Activity Equipment - Climbing Frame
Manufacturer: Not Identified
Surface Type: Grass Matrix Tiles
Equipment Compliance: No
Surface Area Compliance: Yes
Ref/Part Number:
Total Findings: 2

There are falls in excess of 600mm between adjacent components on the structure, in contravention of the recommendations set out in BS EN 1176 Part 1; 4.2.8.4 - Monitor use

The surface has subsided in some areas - Monitor for any further deterioration and repair as required

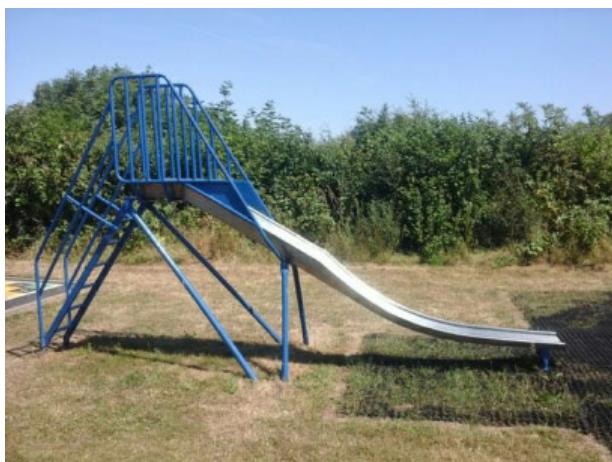
Item: Other - Free Standing Slide
Manufacturer: Wicksteed Playgrounds
Surface Type: Grass
Equipment Compliance: No
Surface Area Compliance: Yes
Ref/Part Number:
Total Findings: 4

This item has no slide bar fitted as required by BS EN 1176 Part 3 - Monitor use

There are a number of dents in the slide surface - Monitor for any further deterioration and repair as required

The item fails to meet the requirements of BS EN 1176:2008 Part 1 4.2.7.2 head and neck entrapment in the barriers and/or steps - Monitor use

There are projecting bolt thread(s) present - Remove excess thread length and deburr or provide cap

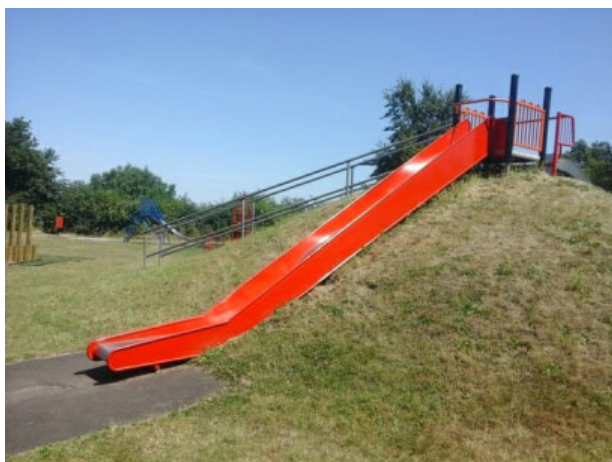
Item: Other - Embankment Slide
Manufacturer: Hags SMP
Surface Type: Wet Pour
Equipment Compliance: Yes
Surface Area Compliance: Yes
Ref/Part Number:
Total Findings: 4

The safety surface around the area is beginning to wear - Monitor for any further deterioration and repair as required

There are a number of dents in the slide surface - Monitor for any further deterioration and repair as required

There is or are fixings missing on the item - Replace all missing fixings

The surface has eroded in some areas - Reinstatement the surface

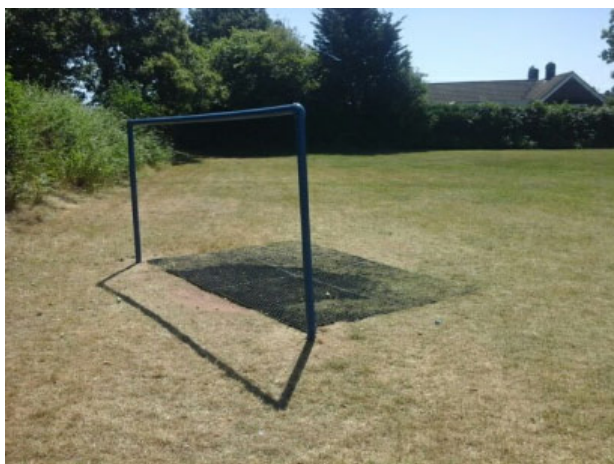
Item: Multi Use Games Area - Goal End
Manufacturer: Owner/Operator
Surface Type: All Weather Surface
Equipment Compliance: N/A
Surface Area Compliance: N/A
Ref/Part Number:
Total Findings: 3

The surface has eroded in some areas - Reinstate the surface

The edges of the grass mat surface have not been installed in accordance with the API Code of Practice - Tuck in edges of grass mat to remove trip hazards

The item is slightly loose in its foundations - Monitor for any further deterioration and repair as required

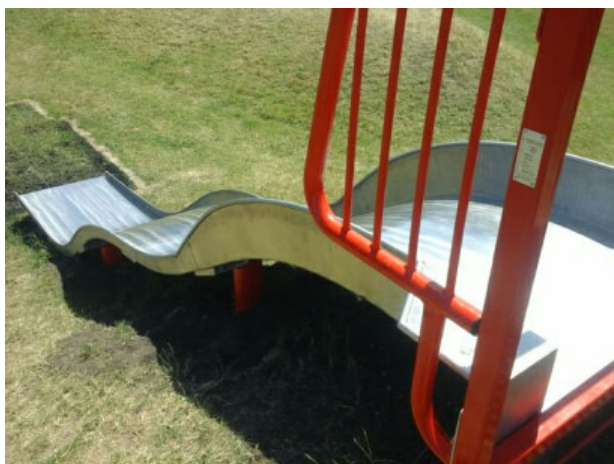
Item: Other - Embankment Slide
Manufacturer: Wicksteed Playgrounds
Surface Type: Grass Matrix Tiles
Equipment Compliance: Yes
Surface Area Compliance: Yes
Ref/Part Number:
Total Findings: 1

The surface has eroded and the foundations are exposed - Reinstate surrounding surfaces to cover the foundations

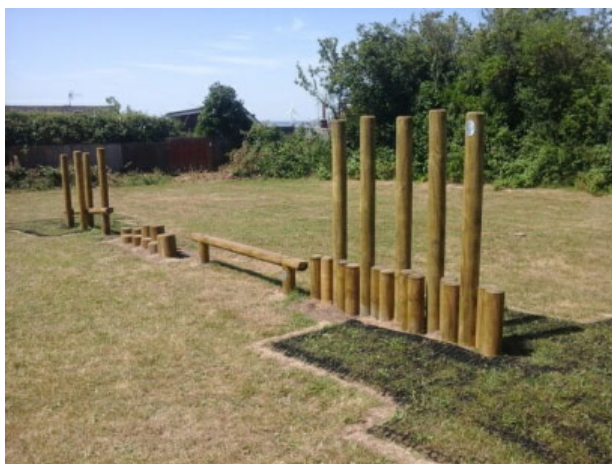
Item: Activity Equipment - Activity Trail
Manufacturer: Wicksteed Playgrounds
Surface Type: Grass
Equipment Compliance: No
Surface Area Compliance: Yes
Ref/Part Number:
Total Findings: 3

The surface has eroded in some areas - Reinstate the surface

There are trip hazards present - Reinstate surrounding surfaces to level to remove the trip points

The projecting foundations forms a hard object within the falling space of the equipment in contravention of the requirements of BS EN 1176 Part 1 - Reinstate surface

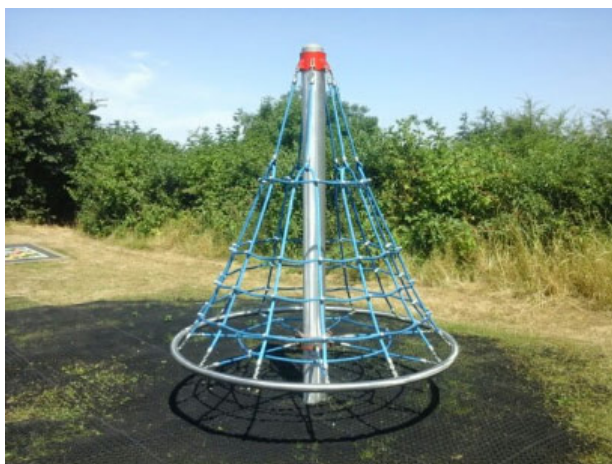
Item: Rotor Play - Cone Climber
Manufacturer: Wicksteed Playgrounds
Surface Type: Grass Matrix Tiles
Equipment Compliance: Yes
Surface Area Compliance: Yes
Ref/Part Number:
Total Findings: 1

Fixing Pins have been installed in the impact areas of the grass mats - Remove pins from impact areas

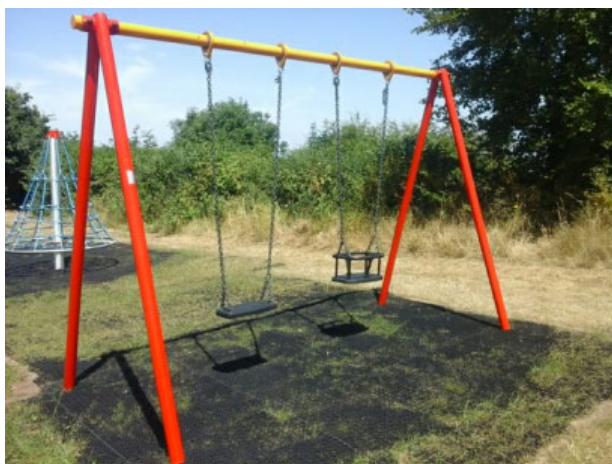
Item: Swings - 1 Bay 2 Seat Swing
Manufacturer: Wicksteed Playgrounds
Surface Type: Grass Matrix Tiles
Equipment Compliance: Yes
Surface Area Compliance: Yes
Ref/Part Number:
Total Findings: 1

Fixing Pins have been installed in the impact areas of the grass mats - Remove pins from impact areas

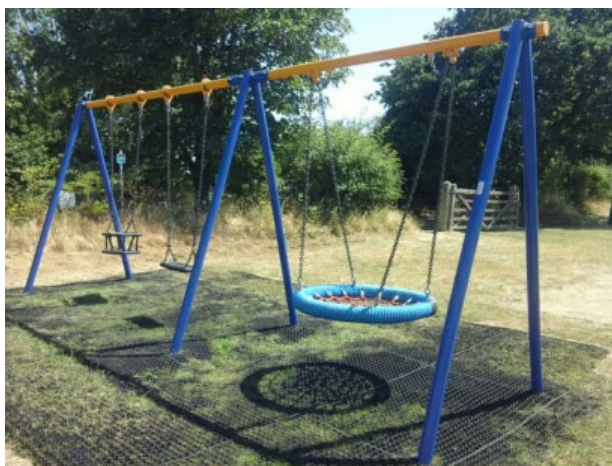
Item: Swings - 2 Bay 2 Cradle 1 Basket
Manufacturer: Wicksteed Playgrounds
Surface Type: Grass Matrix Tiles
Equipment Compliance: No
Surface Area Compliance: Yes
Ref/Part Number:
Total Findings: 3

Fixing Pins have been installed in the impact areas of the grass mats - Remove pins from impact areas

The bushes are worn or missing - Replace worn or missing bushes

The seats are too close to the frame as defined in BS EN 1176 Part 2; this is a low risk failure and no remedial action is required - Monitor use

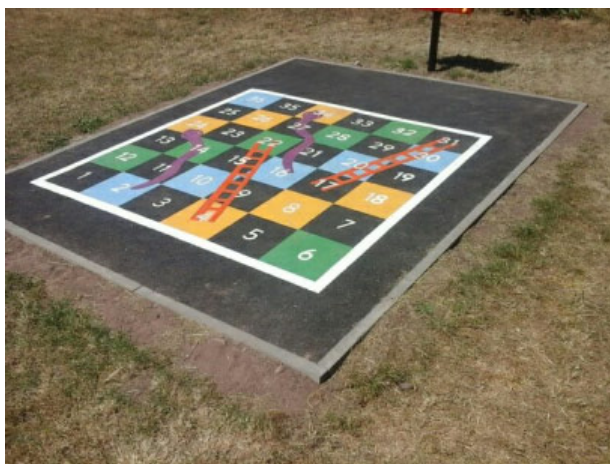
Item: Other - Surface Graphics
Manufacturer: Owner/Operator
Surface Type: Bitmac
Equipment Compliance: N/A
Surface Area Compliance: N/A
Ref/Part Number:
Total Findings: 1

There are trip hazards at the edges of the surface - Reinstate surrounding surface levels to remove the trip points

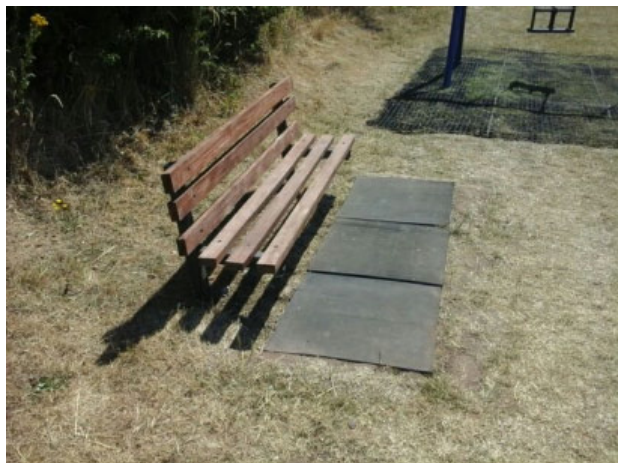
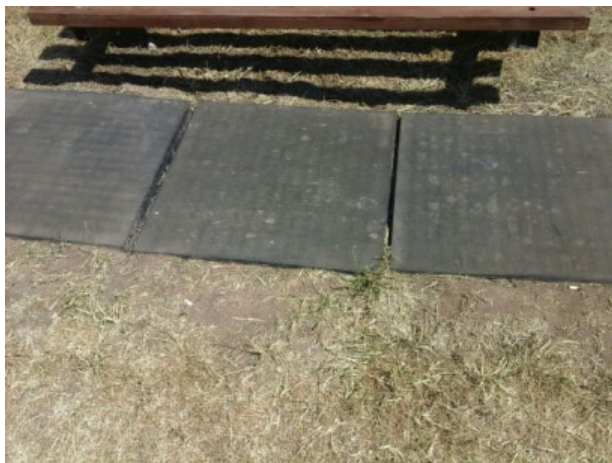
Finding: There are trip hazards present

Action: Reinstate surrounding surfaces to level to remove the trip points

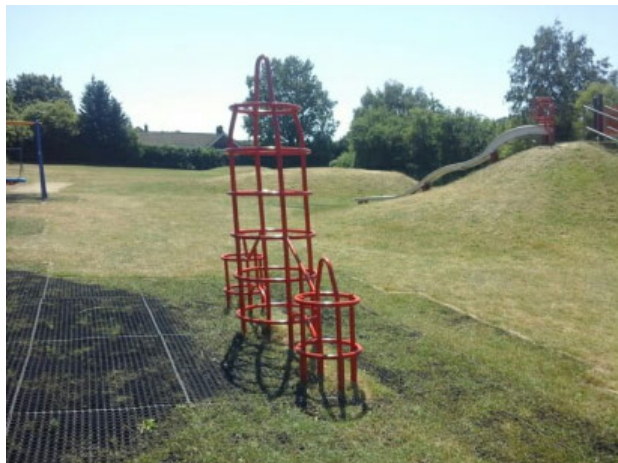
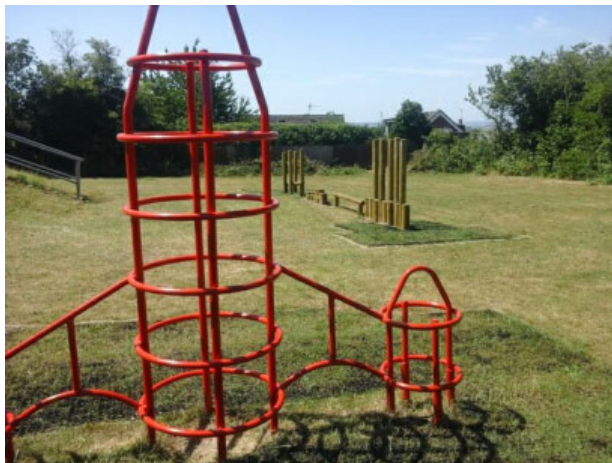
Finding: There are falls in excess of 600mm between adjacent components on the structure, in contravention of the recommendations set out in BS EN 1176 Part 1; 4.2.8.4

Action: Monitor use

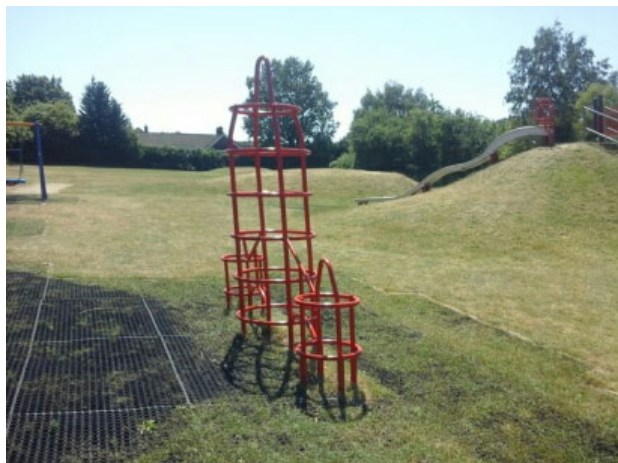
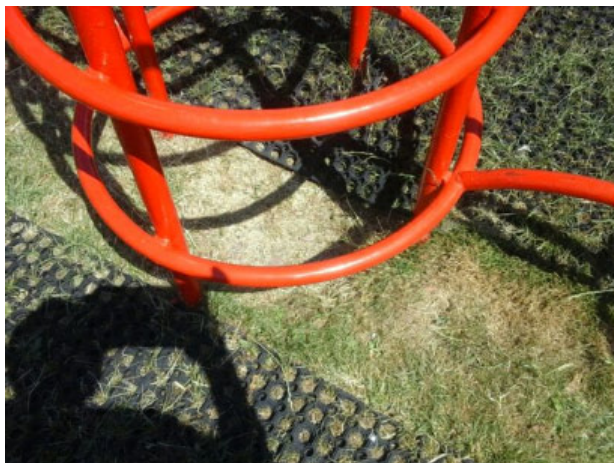
Finding: The surface has subsided in some areas

Action: Monitor for any further deterioration and repair as required

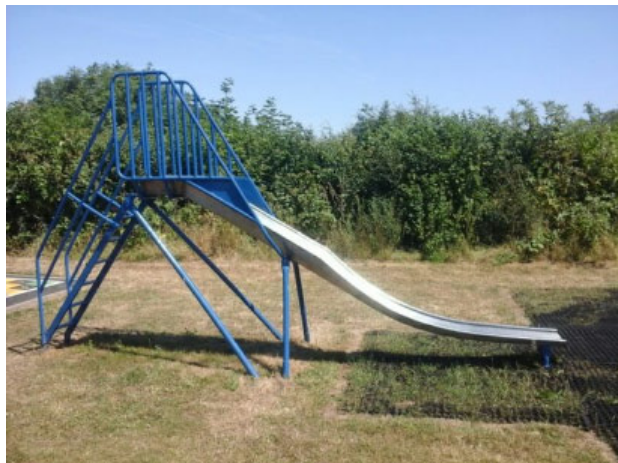
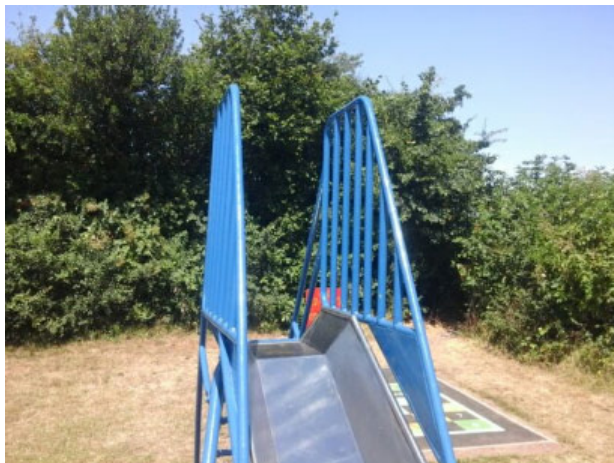
Finding: This item has no slide bar fitted as required by BS EN 1176 Part 3

Action: Monitor use

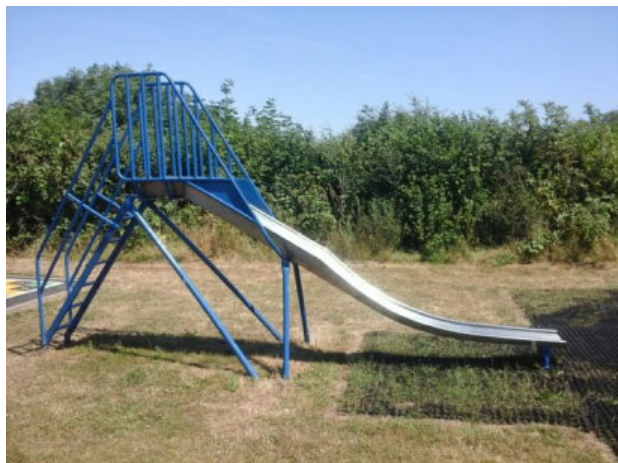
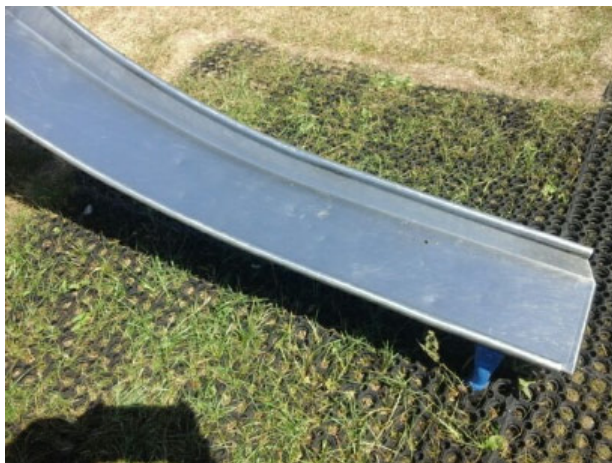
Finding: There are a number of dents in the slide surface

Action: Monitor for any further deterioration and repair as required

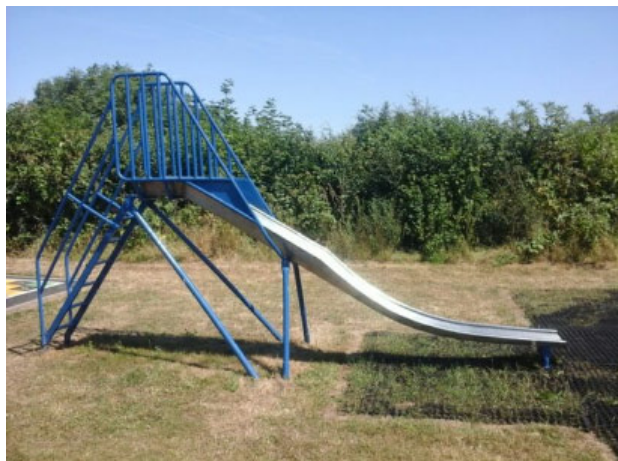
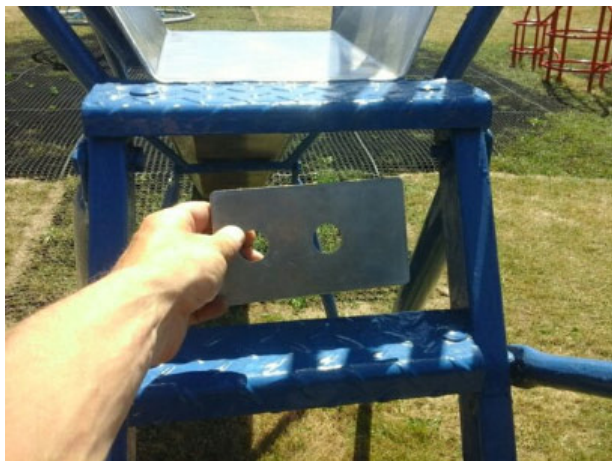
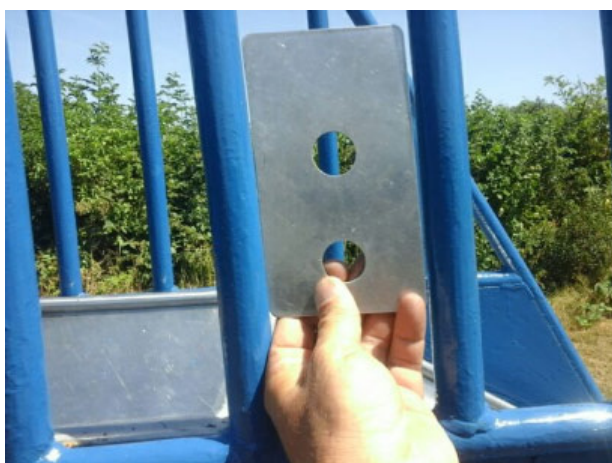
Finding: The item fails to meet the requirements of BS EN 1176:2008 Part 1 4.2.7.2 head and neck entrapment in the barriers and/or steps

Action: Monitor use

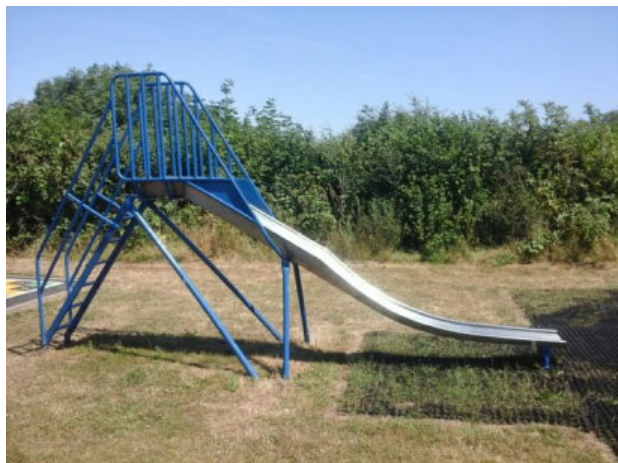
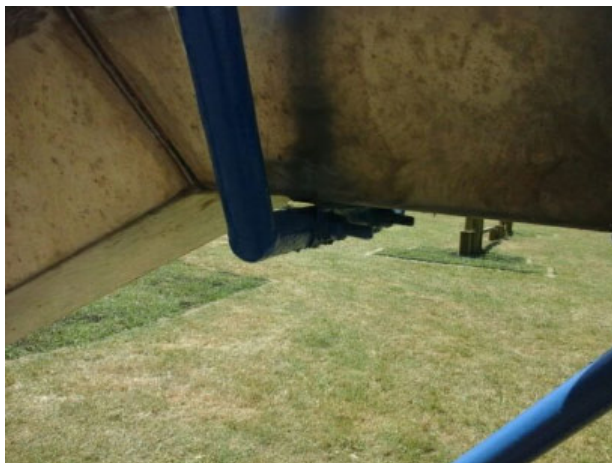
Finding: There are projecting bolt thread(s) present

Action: Remove excess thread length and deburr or provide cap

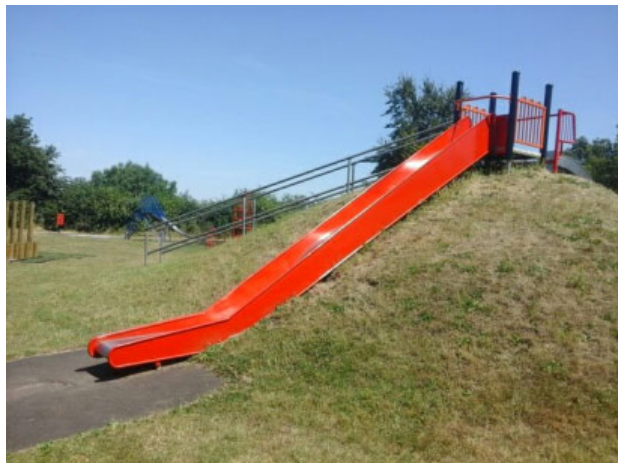
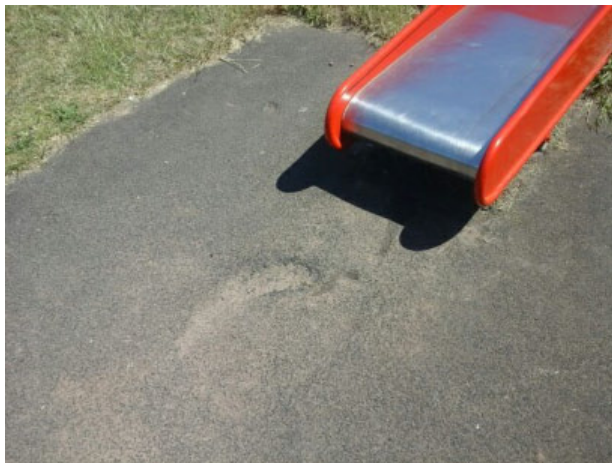
Finding: The safety surface around the area is beginning to wear

Action: Monitor for any further deterioration and repair as required

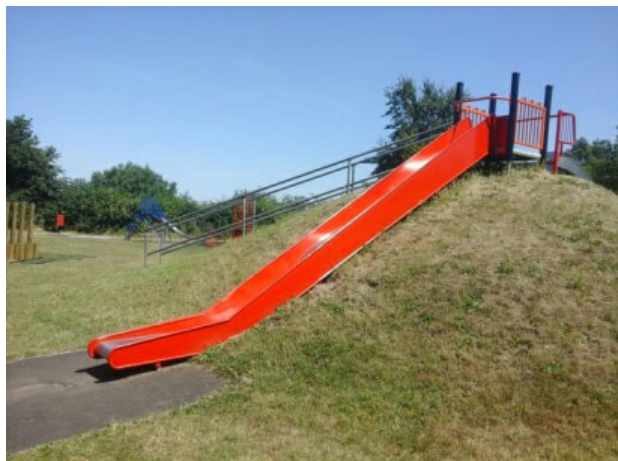
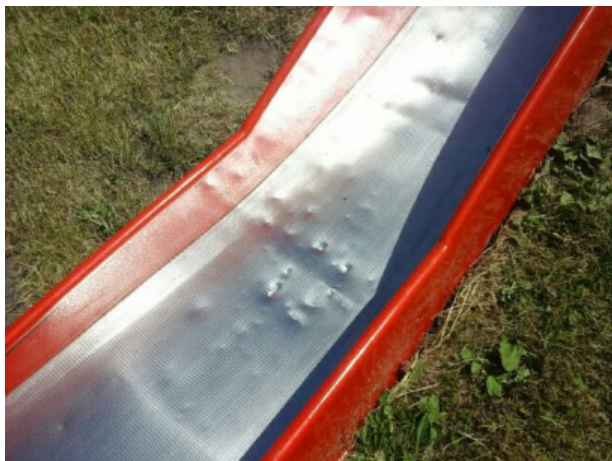
Finding: There are a number of dents in the slide surface

Action: Monitor for any further deterioration and repair as required

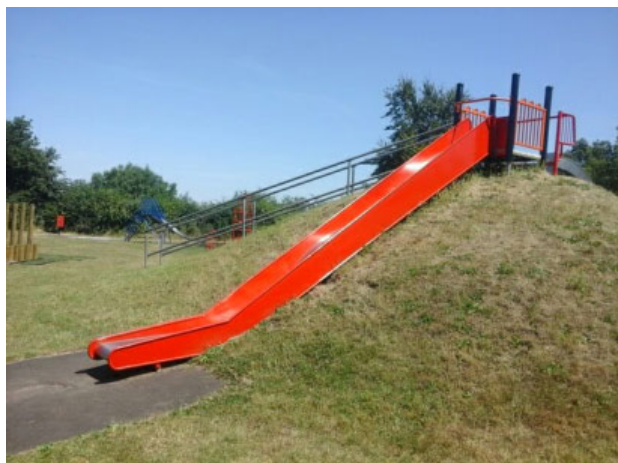
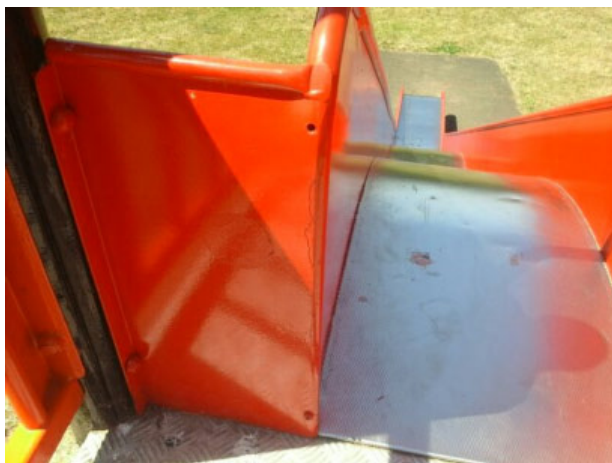
Finding: There is or are fixings missing on the item

Action: Replace all missing fixings

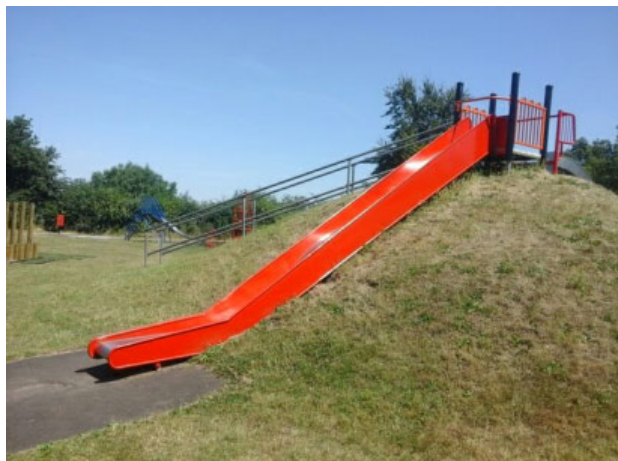
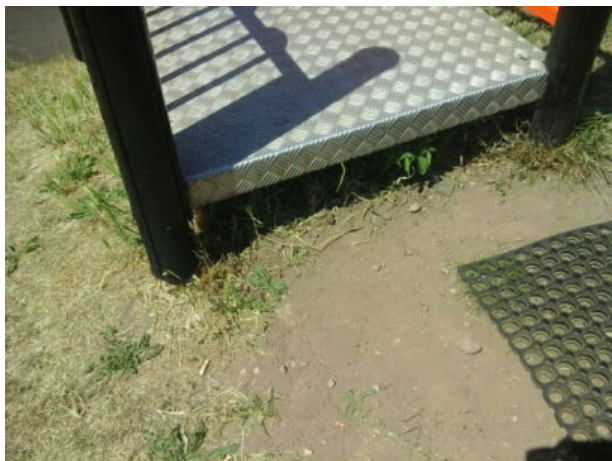
Finding: The surface has eroded in some areas

Action: Reinstate the surface

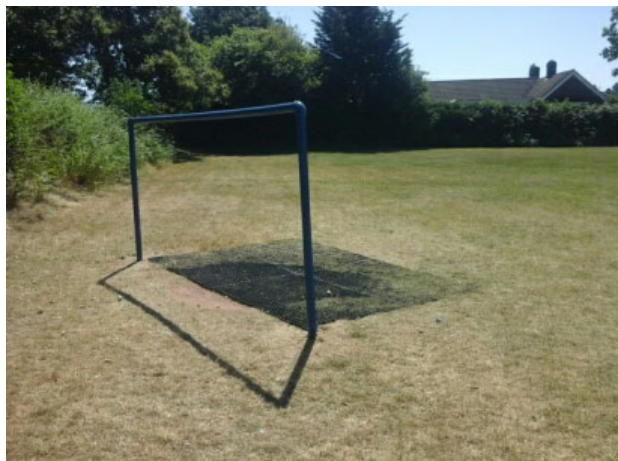
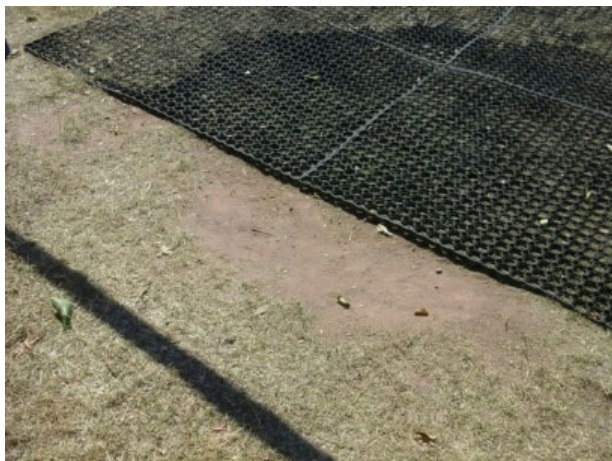
Finding: The surface has eroded in some areas

Action: Reinstate the surface

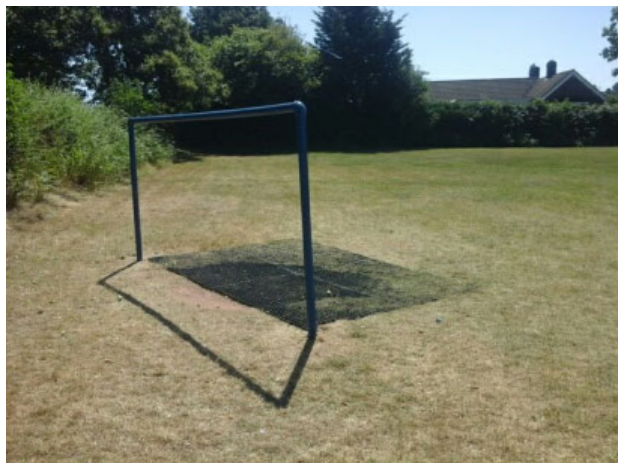
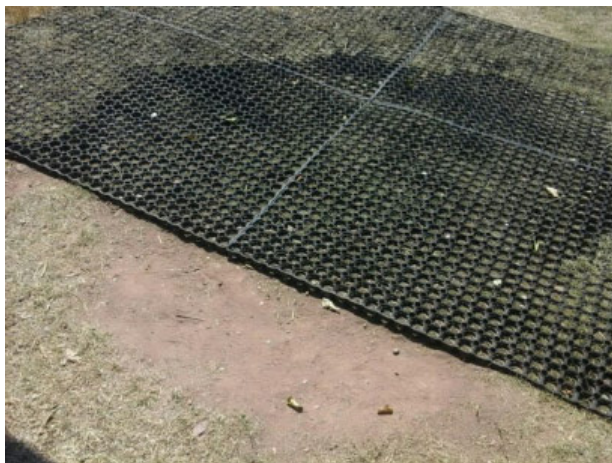
Finding: The edges of the grass mat surface have not been installed in accordance with the API Code of Practice

Action: Tuck in edges of grass mat to remove trip hazards

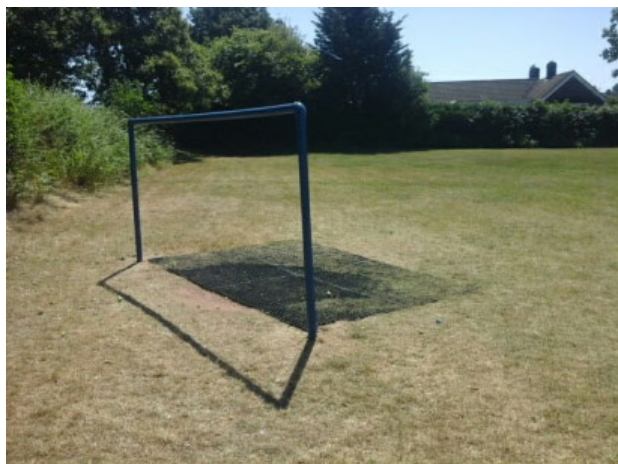
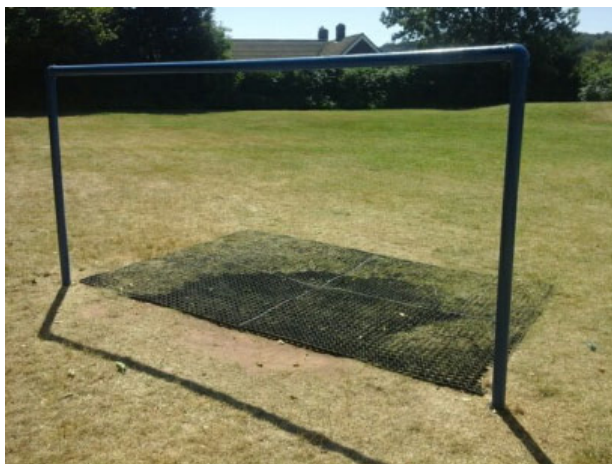
Finding: The item is slightly loose in its foundations

Action: Monitor for any further deterioration and repair as required

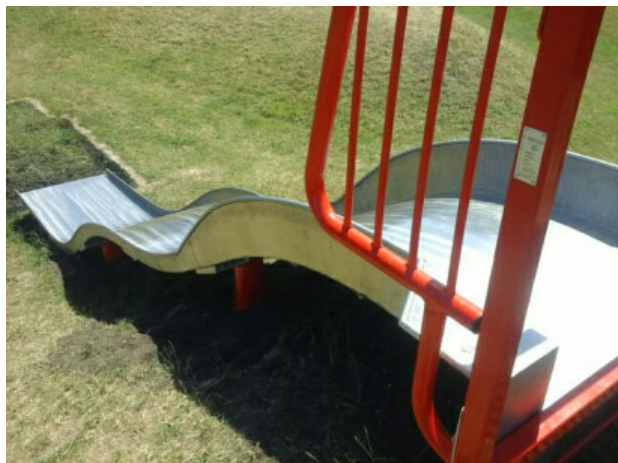
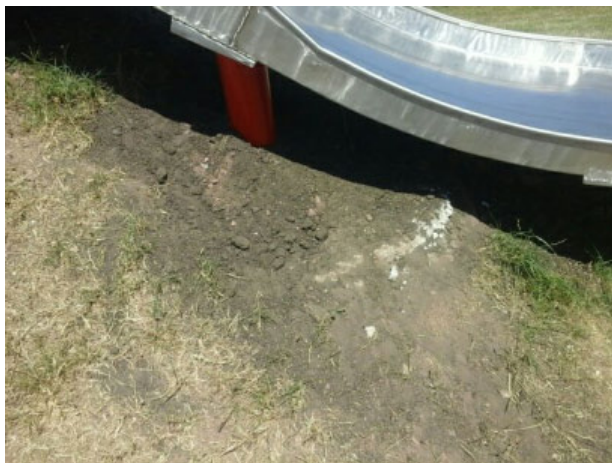
Finding: The surface has eroded and the foundations are exposed

Action: Reinstate surrounding surfaces to cover the foundations

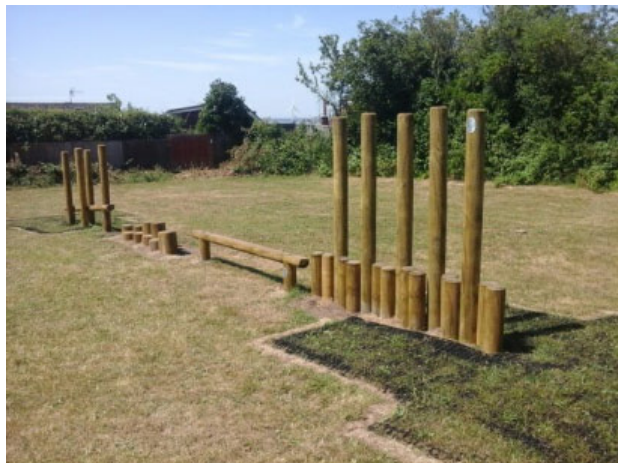
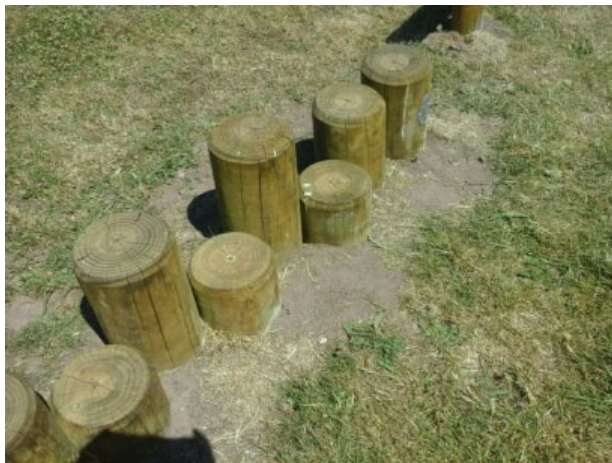
Finding: The surface has eroded in some areas

Action: Reinstate the surface

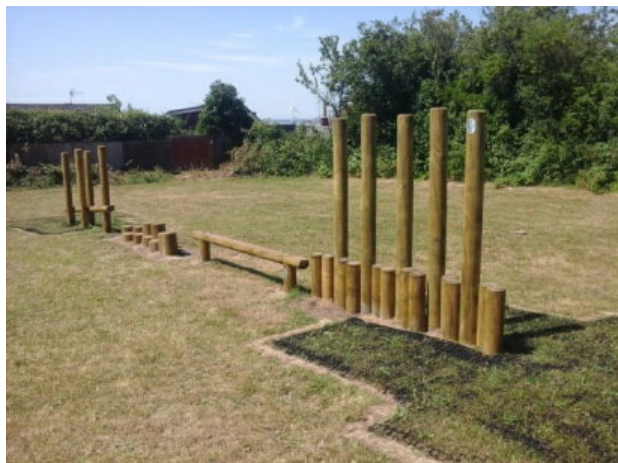
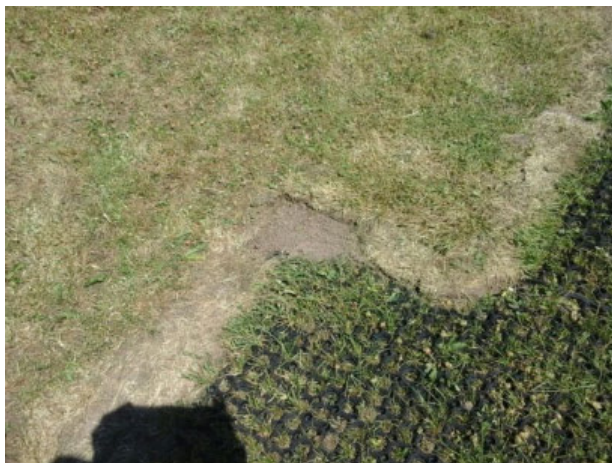
Finding: There are trip hazards present

Action: Reinstate surrounding surfaces to level to remove the trip points

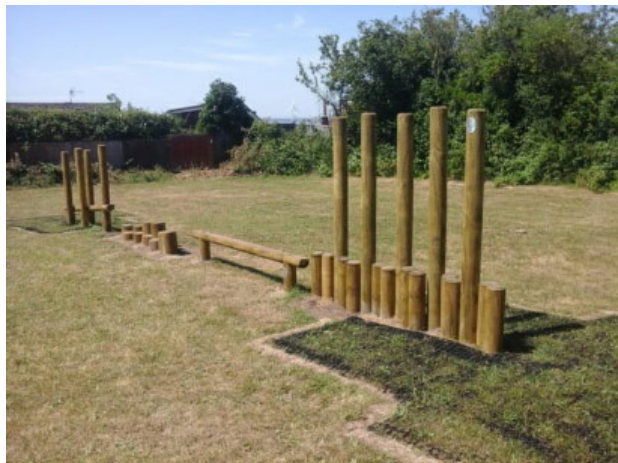
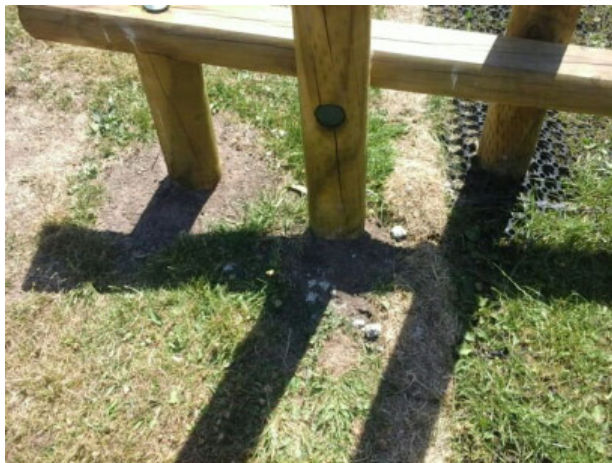
Finding: The projecting foundations forms a hard object within the falling space of the equipment in contravention of the requirements of BS EN 1176 Part 1

Action: Reinstate surface

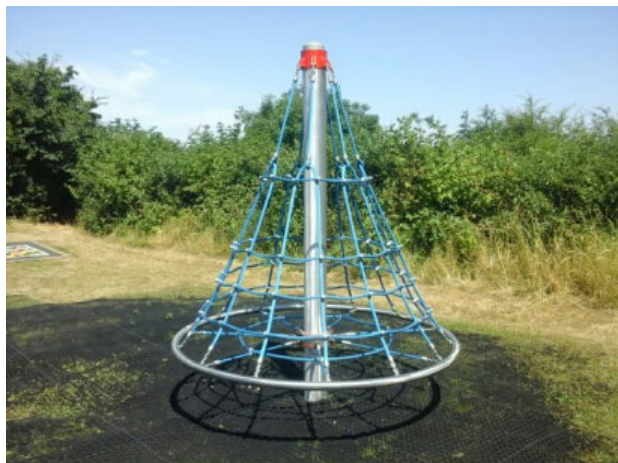
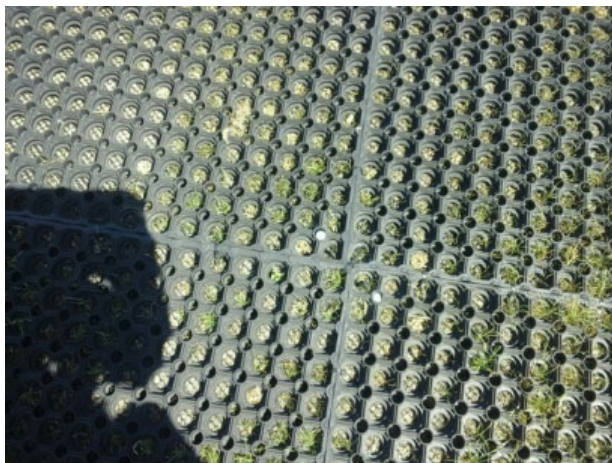
Finding: Fixing Pins have been installed in the impact areas of the grass mats

Action: Remove pins from impact areas

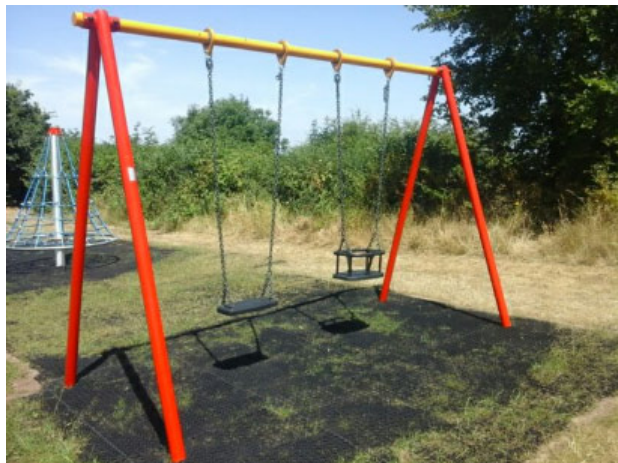
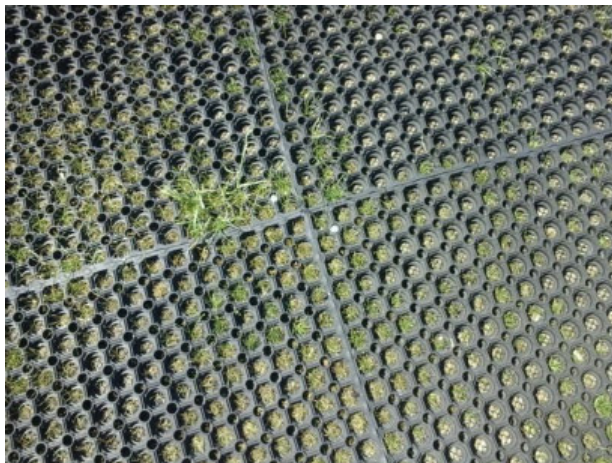
Finding: Fixing Pins have been installed in the impact areas of the grass mats

Action: Remove pins from impact areas

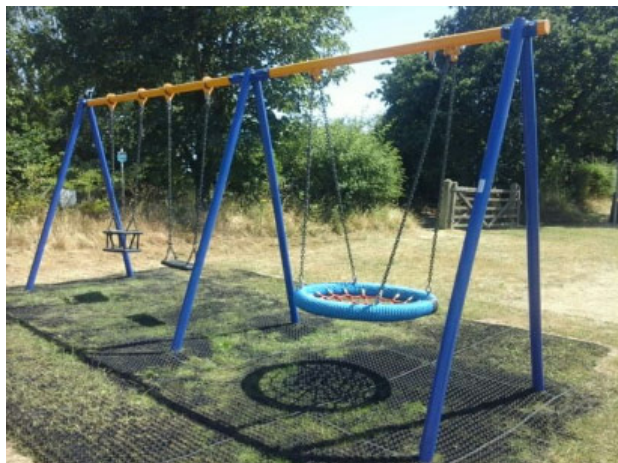
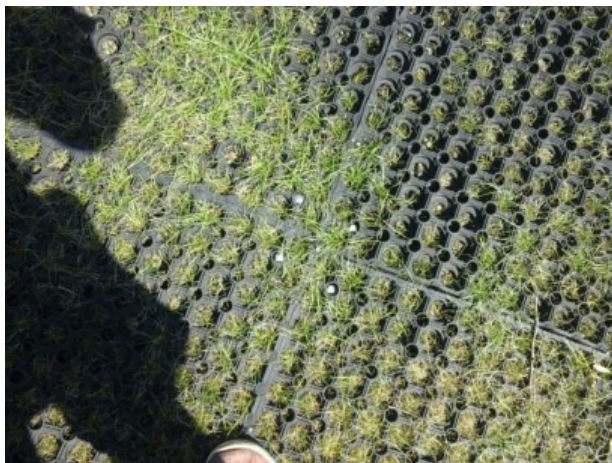
Finding: Fixing Pins have been installed in the impact areas of the grass mats

Action: Remove pins from impact areas

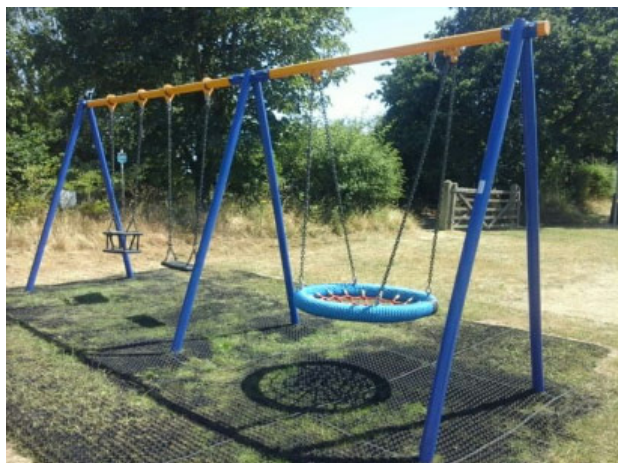
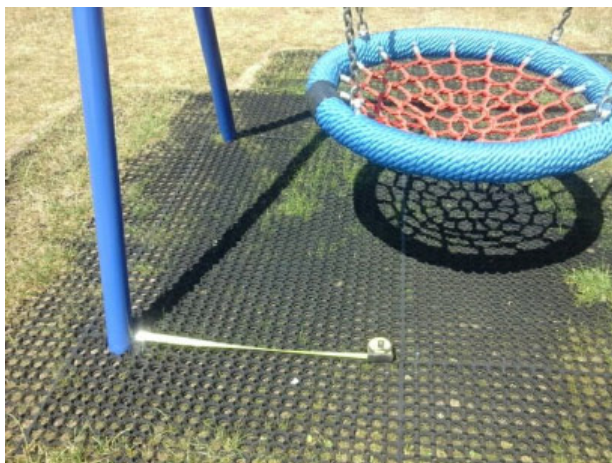
Finding: The seats are too close to the frame as defined in BS EN 1176 Part 2; this is a low risk failure and no remedial action is required

Action: Monitor use

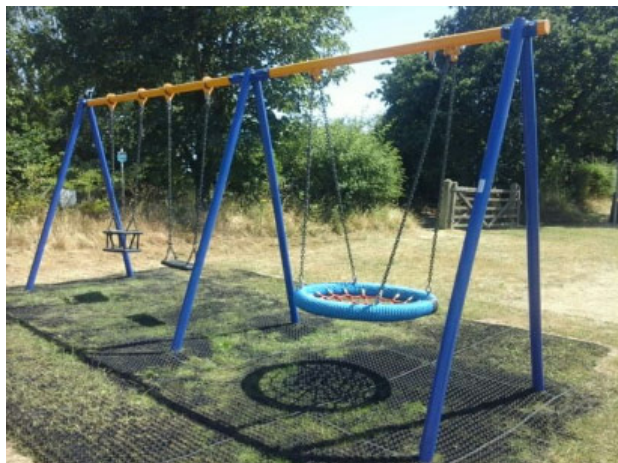
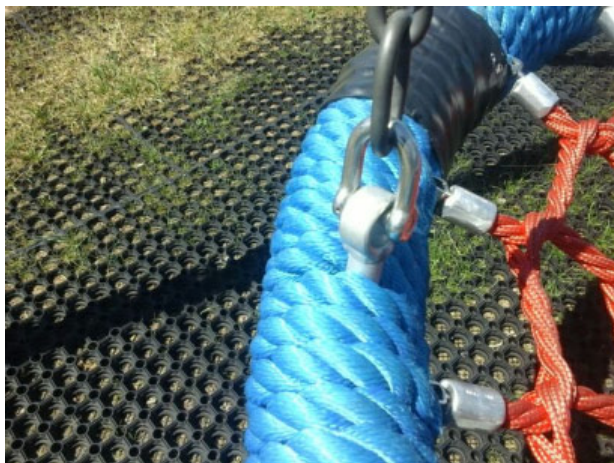
Finding: The bushes are worn or missing

Action: Replace worn or missing bushes

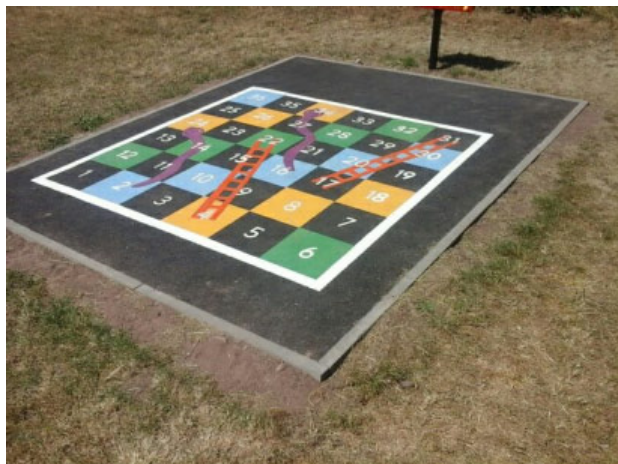
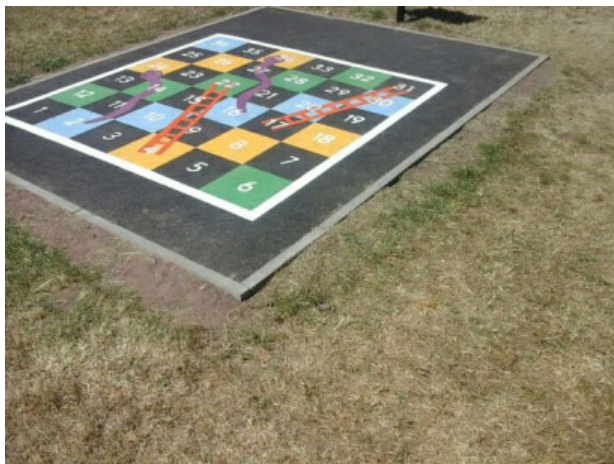
Finding: There are trip hazards at the edges of the surface

Action: Reinstate surrounding surface levels to remove the trip points
