Annual Inspection

Frodsham Town Council

Park Lane

Annual Inspection - 02 July 2018 at 12:12 Inspector: Matt Hall RPII Annual Inspector (Outdoor)

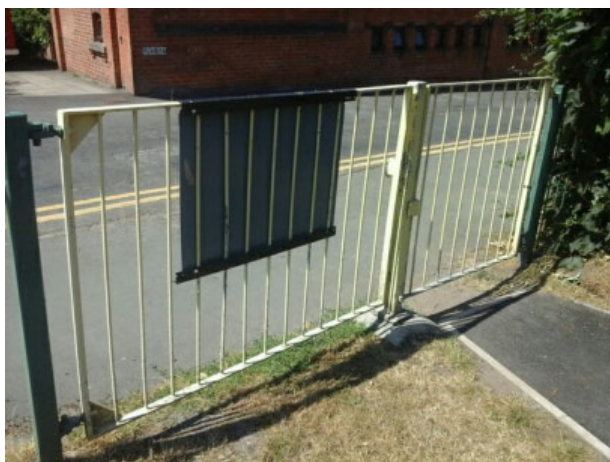
Item: Ancillary Items - Gate - Combination
Manufacturer: Owner/Operator
Surface Type: Grass
Equipment Compliance: N/A
Surface Area Compliance: N/A
Ref/Part Number:
Total Findings: 3

The area under the gate has eroded leaving uneven areas, or the concrete foundations exposed, resulting in trip hazards at the entrance/exit to the playground - Reinstate to level with surrounding surfaces

The rubber buffer is missing from the latch plate - Replace rubber buffer

The gate is closing too quickly (less than 4 seconds) - Take corrective action to ensure that the gate closes in 4-8 seconds

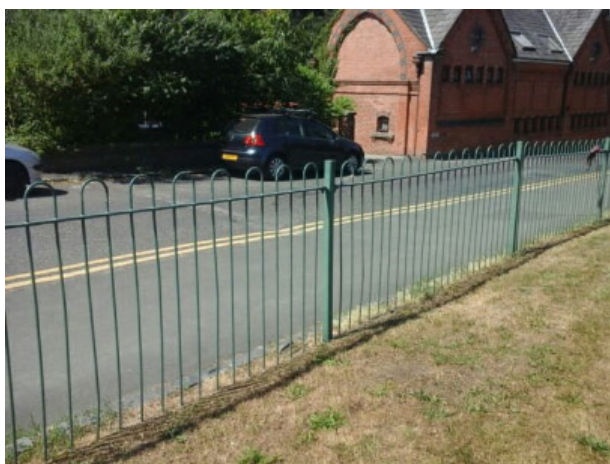
Item: Ancillary Items - Fence - Bow Top
Manufacturer: Owner/Operator
Surface Type: N/A
Equipment Compliance: N/A
Surface Area Compliance: N/A
Ref/Part Number:
Total Findings: 1

There is some damage to the fence sections - Monitor for any further deterioration and repair as required

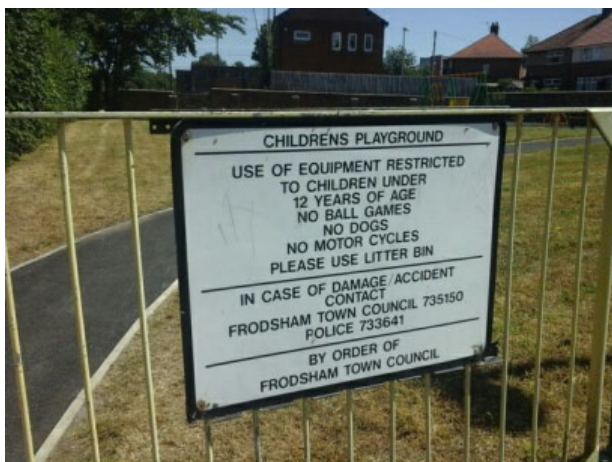
Item: Ancillary Items - Sign
Manufacturer: Owner/Operator
Surface Type: N/A
Equipment Compliance: N/A
Surface Area Compliance: N/A
Ref/Part Number:
Total Findings: 1

This item is satisfactory - no work required

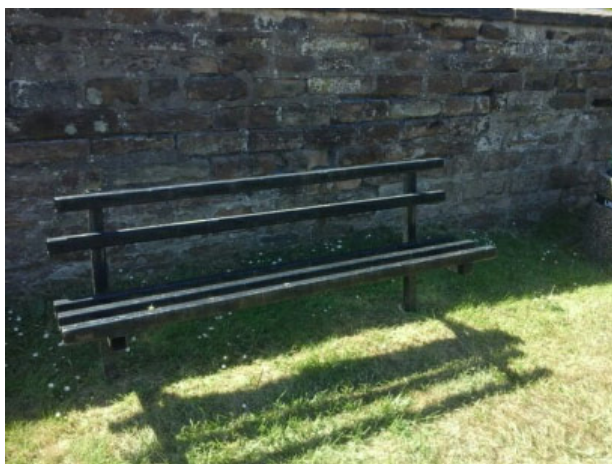
Item: Ancillary Items - Bench
Manufacturer: Owner/Operator
Surface Type: Grass
Equipment Compliance: N/A
Surface Area Compliance: N/A
Ref/Part Number:
Total Findings: 1

The end caps are missing - Replace caps

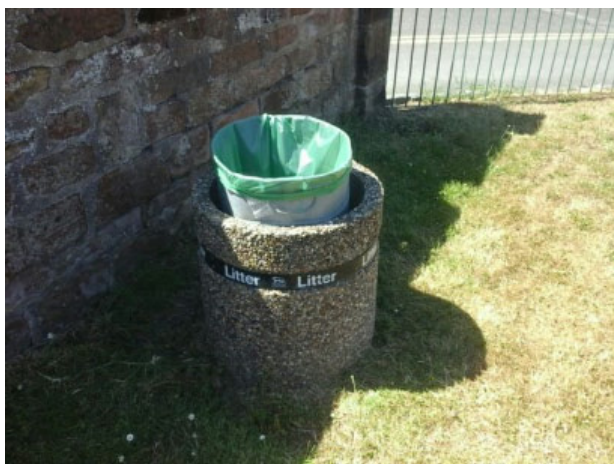
Item: Ancillary Items - Litter Bin
Manufacturer: Owner/Operator
Surface Type: N/A
Equipment Compliance: N/A
Surface Area Compliance: N/A
Ref/Part Number:
Total Findings: 1

The liner of the litter bin is not secured - Ensure the lid/door is kept locked and the liner secured

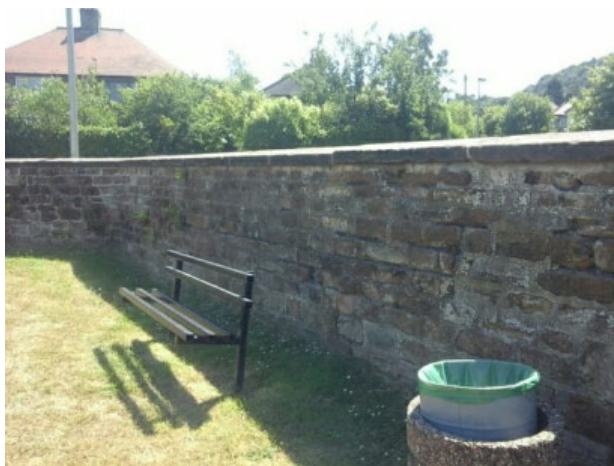
Item: Ancillary Items - Wall
Manufacturer: Owner/Operator
Surface Type: N/A
Equipment Compliance: N/A
Surface Area Compliance: N/A
Ref/Part Number:
Total Findings: 2

Coping stones missing - Repair as required

The brickwork is deteriorating - Monitor for any further deterioration and repair as required

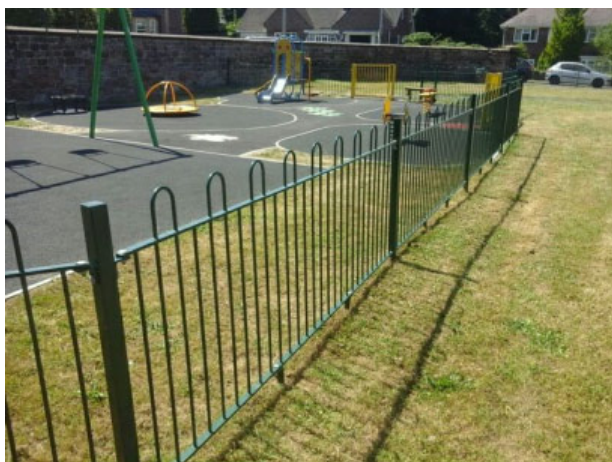
Item: Ancillary Items - Fence - Bow Top
Manufacturer: Owner/Operator
Surface Type: Grass
Equipment Compliance: N/A
Surface Area Compliance: N/A
Ref/Part Number:
Total Findings: 1

This item is satisfactory - no work required

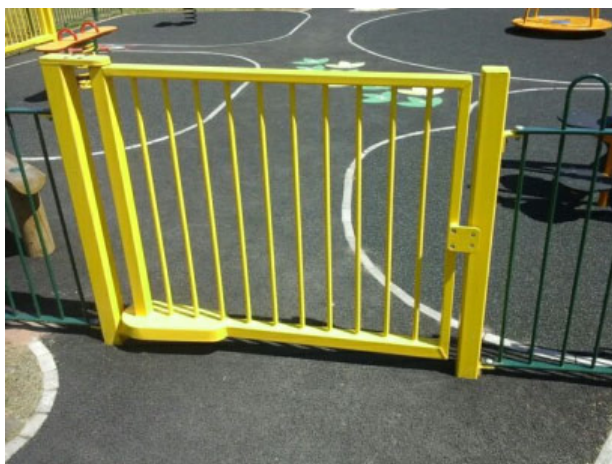
Item: Ancillary Items - Gate - Self Closing
Manufacturer: Owner/Operator
Surface Type: Bitmac
Equipment Compliance: N/A
Surface Area Compliance: N/A
Ref/Part Number:
Surface Nominal Depth: 2mm
Total Findings: 1

This item is satisfactory - no work required

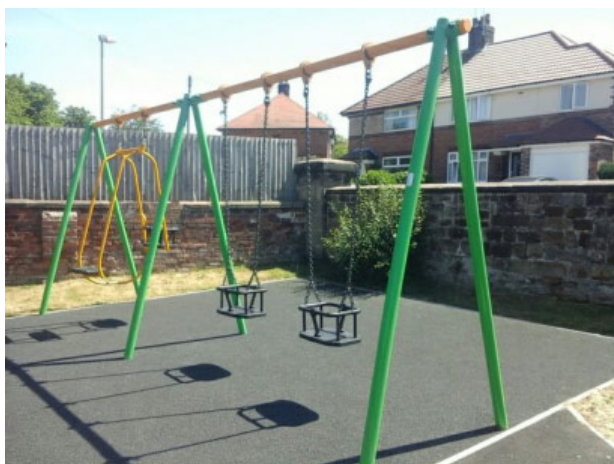
Item: Swings - 2 Bay 2 Cradle 1 Inclusive Seat
Manufacturer: Wicksteed Playgrounds
Surface Type: Wet Pour
Equipment Compliance: No
Surface Area Compliance: Yes
Ref/Part Number:
Total Findings: 2

Parts of the steel seat frame project outside of the seat and have no impact attenuation properties to protect users passing by or underneath - Refer to the manufacturer for confirmation of design risk assessment

There are trip hazards at the edges of the surface - Reinstate surrounding surface levels to remove the trip points

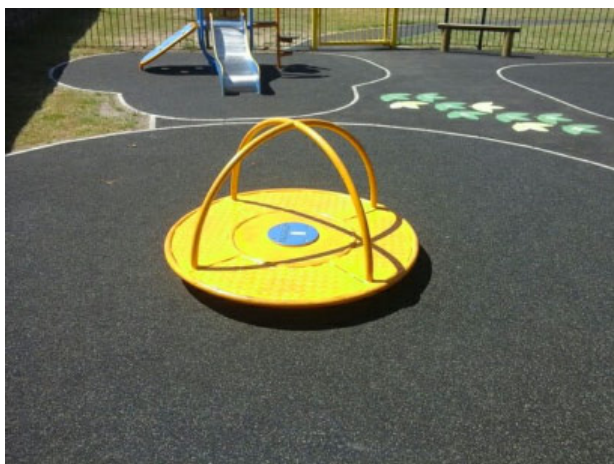
Item: Rotor Play - Roundabout
Manufacturer: Wicksteed Playgrounds
Surface Type: Wet Pour
Equipment Compliance: Yes
Surface Area Compliance: Yes
Ref/Part Number:
Total Findings: 1

This item is satisfactory - no work required

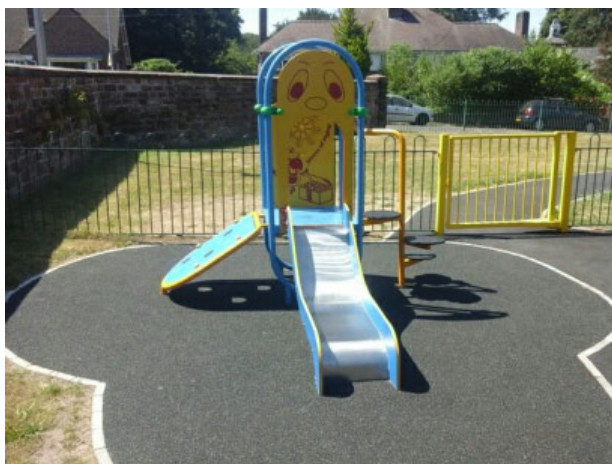
Item: Activity Equipment - Multi Play (Toddler)
Manufacturer: Wicksteed Playgrounds
Surface Type: Wet Pour
Equipment Compliance: No
Surface Area Compliance: N/A
Ref/Part Number:
Total Findings: 1

The fence forms a hard object within the falling space of the equipment in contravention of the requirements of BS EN 1176 Part 1 - Monitor use

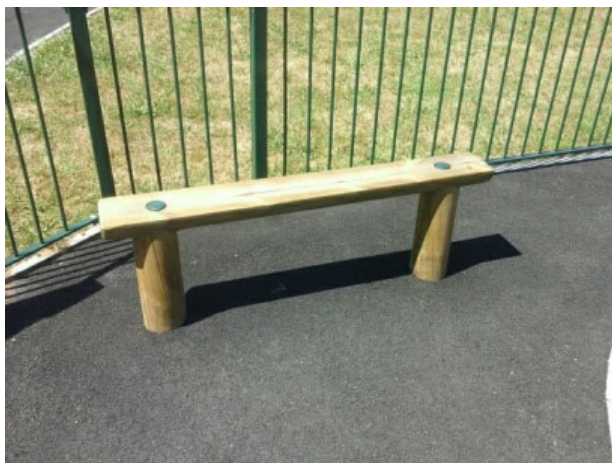
Item: Ancillary Items - Bench
Manufacturer: Wicksteed Playgrounds
Surface Type: Bitmac
Equipment Compliance: N/A
Surface Area Compliance: N/A
Ref/Part Number:
Total Findings: 1

This item is satisfactory - no work required

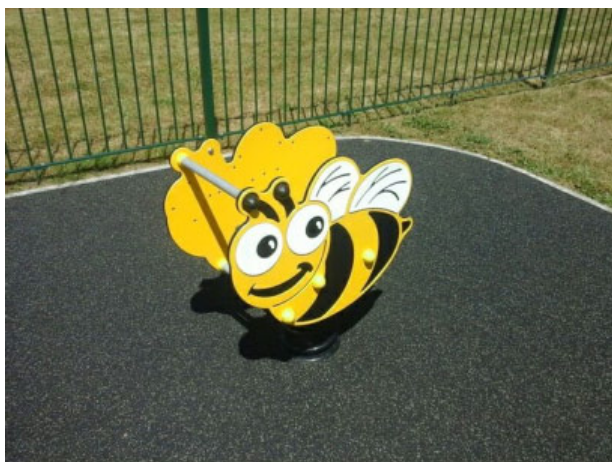
Item: Rocking Equipment - Spring Bee
Manufacturer: Wicksteed Playgrounds
Surface Type: Wet Pour
Equipment Compliance: Yes
Surface Area Compliance: Yes
Ref/Part Number:
Total Findings: 1

This item is satisfactory - no work required

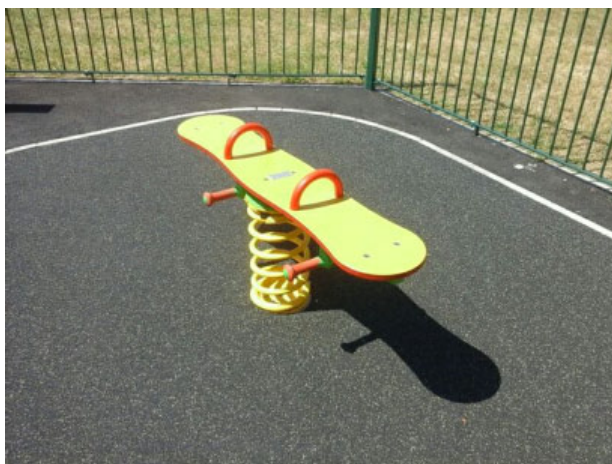
Item: Rocking Equipment - Spring See-Saw
Manufacturer: Wicksteed Playgrounds
Surface Type: Wet Pour
Equipment Compliance: Yes
Surface Area Compliance: Yes
Ref/Part Number:
Total Findings: 1

This item is satisfactory - no work required

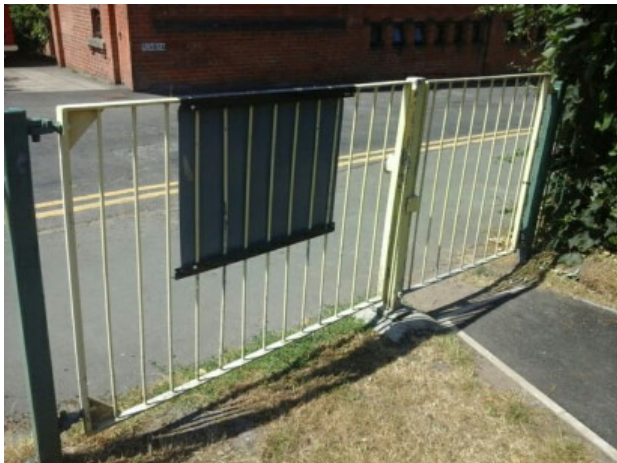
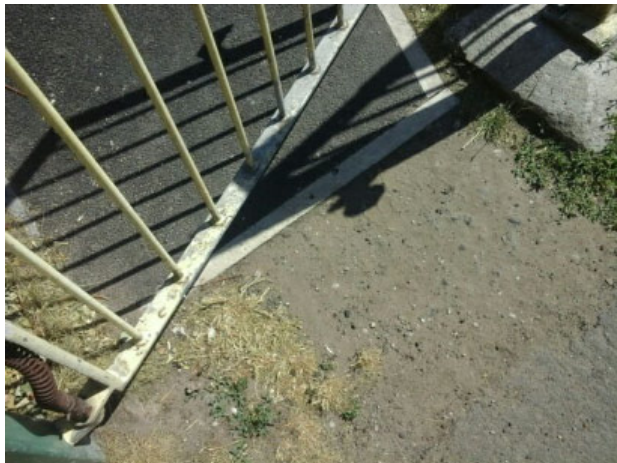
8 - Low Risk (Finding 1)			
Item:	Ancillary Items - Gate - Combination	Risk Level:	L - Low Risk
Manufacturer:	Owner/Operator	Surface:	Grass

Finding:	The area under the gate has eroded leaving uneven areas, or the concrete foundations exposed, resulting in trip hazards at the entrance/exit to the playground		
Action:	Reinstate to level with surrounding surfaces

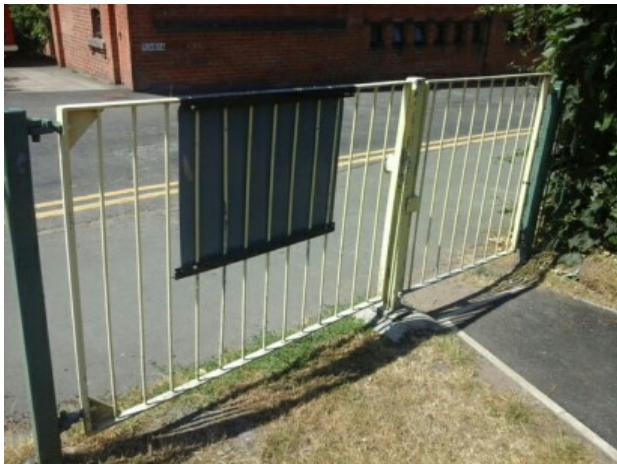
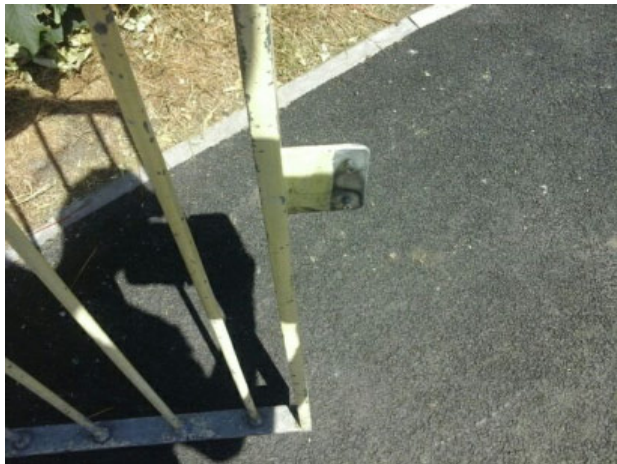
6 - Low Risk (Finding 2)			
Item:	Ancillary Items - Gate - Combination	Risk Level:	L - Low Risk
Manufacturer:	Owner/Operator	Surface:	Grass

Finding:	The rubber buffer is missing from the latch plate		
Action:	Replace rubber buffer

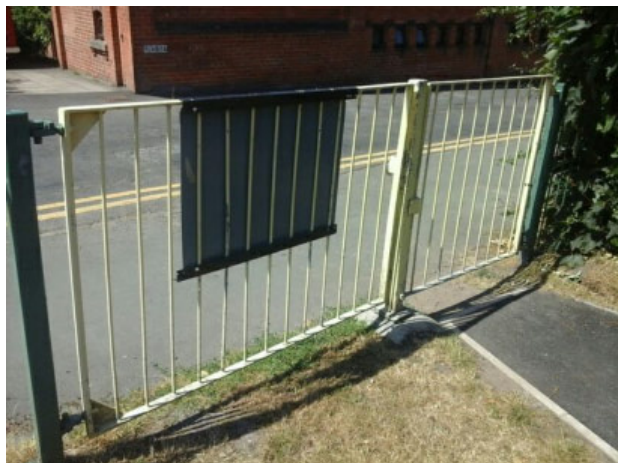
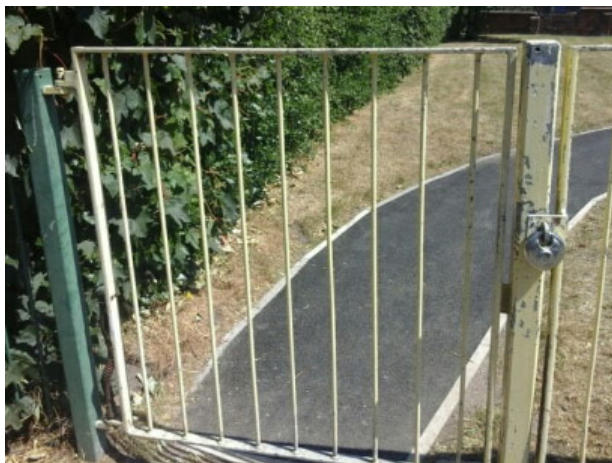
Item: Ancillary Items - Gate - Combination
Manufacturer: Owner/Operator

Finding: The gate is closing too quickly (less than 4 seconds)

Action: Take corrective action to ensure that the gate closes in 4-8 seconds

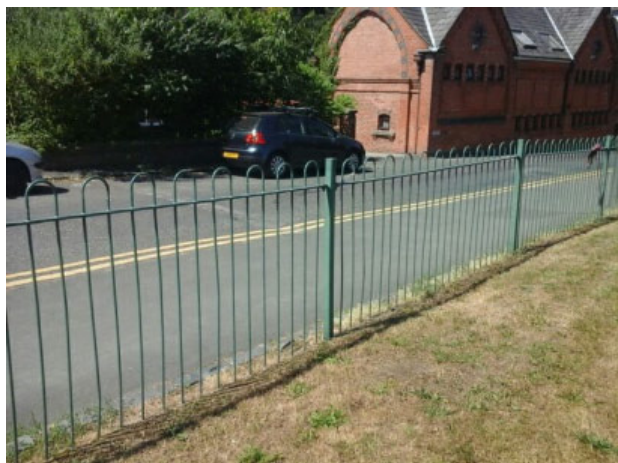
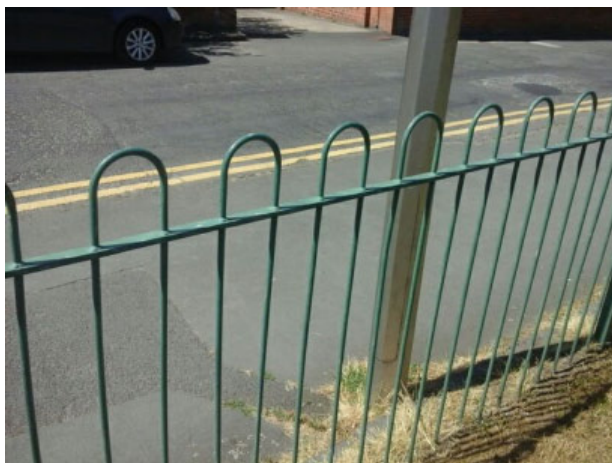
Item: Ancillary Items - Fence - Bow Top
Manufacturer: Owner/Operator

Finding: There is some damage to the fence sections

Action: Monitor for any further deterioration and repair as required

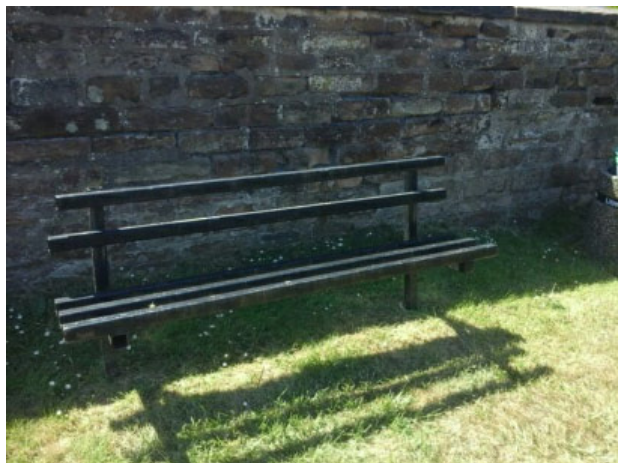
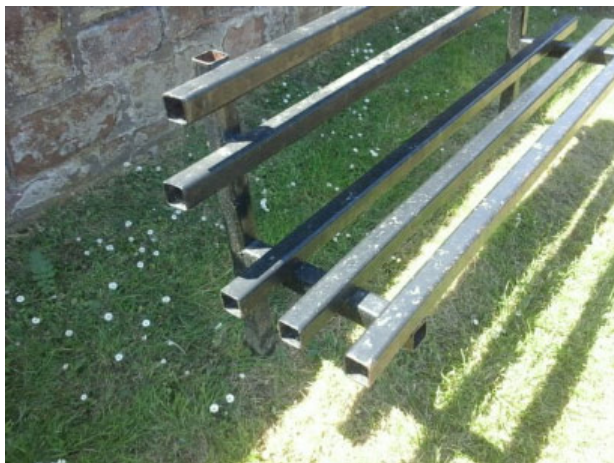
Item: Ancillary Items - Bench
Manufacturer: Owner/Operator

Finding: The end caps are missing

Action: Replace caps

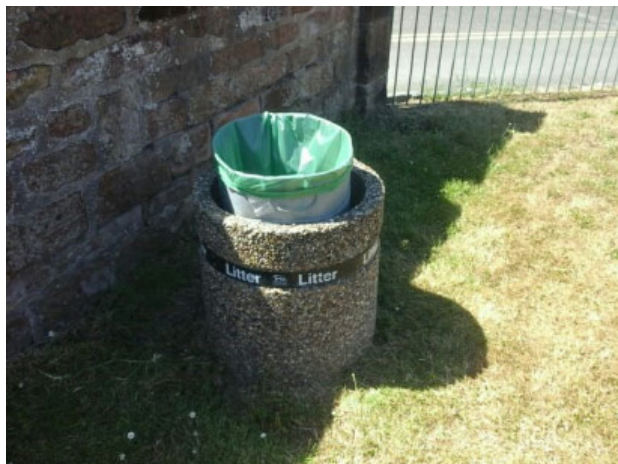
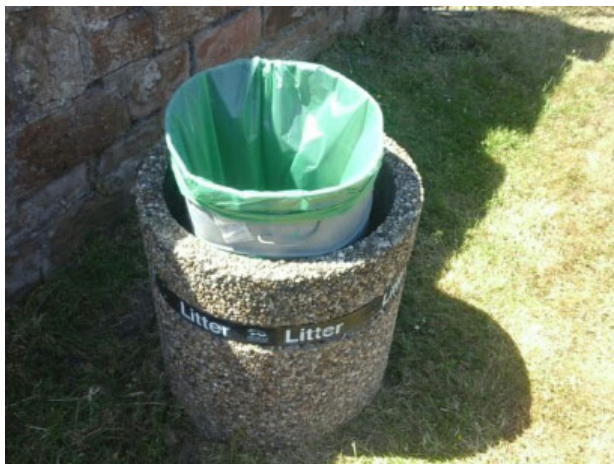
Item: Ancillary Items - Litter Bin
Manufacturer: Owner/Operator

Finding: The liner of the litter bin is not secured

Action: Ensure the lid/door is kept locked and the liner secured

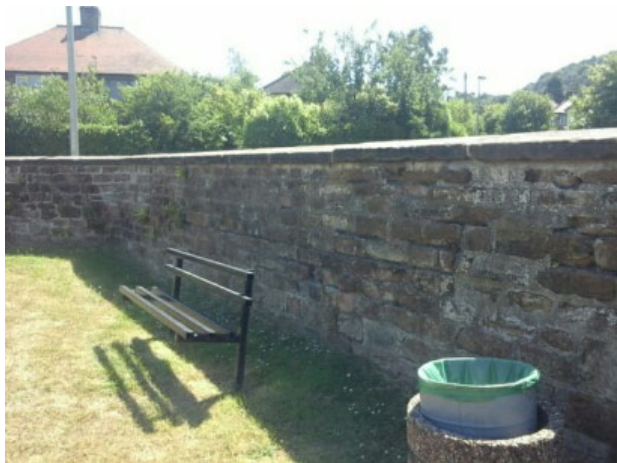
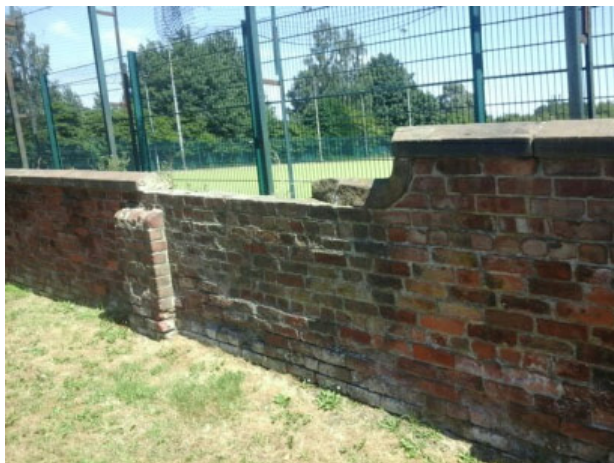
Item: Ancillary Items - Wall

Finding: Coping stones missing

Action: Repair as required

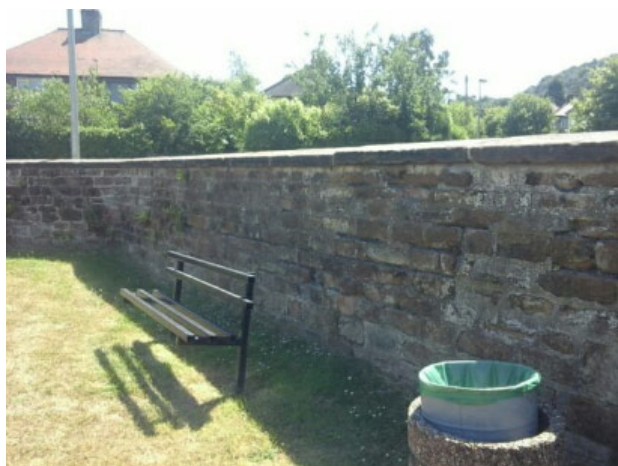
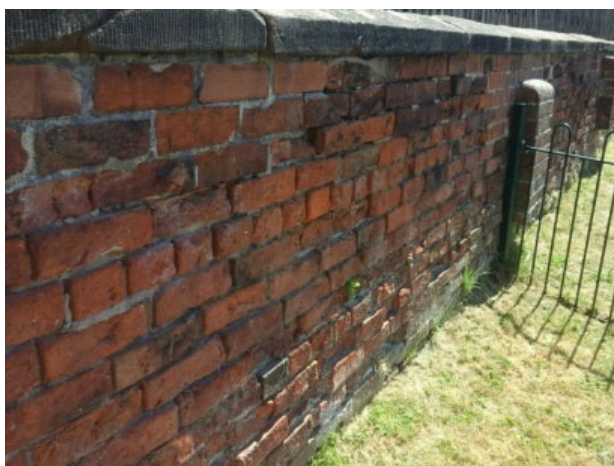
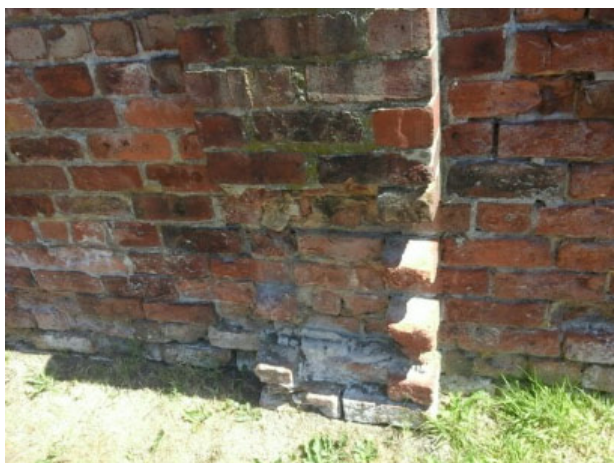
Item: Ancillary Items - Wall
Manufacturer: Owner/Operator

Finding: The brickwork is deteriorating

Action: Monitor for any further deterioration and repair as required

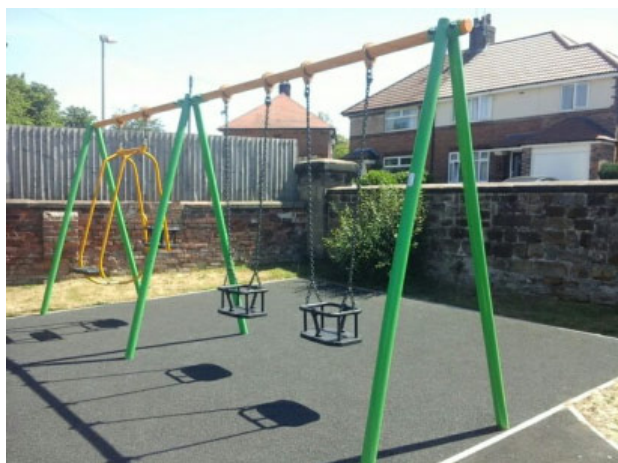
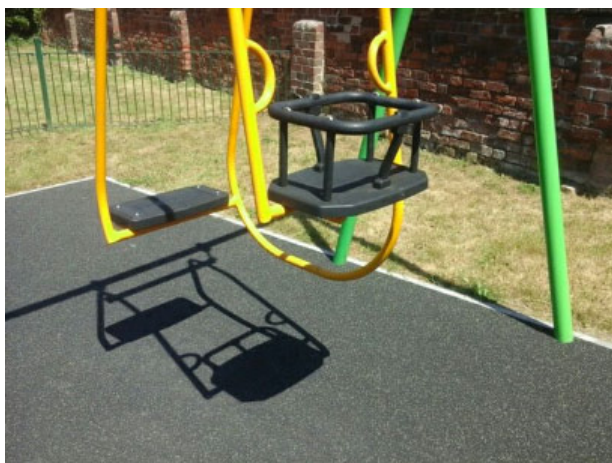
Item: Swings - 2 Bay 2 Cradle 1 Inclusive Seat

Finding: Parts of the steel seat frame project outside of the seat and have no impact attenuation properties to protect users passing by.or underneath

Action: Refer to the manufacturer for confirmation of design risk assessment

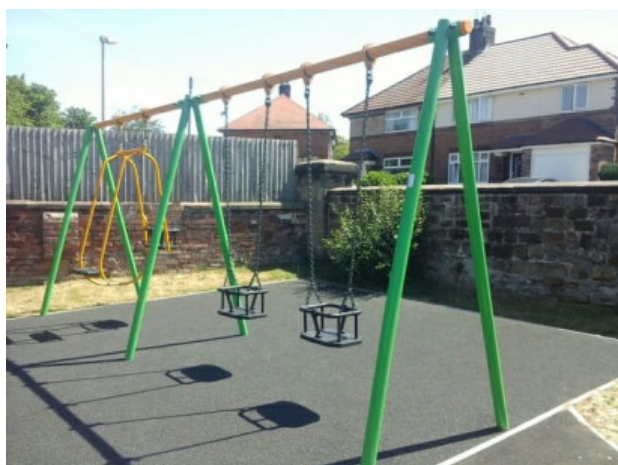
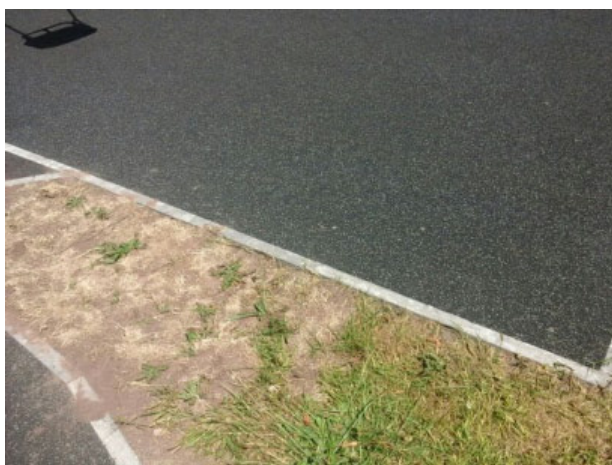
Item: Swings - 2 Bay 2 Cradle 1 Inclusive Seat

Finding: There are trip hazards at the edges of the surface

Action: Reinstate surrounding surface levels to remove the trip points

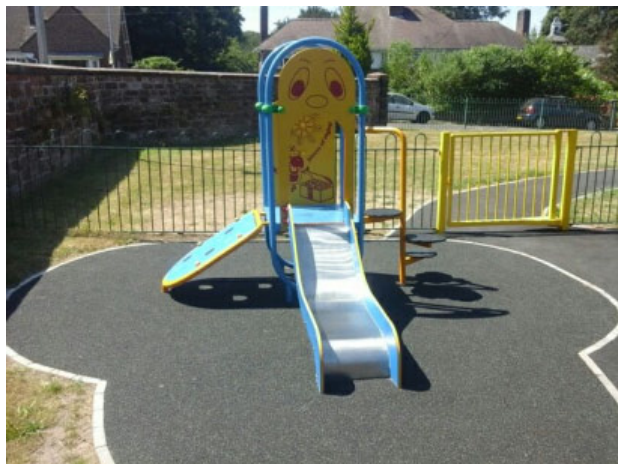
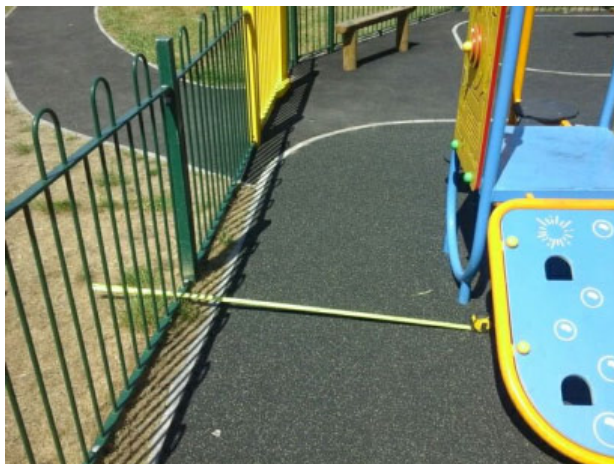
Item: Activity Equipment - Multi Play (Toddler)

Finding: The fence forms a hard object within the falling space of the equipment in contravention of the requirements of BS EN 1176 Part 1

Action: Monitor use
