Annual Inspection

Frodsham Town Council

Top Road

Annual Inspection - 02 July 2018 at 14:19 Inspector: Matt Hall RPII Annual Inspector (Outdoor)

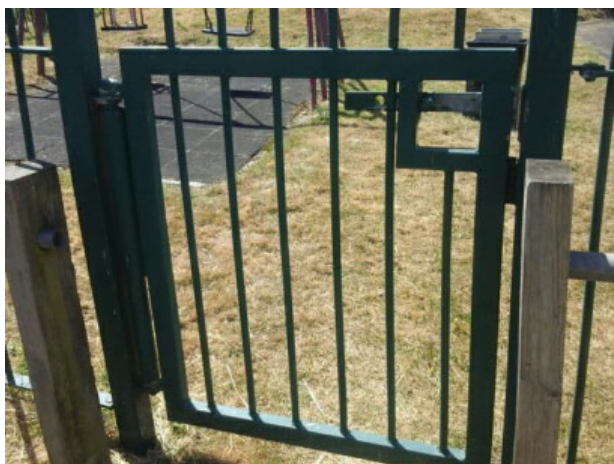
Item: Ancillary Items - Gate - Self Closing
Manufacturer: Owner/Operator
Surface Type: Grass
Equipment Compliance: N/A
Surface Area Compliance: N/A
Ref/Part Number:
Total Findings: 2

The rubber buffer is missing from the latch plate - Replace rubber buffer

The gate is closing too quickly (less than 4 seconds) - Take corrective action to ensure that the gate closes in 4-8 seconds

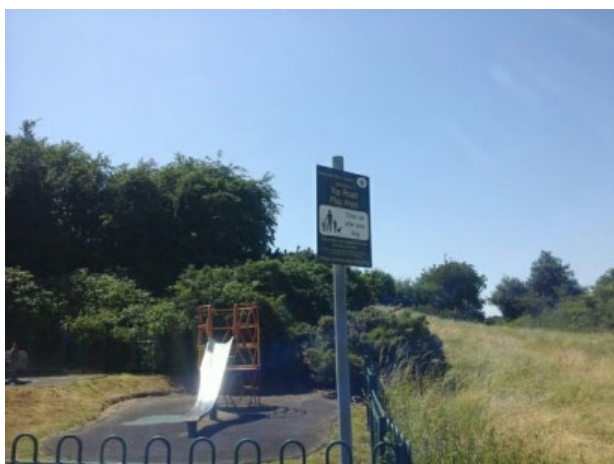
Item: Ancillary Items - Sign
Manufacturer: Owner/Operator
Surface Type: N/A
Equipment Compliance: N/A
Surface Area Compliance: N/A
Ref/Part Number:
Total Findings: 1

This item is satisfactory - no work required

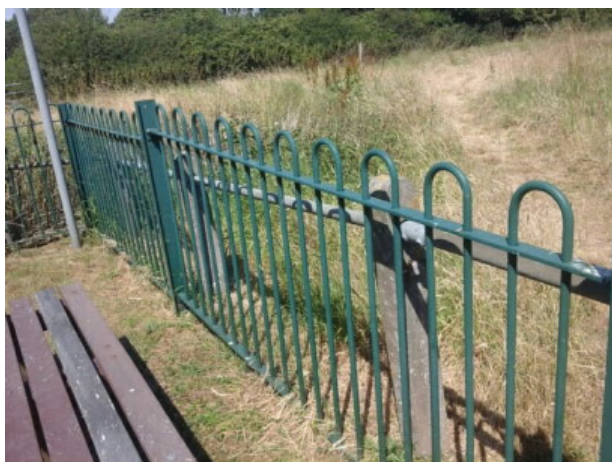
Item: Ancillary Items - Fence - Bow Top
Manufacturer: Owner/Operator
Surface Type: N/A
Equipment Compliance: N/A
Surface Area Compliance: N/A
Ref/Part Number:
Total Findings: 1

This item is satisfactory - no work required

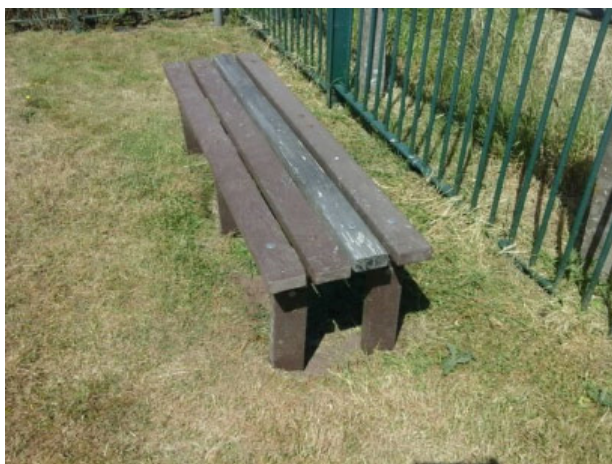
Item: Ancillary Items - Bench
Manufacturer: Owner/Operator
Surface Type: Grass
Equipment Compliance: N/A
Surface Area Compliance: N/A
Ref/Part Number:
Total Findings: 1

This item is satisfactory - no work required

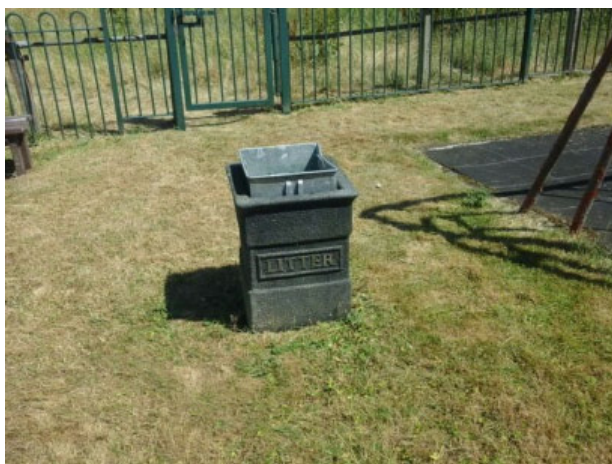
Item: Ancillary Items - Litter Bin
Manufacturer: Owner/Operator
Surface Type: N/A
Equipment Compliance: N/A
Surface Area Compliance: N/A
Ref/Part Number:
Total Findings: 1

The liner of the litter bin is not secured - Ensure the lid/door is kept locked and the liner secured

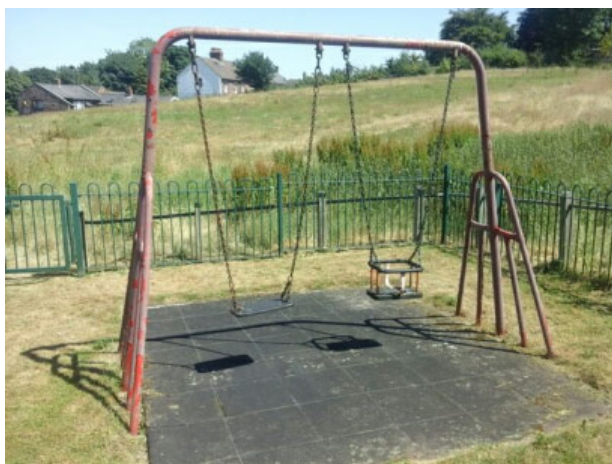
Item: Swings - 1 Bay Mixed Seat, 1 Cradle, 1 Flat
Manufacturer: Wicksteed Playgrounds
Surface Type: Rubber Tiles
Equipment Compliance: No
Surface Area Compliance: No
Ref/Part Number:
Total Findings: 5

The chain openings are in excess of the 8.6mm as recommended by BS EN 1176 - Monitor use

There is some notable evidence of chain wear - Monitor for any further deterioration and replace when 40% worn

There is surface corrosion present on the item - Consider treating and repainting the item

There are gaps opening in between the tiles - Monitor for any further deterioration and repair as required

There is algae or moss growth on the surface resulting in slippery conditions - Clean and treat appropriately

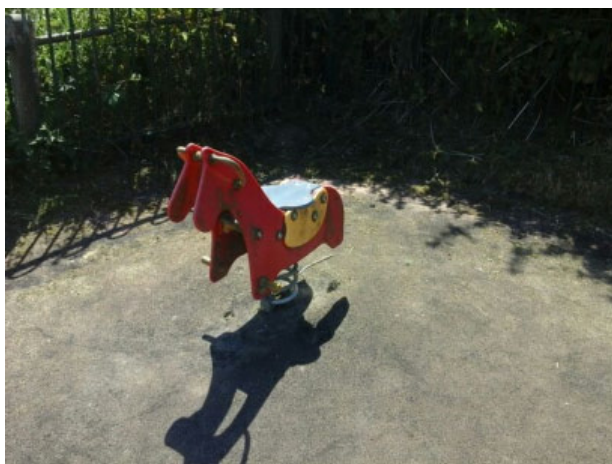
Item: Rocking Equipment - Spring Horse
Manufacturer: Ledon
Surface Type: Wet Pour
Equipment Compliance: No
Surface Area Compliance: Yes
Ref/Part Number:
Total Findings: 4

There is algae or moss growth on the surface resulting in slippery conditions - Clean and treat appropriately

The safety surface under or around this unit has been damaged - Monitor for any further deterioration and repair as required

The end of handgrips and/or footrests have a cross section of less than 15cm² and fail to meet the requirements of BS EN 1176 Part 6 - This is a relatively low risk failure and no remedial action is recommended

The paintwork on the spring has been damaged or worn exposing the metal underneath which is rusting - Treat any rusting components and repaint

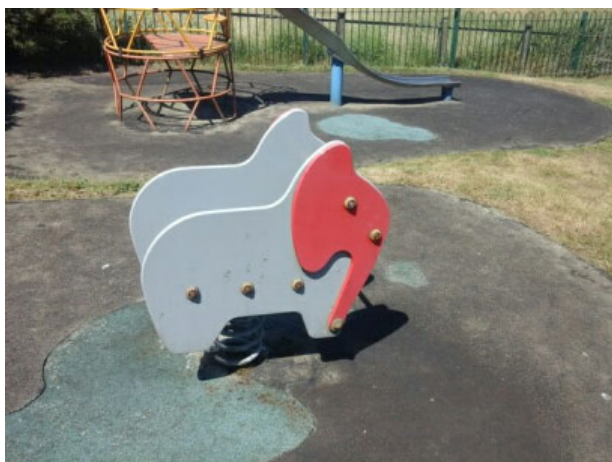
Item: Rocking Equipment - Spring Elephant
Manufacturer: Ledon
Surface Type: Wet Pour
Equipment Compliance: Yes
Surface Area Compliance: Yes
Ref/Part Number:
Total Findings: 7

There are gaps opening between the surfacing and the edging surround or between the joints in the surfacing - Monitor for any further deterioration and repair as required

There are trip hazards at the edges of the surface - Reinstate surrounding surface levels to remove the trip points

The surface is lifting at the edges and creating trip points - Repair perimeter of surfacing to remove trip points

There is/are bolt cap covers missing or damaged on the item - Replace missing or damaged bolt cap covers

The safety surface under or around this unit has been damaged - Monitor for any further deterioration and repair as required

The paintwork on the spring has been damaged or worn exposing the metal underneath which is rusting - Treat any rusting components and repaint

There is algae or moss growth on the surface resulting in slippery conditions - Clean and treat appropriately

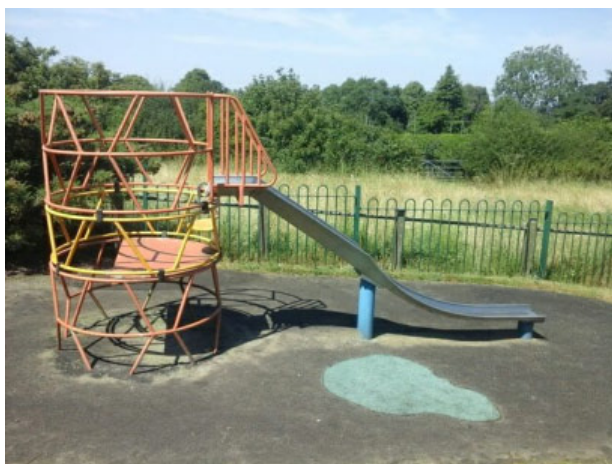
Item: Other - Free Standing Slide
Manufacturer: Wicksteed Playgrounds
Surface Type: Wet Pour
Equipment Compliance: No
Surface Area Compliance: Yes
Ref/Part Number:
Total Findings: 6

There is algae or moss growth on the surface resulting in slippery conditions - Clean and treat appropriately

There are gaps opening between the surfacing and the edging surround or between the joints in the surfacing - Monitor for any further deterioration and repair as required

There are trip hazards at the edges of the surface - Reinstate surrounding surface levels to remove the trip points

The surface is lifting at the edges and creating trip points - Repair perimeter of surfacing to remove trip points

This item has no slide bar fitted as required by BS EN 1176 Part 3 - Monitor use

The item fails to meet the requirements of BS EN 1176:2008 Part 1 4.2.7.2 head and neck entrapment in the barriers and/or steps - Monitor use

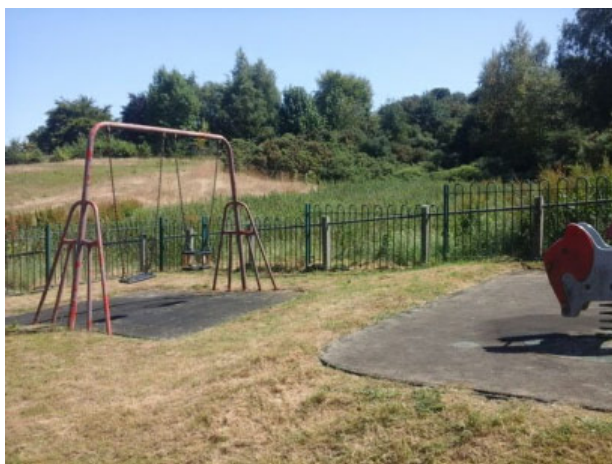
Item: Ancillary Items - Site General
Manufacturer: Owner/Operator
Surface Type: N/A
Equipment Compliance: N/A
Surface Area Compliance: N/A
Ref/Part Number:
Total Findings: 1

There are hostile bushes growing into the play area - Cut back foliage

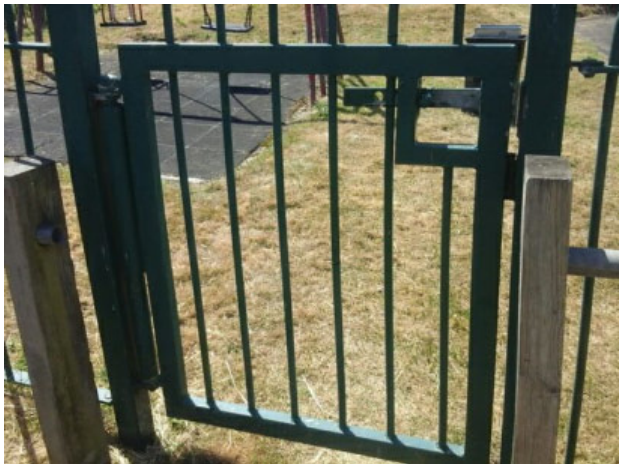
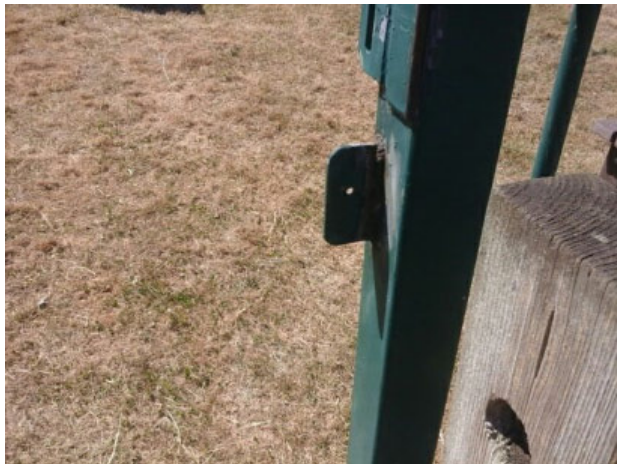
Finding:	The rubber buffer is missing from the latch plate		Action: Replace rubber buffer

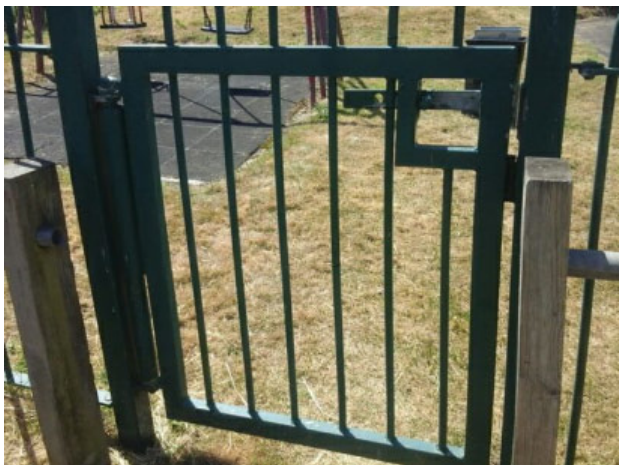
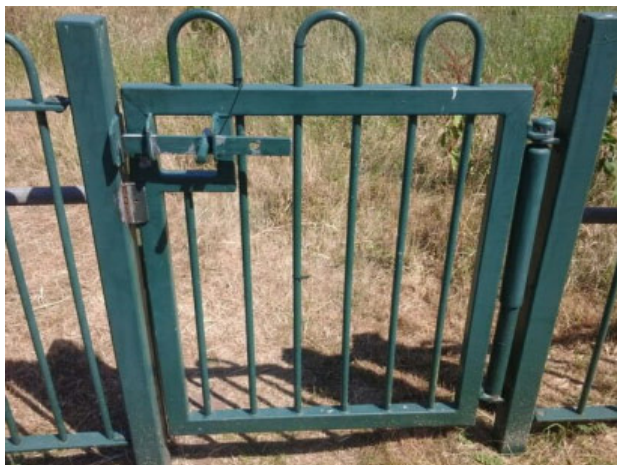
Finding:	The gate is closing too quickly (less than 4 seconds)		Action: Take corrective action to ensure that the gate closes in 4-8 seconds

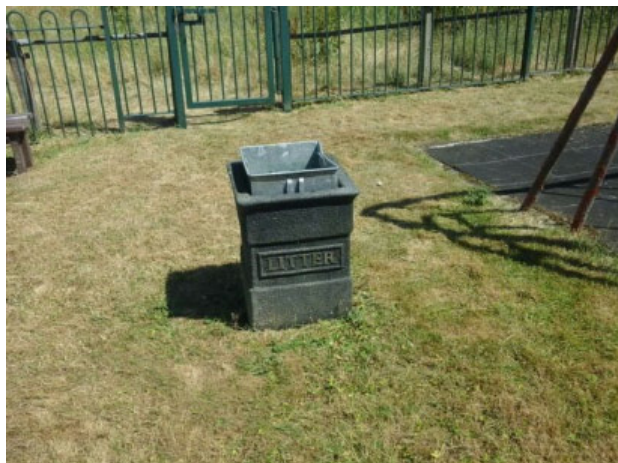
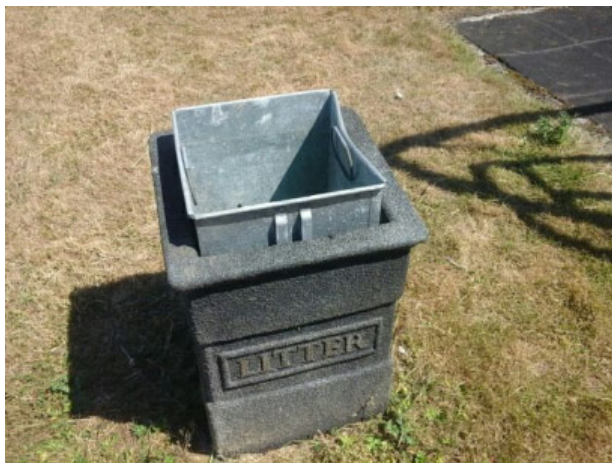
Finding: The liner of the litter bin is not secured

Action: Ensure the lid/door is kept locked and the liner secured

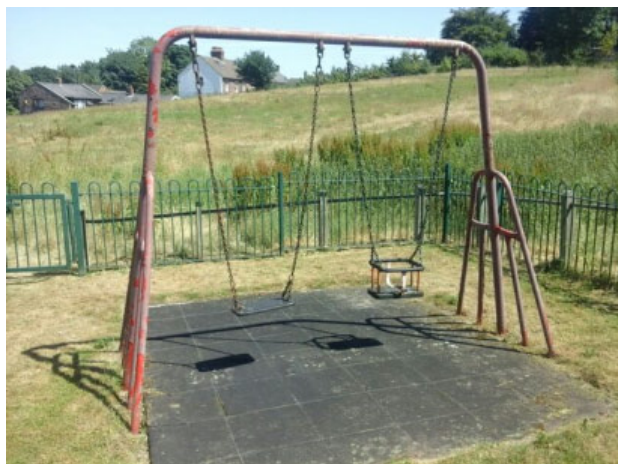
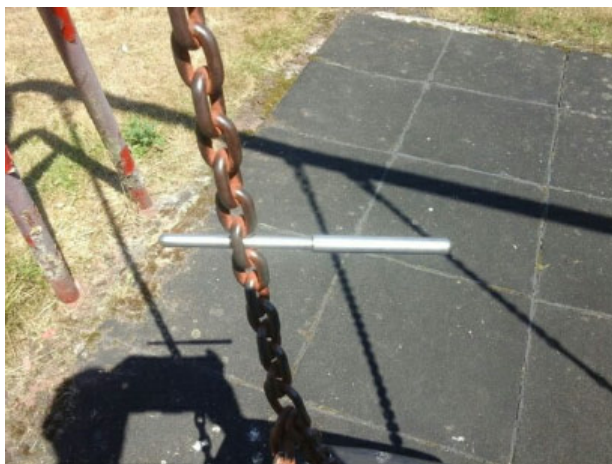
Finding: The chain openings are in excess of the 8.6mm as recommended by BS EN 1176

Action: Monitor use

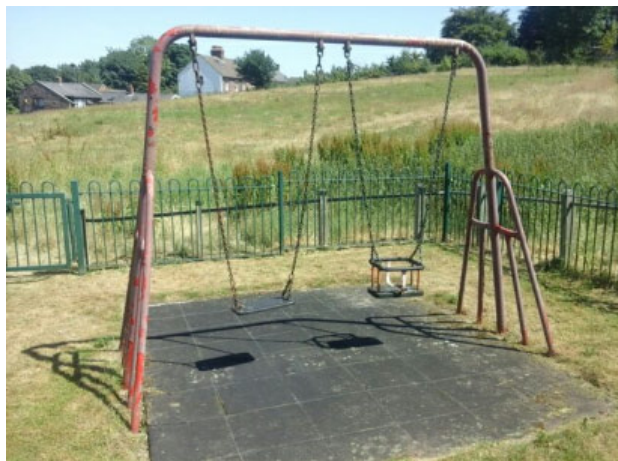
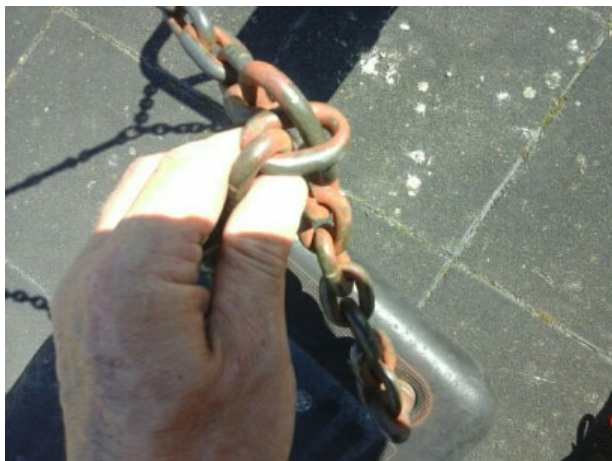
Finding: There is some notable evidence of chain wear
Action: Monitor for any further deterioration and replace when 40% worn

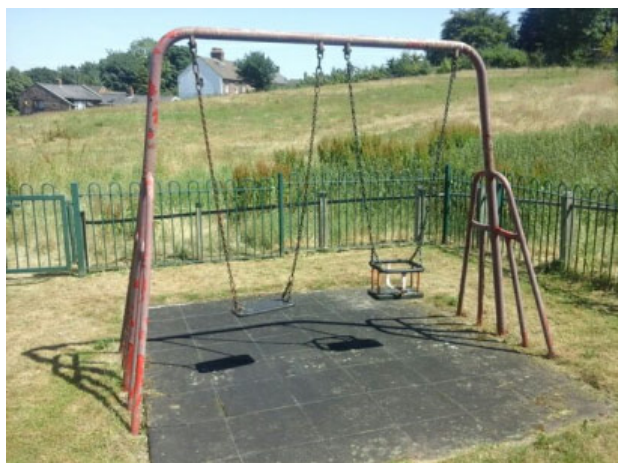
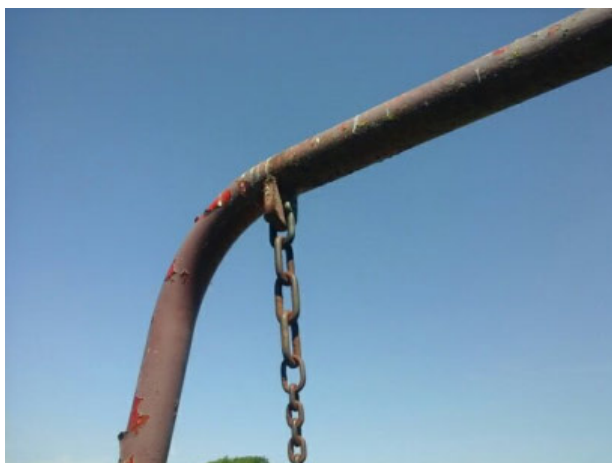
Finding: There is surface corrosion present on the item
Action: Consider treating and repainting the item

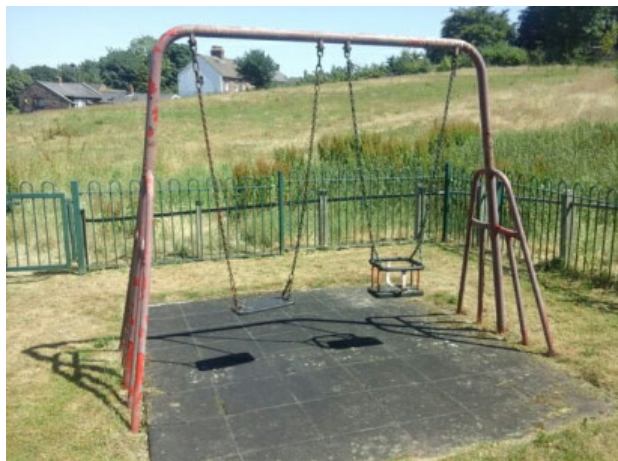
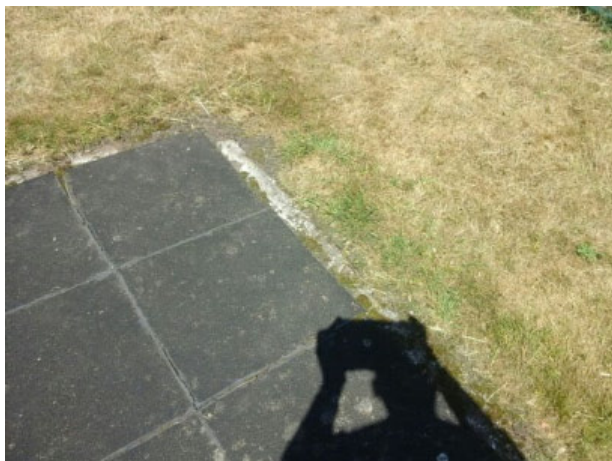
Finding: There are gaps opening in between the tiles
Action: Monitor for any further deterioration and repair as required

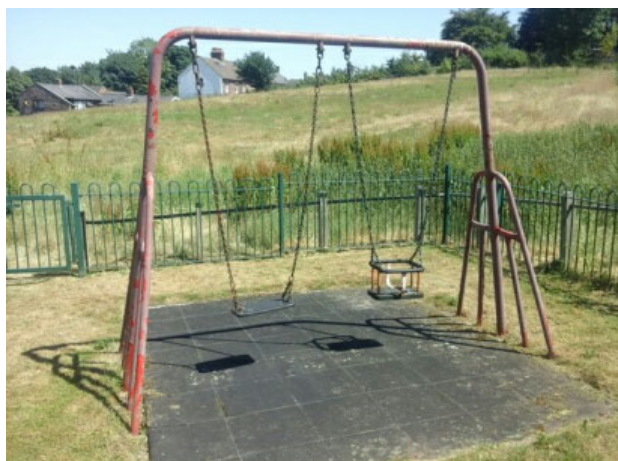
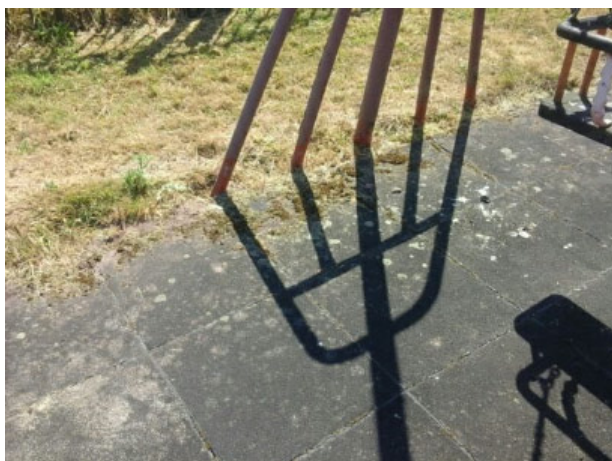
Finding: There is algae or moss growth on the surface resulting in slippery conditions
Action: Clean and treat appropriately

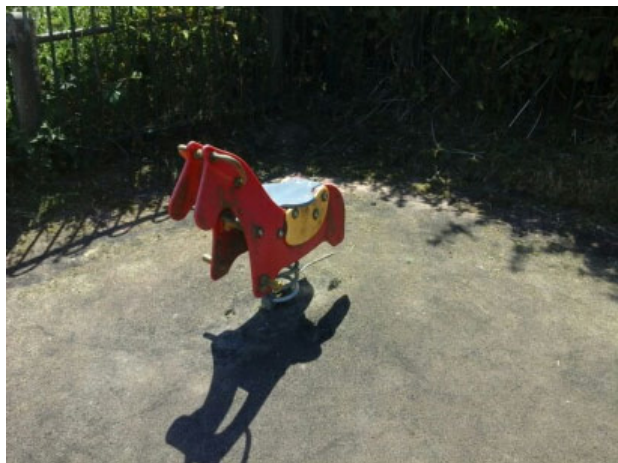
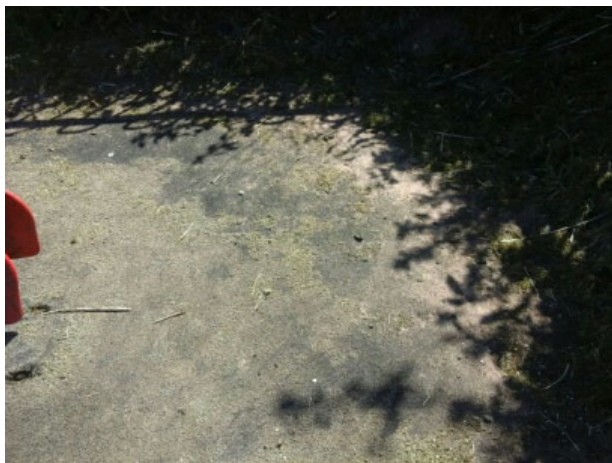
Finding: There is algae or moss growth on the surface resulting in slippery conditions
Action: Clean and treat appropriately

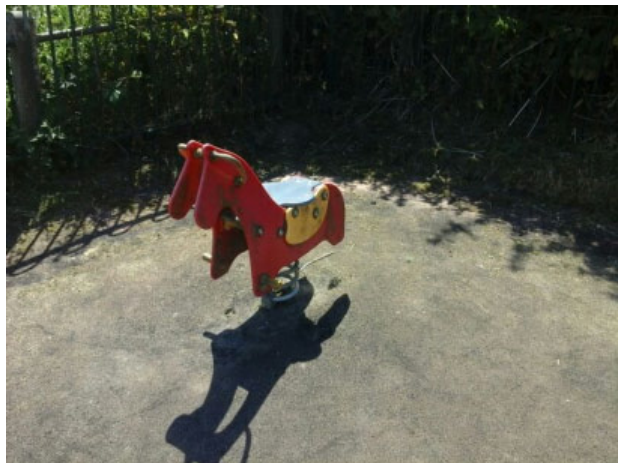
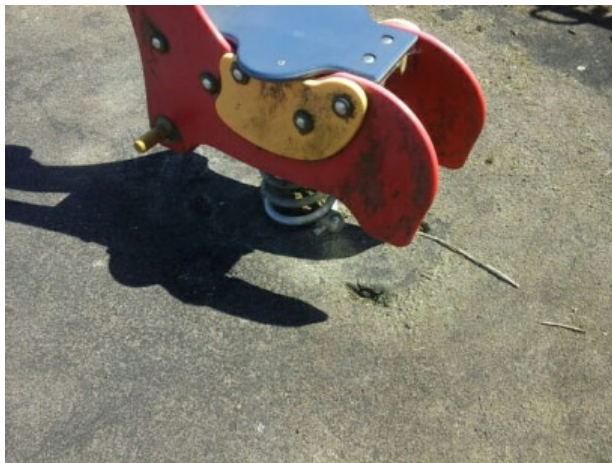
Finding: The safety surface under or around this unit has been damaged
Action: Monitor for any further deterioration and repair as required

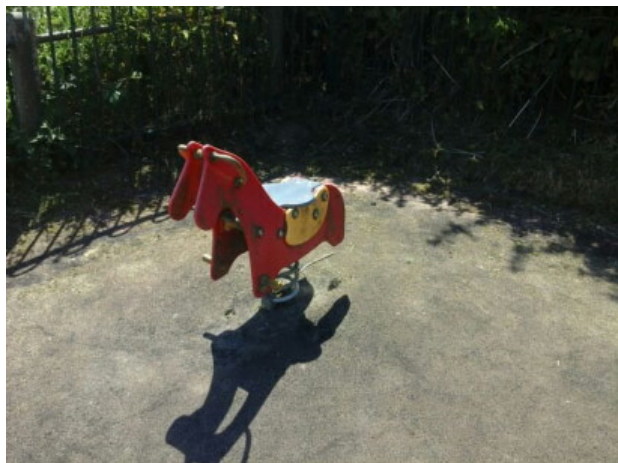
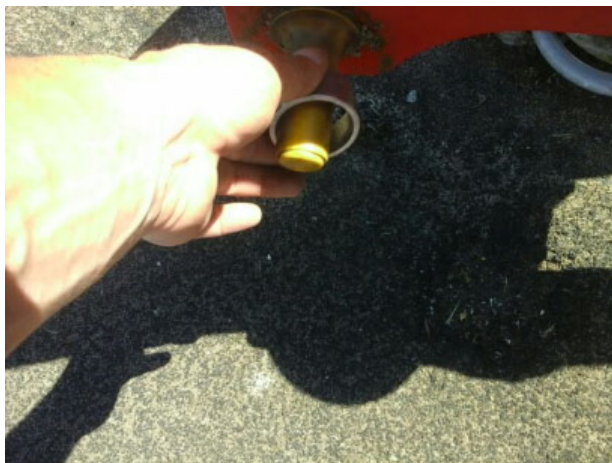
Finding: The end of handgrips and/or footrests have a cross section of less than 15cm² and fail to meet the requirements of BS EN 1176 Part 6

Action: This is a relatively low risk failure and no remedial action is recommended

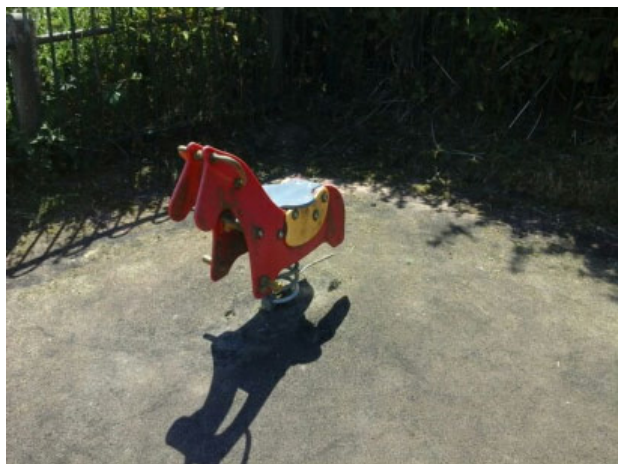
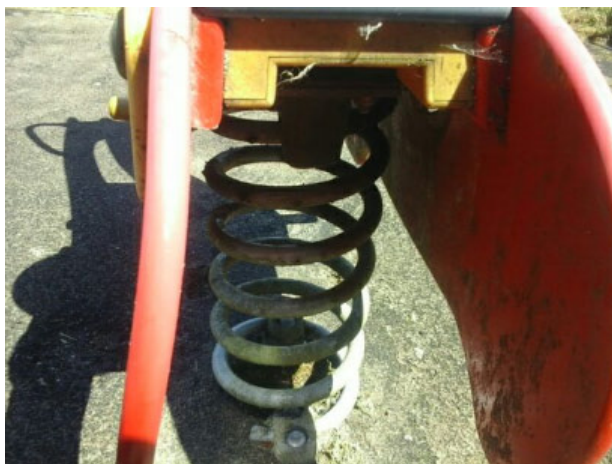
Finding: The paintwork on the spring has been damaged or worn exposing the metal underneath which is rusting

Action: Treat any rusting components and repaint

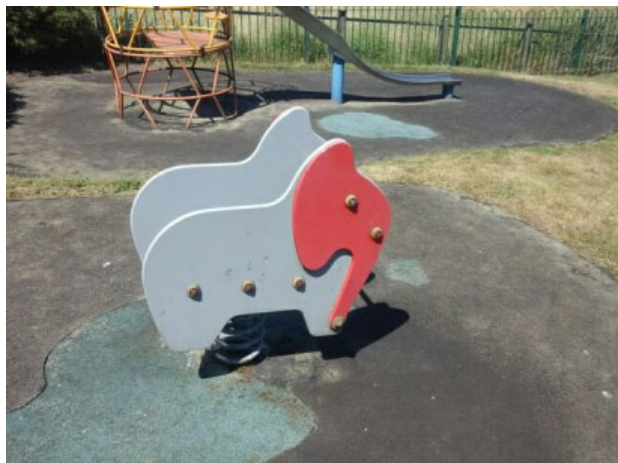
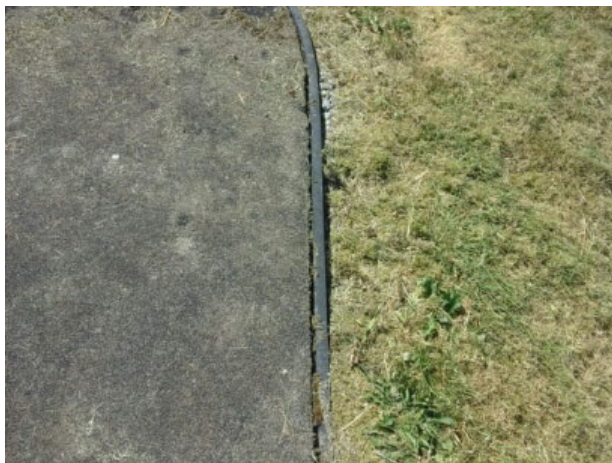
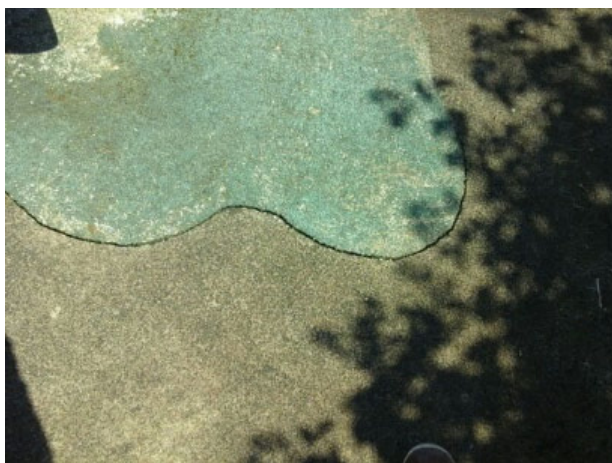
Finding: There are gaps opening between the surfacing and the edging surround or between the joints in the surfacing

Action: Monitor for any further deterioration and repair as required

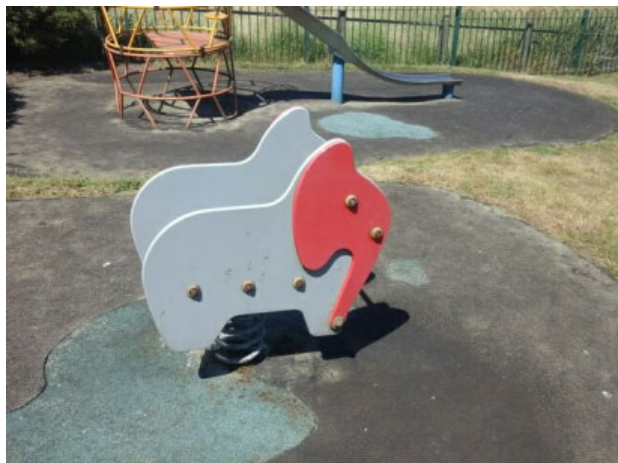
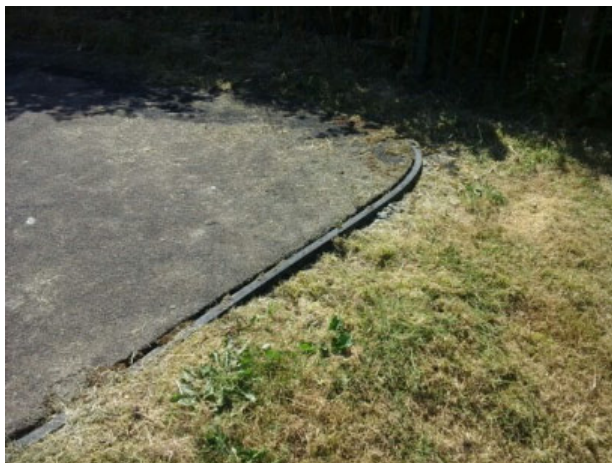
Finding: There are trip hazards at the edges of the surface

Action: Reinstate surrounding surface levels to remove the trip points

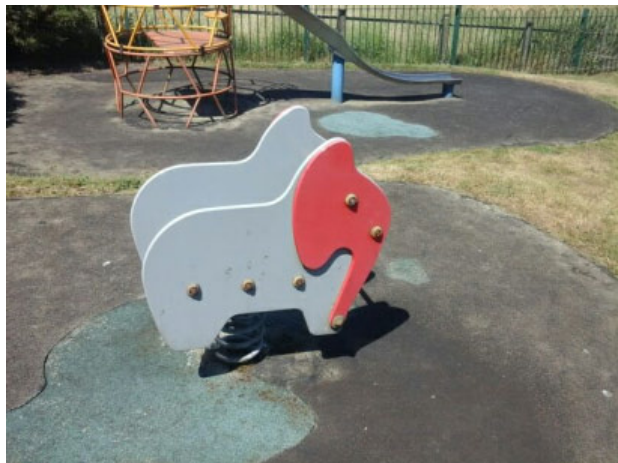
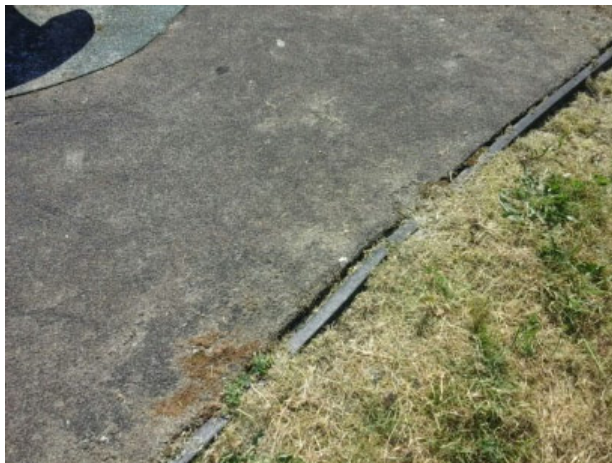
Finding: The surface is lifting at the edges and creating trip points

Action: Repair perimeter of surfacing to remove trip points

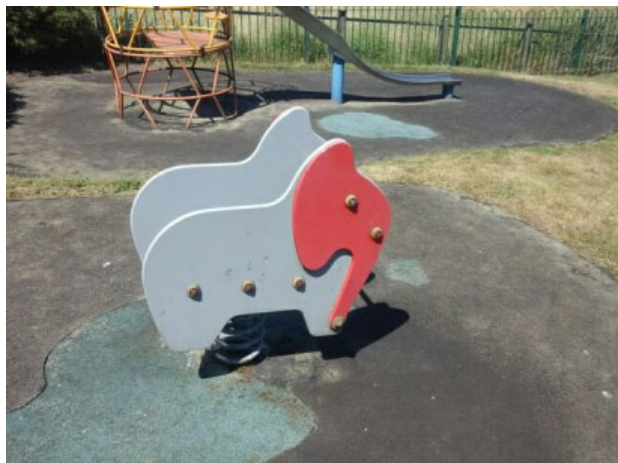
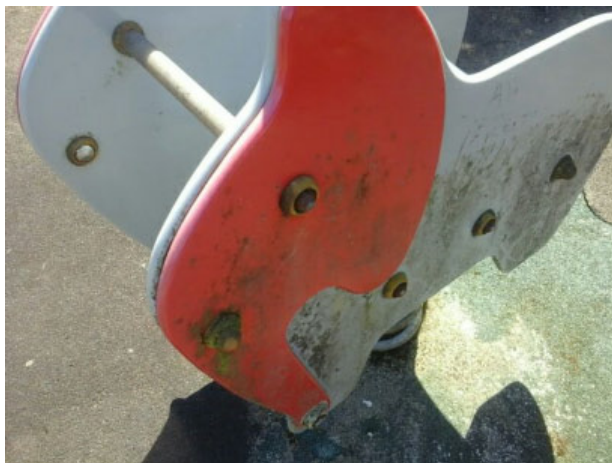
Finding: There is/are bolt cap covers missing or damaged on the item

Action: Replace missing or damaged bolt cap covers

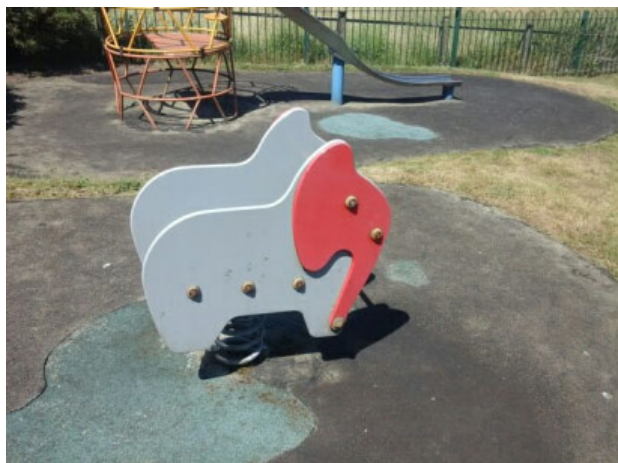
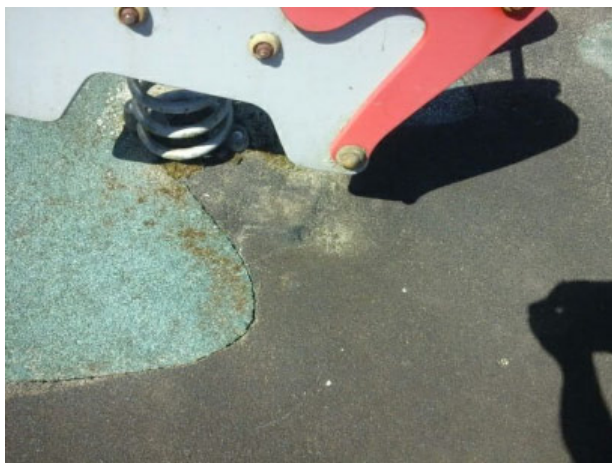
Finding: The safety surface under or around this unit has been damaged

Action: Monitor for any further deterioration and repair as required

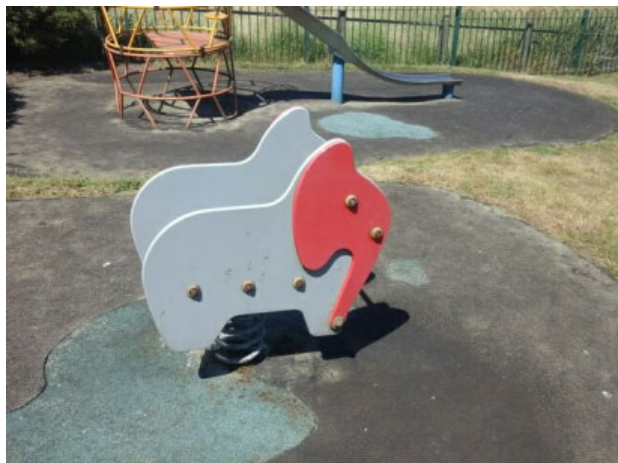
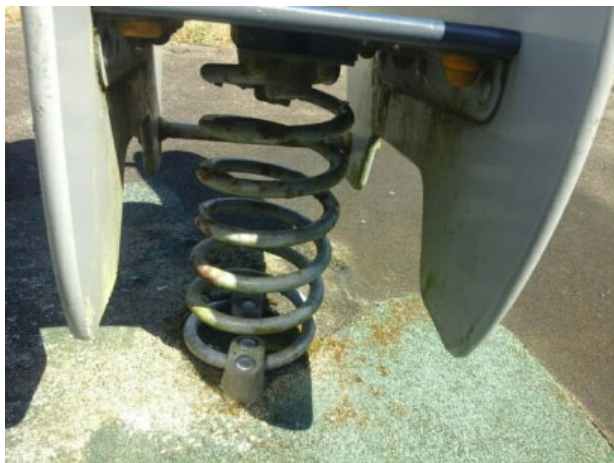
Finding: The paintwork on the spring has been damaged or worn exposing the metal underneath which is rusting

Action: Treat any rusting components and repaint

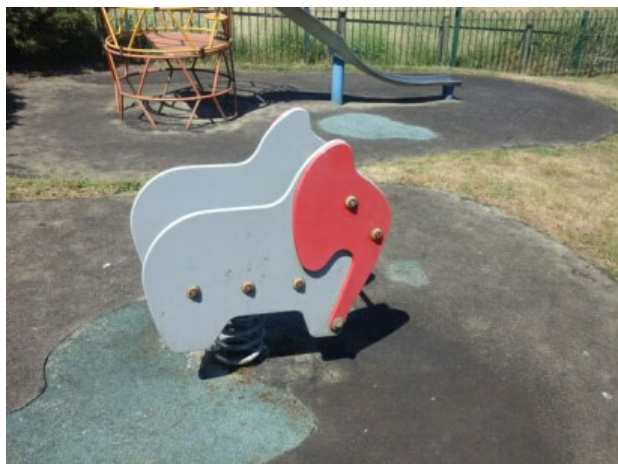
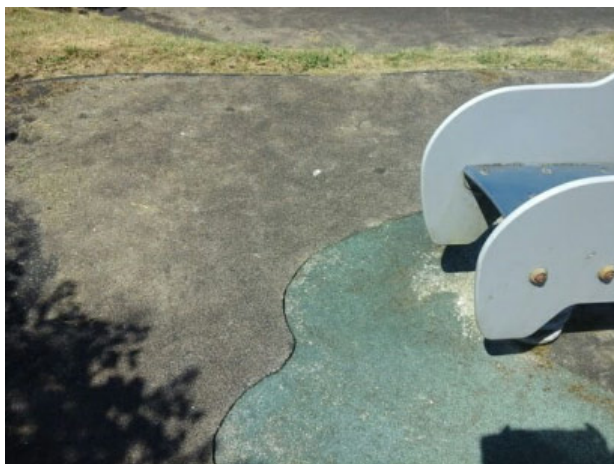
Finding: There is algae or moss growth on the surface resulting in slippery conditions

Action: Clean and treat appropriately

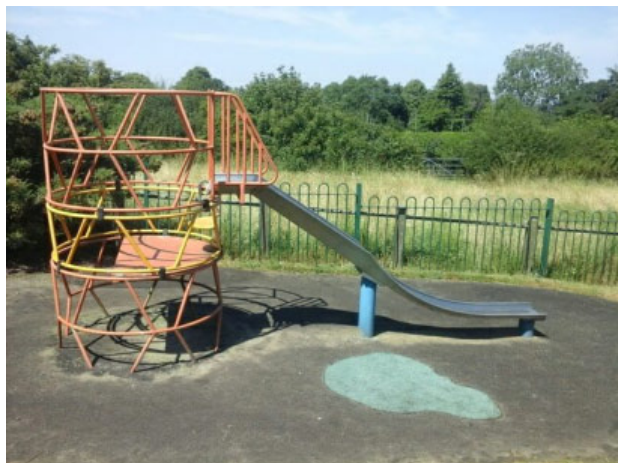
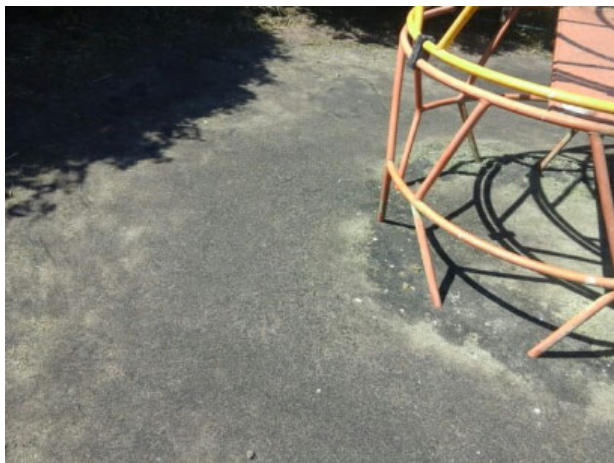
Finding: There is algae or moss growth on the surface resulting in slippery conditions
Action: Clean and treat appropriately

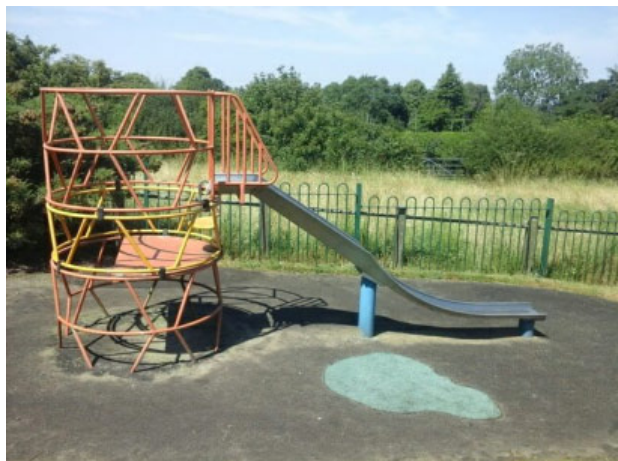
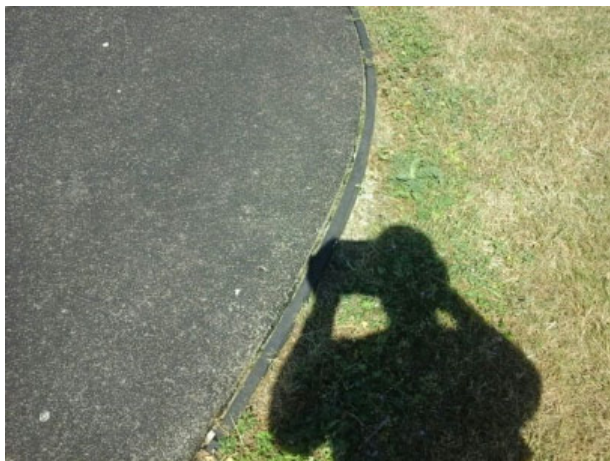
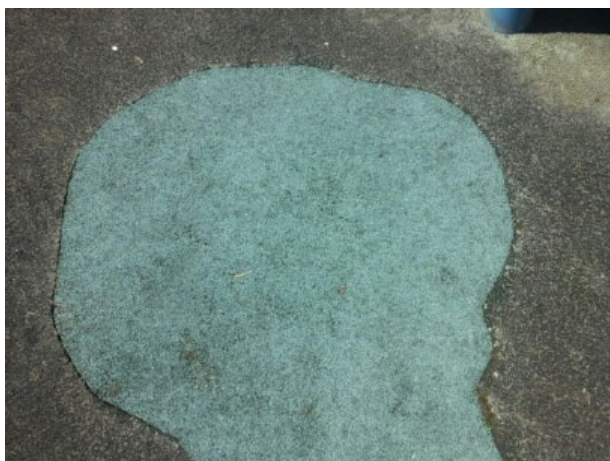
Finding: There are gaps opening between the surfacing and the edging surround or between the joints in the surfacing

Action: Monitor for any further deterioration and repair as required

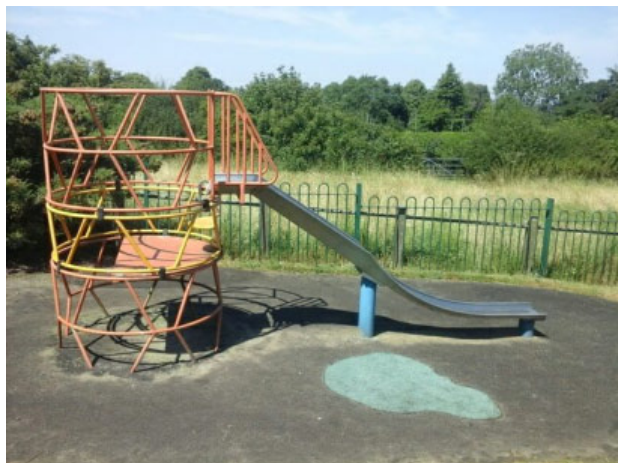
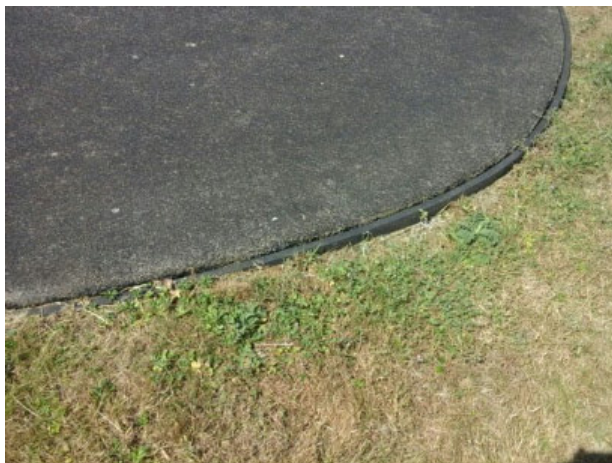
Finding: There are trip hazards at the edges of the surface

Action: Reinstate surrounding surface levels to remove the trip points

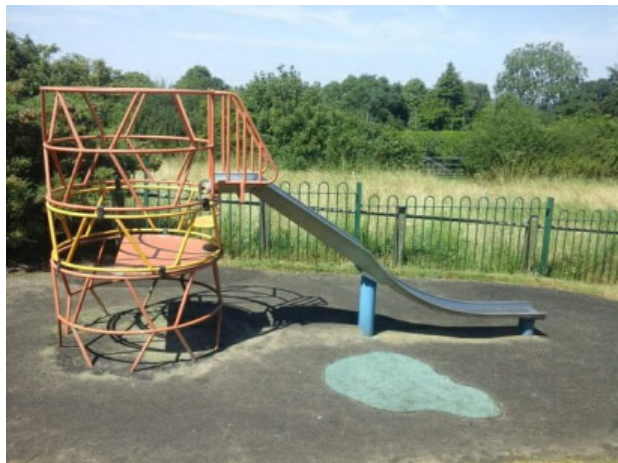
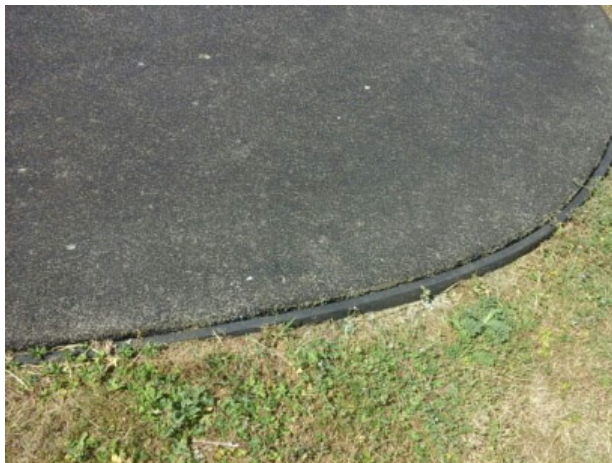
Finding: The surface is lifting at the edges and creating trip points

Action: Repair perimeter of surfacing to remove trip points

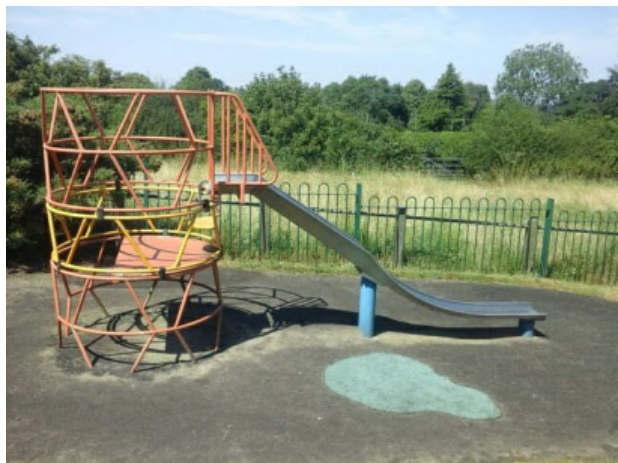
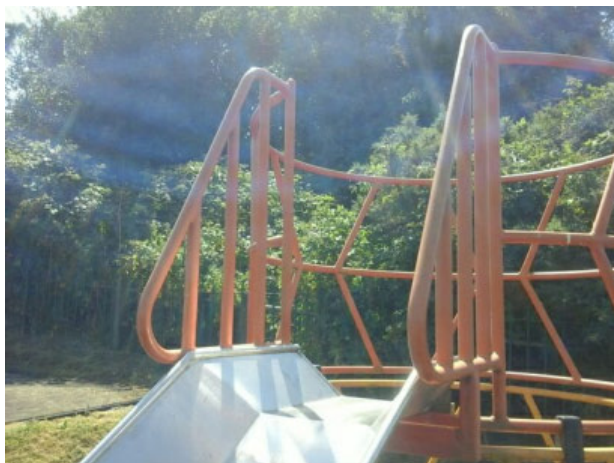
Finding: This item has no slide bar fitted as required by BS EN 1176 Part 3

Action: Monitor use

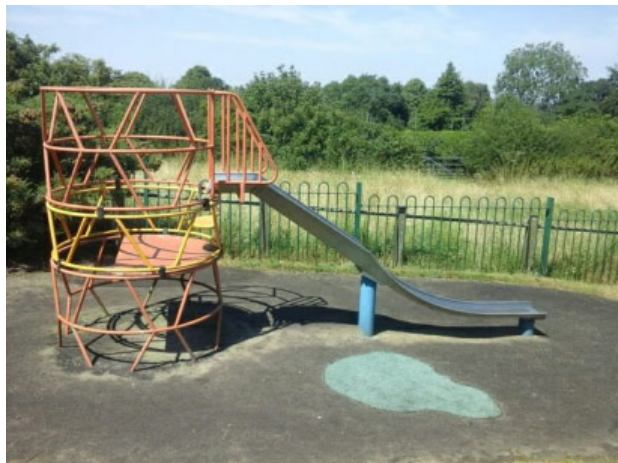
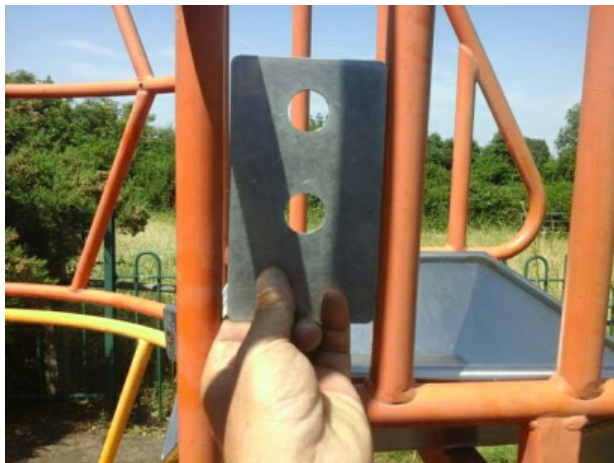
Finding: The item fails to meet the requirements of BS EN 1176:2008 Part 1 4.2.7.2 head and neck entrapment in the barriers and/or steps

Action: Monitor use

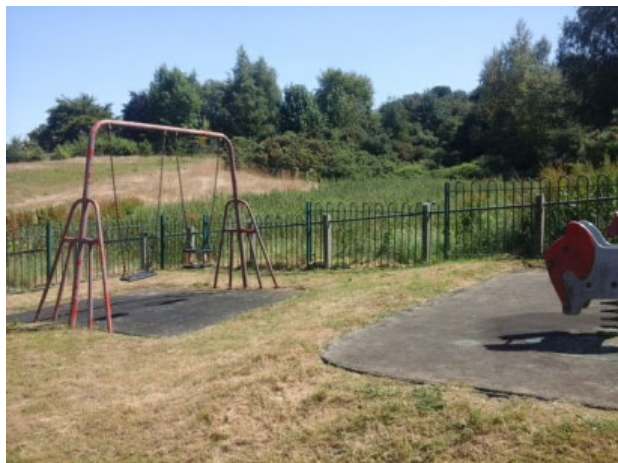
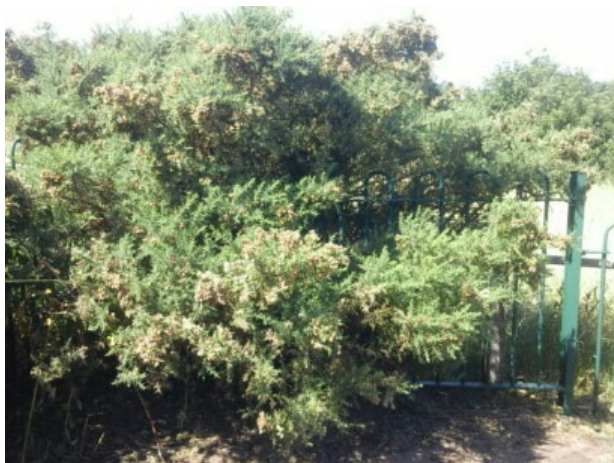
Finding: There are hostile bushes growing into the play area

Action: Cut back foliage
