Annual Inspection

Frodsham Town Council

Park Lane

Inspection Ref: 1409107

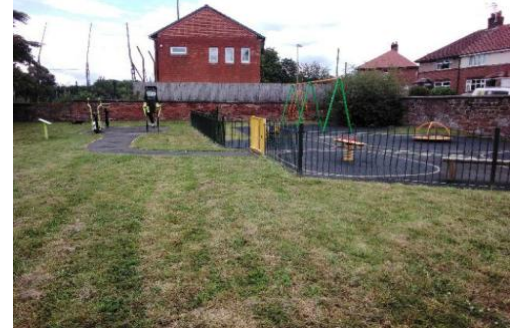
Item: Site General
Manufacturer: Owner/Operator
Surface Type: N/A
Item Quantity: 1
Equipment Compliance: N/A
Surface Area Compliance: N/A

The site is accessible to the public during the COVID 19 pandemic. The government have released guidelines for safely re-opening these types of facilities which is available on the government website. - Ensure there is an appropriate risk assessment in place and review regularly

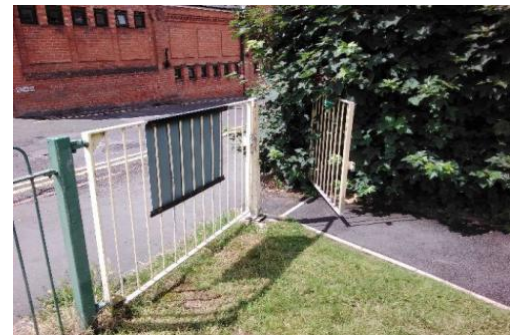
Item: Gate - Combination
Manufacturer: Owner/Operator
Surface Type: Grass
Item Quantity: 1
Equipment Compliance: N/A
Surface Area Compliance: N/A

Foliage has encroached on the item - Cut back foliage

The gate is not operating correctly - Take effective action to ensure the gate closes between 4 and 8 seconds

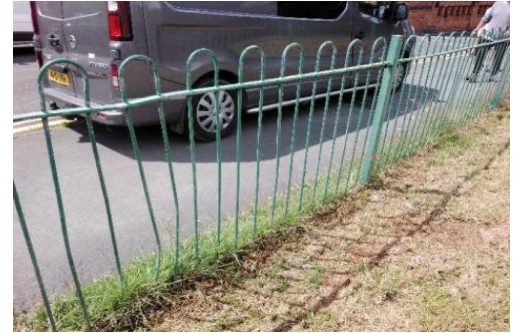
Item: Fence - Bow Top
Manufacturer: Owner/Operator
Surface Type: N/A
Item Quantity: 1
Equipment Compliance: N/A
Surface Area Compliance: N/A

There is some damage to the fence sections - Monitor for any further deterioration and repair as required

There are a number of loose posts around the fence - Monitor for any further deterioration and reset as required

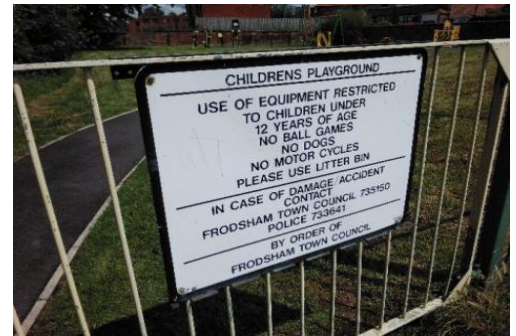
Item: Sign
Manufacturer: Owner/Operator
Surface Type: N/A
Item Quantity: 1
Equipment Compliance: N/A
Surface Area Compliance: N/A

BS EN 1176 Part 7 recommends that signage shall include the site name / address - Provide additional information

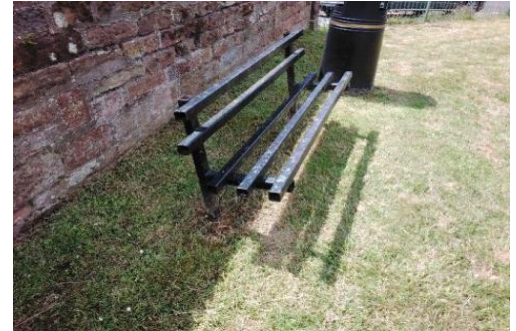
Item: Bench
Manufacturer: Owner/Operator
Surface Type: Grass
Item Quantity: 1
Equipment Compliance: N/A
Surface Area Compliance: N/A

There are post / end caps missing from the item - Replace missing post caps

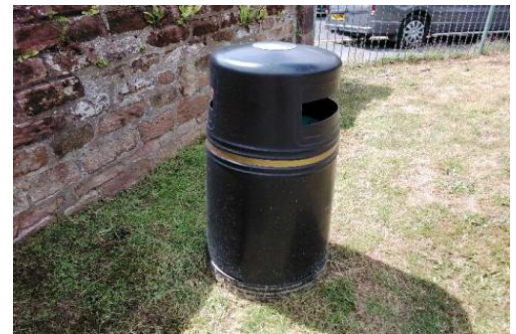
Item: Litter Bin
Manufacturer: Owner/Operator
Surface Type: N/A
Item Quantity: 1
Equipment Compliance: N/A
Surface Area Compliance: N/A

The lid or door of the litter bin is not secured - Ensure the lid or door is kept locked

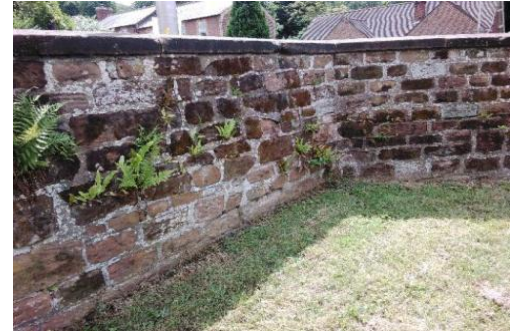
Item: Wall
Manufacturer: Owner/Operator
Surface Type: N/A
Item Quantity: 1
Equipment Compliance: N/A
Surface Area Compliance: N/A

The brickwork is deteriorating - Monitor for any further deterioration and repair as required

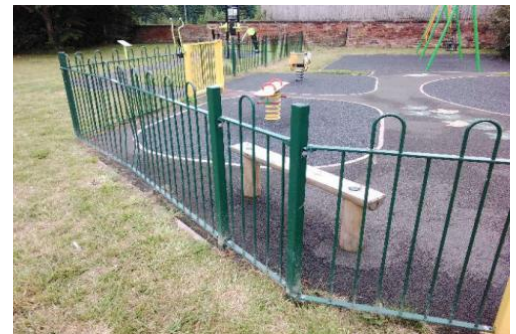
Item: Fence - Bow Top
Manufacturer: Owner/Operator
Surface Type: Grass
Item Quantity: 1
Equipment Compliance: N/A
Surface Area Compliance: N/A

There is some damage to the fence sections - Monitor for any further deterioration and repair as required

Shear nuts have not been fully tightened and are still present on fixings - Tighten heads on nuts to shear off and secure

There is some evidence of fire damage to the item - Monitor for any further deterioration and repair as required

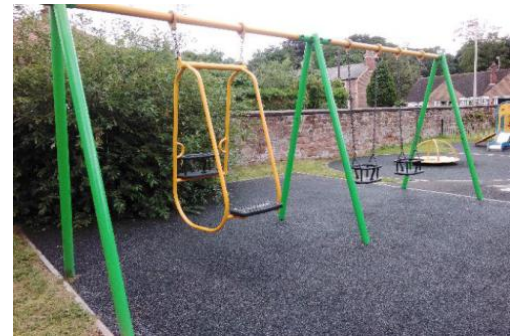
Item: 2 Bay 2 Cradle 1 Inclusive Seat
Manufacturer: Wicksteed Playgrounds
Surface Type: Wet Pour
Item Quantity: 1
Equipment Compliance: No
Surface Area Compliance: Yes
Total Findings: 2

Foliage has encroached on the free space of the item - Cut back foliage ensuring no sharp ends project

Parts of the steel seat frame project outside of the seat and have no impact attenuation properties to protect users passing by or underneath - Refer to the manufacturer for confirmation of design risk assessment

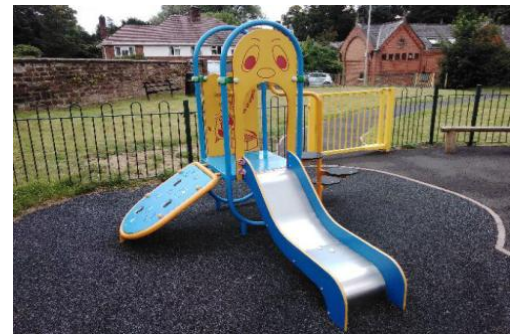
Item: Multi Play (Toddler)
Manufacturer: Wicksteed Playgrounds
Surface Type: Wet Pour
Item Quantity: 1
Equipment Compliance: No
Surface Area Compliance: Yes

The fence forms a hard object within the falling space of the equipment in contravention of the requirements of BS EN 1176 Part 1 - Monitor - No remedial work recommended

There are projecting bolt thread(s) present - Remove excess thread length and deburr or provide cap

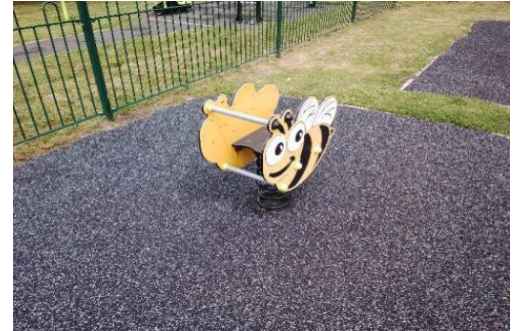
Item: Spring Bee
Manufacturer: Wicksteed Playgrounds
Surface Type: Wet Pour
Item Quantity: 1
Equipment Compliance: Yes
Surface Area Compliance: Yes

The Handgrips/Footrests rotate and may cause an unexpected movement for the user - Secure Handgrips/Footrests to prevent rotation.

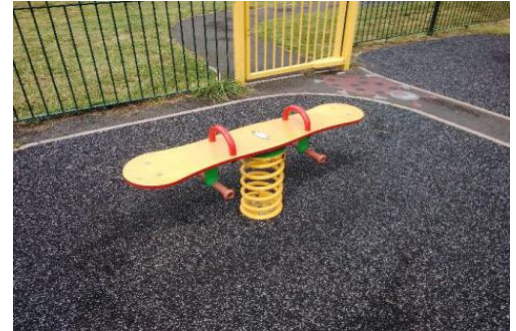
Item: Spring See-Saw
Manufacturer: Wicksteed Playgrounds
Surface Type: Wet Pour
Item Quantity: 1
Equipment Compliance: Yes
Surface Area Compliance: Yes

The end caps are missing on the Handgrips/Footrests - Replace missing end caps

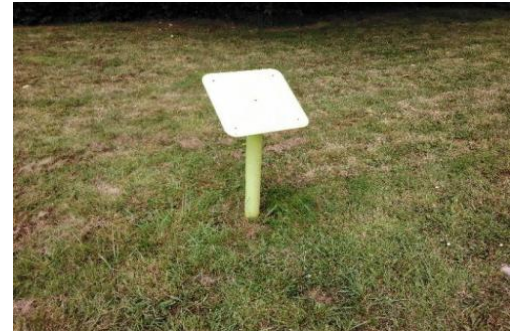
Item: Sign
Manufacturer: Owner/Operator
Surface Type: Grass
Item Quantity: 1
Equipment Compliance: N/A
Surface Area Compliance: N/A

Signage should be provided for the outdoor fitness equipment in accordance with the requirements of BS EN 16630, key requirements of the sign include, but are not limited to, intended users, medical safety and emergency contact details - Provide appropriate signage

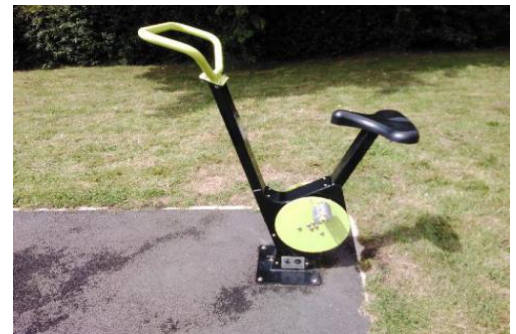
Item: Cycle
Manufacturer: The Great Outdoor Gym Company
Surface Type: Bitmac
Item Quantity: 1
Equipment Compliance: Yes
Surface Area Compliance: Yes

Noisy under operation - Rectify

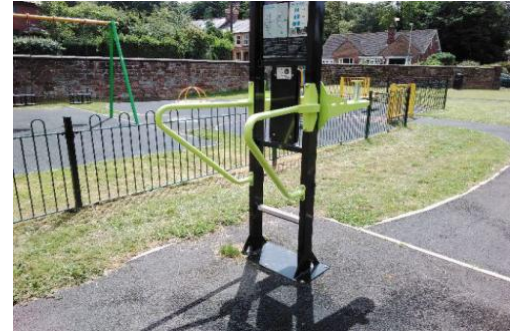
Item: Fit Point
Manufacturer: The Great Outdoor Gym Company
Surface Type: Bitmac
Item Quantity: 1
Equipment Compliance: Yes
Surface Area Compliance: Yes

There is weed / vegetation growth on, between, or around the edges of the surfacing - Remove weed / vegetation growth

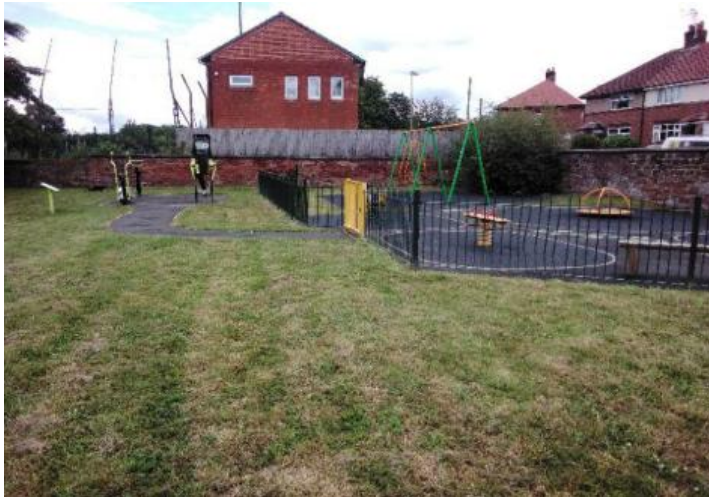
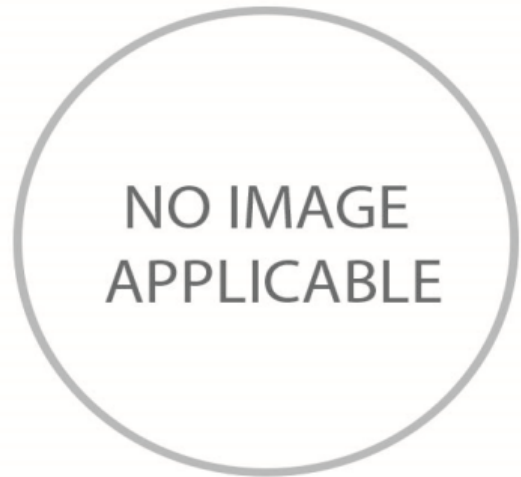
Item: Ancillary Items - Site General
Manufacturer: Owner/Operator

Finding: The site is accessible to the public during the COVID 19 pandemic. The government have released guidelines for safely re-opening these types of facilities which is available on the government website.

Action: Ensure there is an appropriate risk assessment in place and review regularly

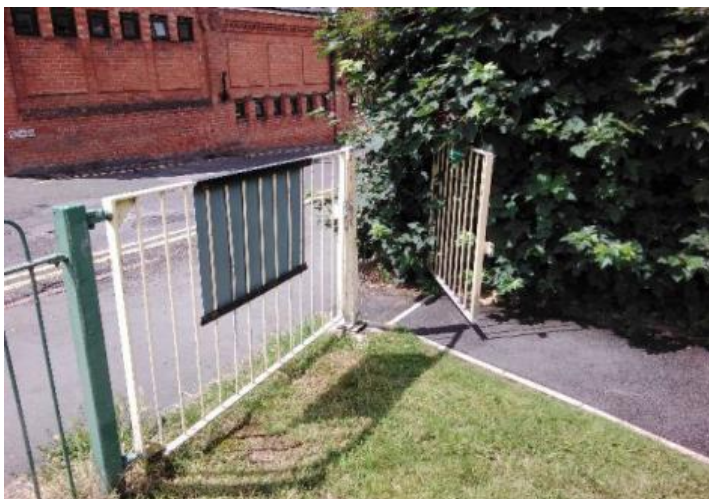
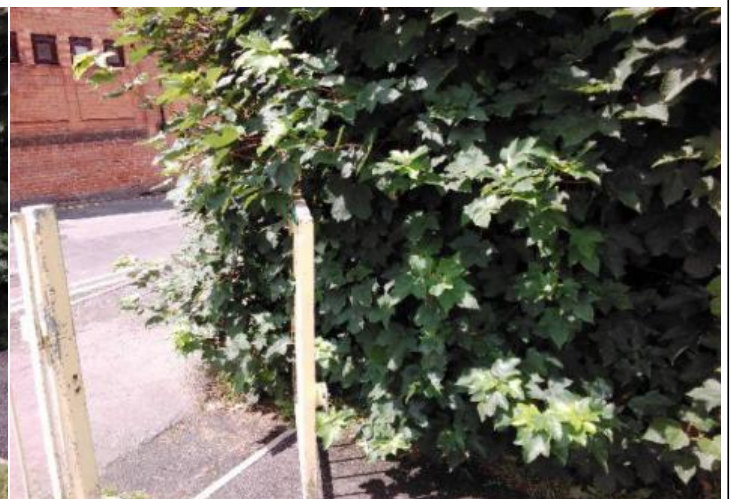
Item: Gates - Gate - Combination
Manufacturer: Owner/Operator

Finding: Foliage has encroached on the item

Action: Cut back foliage

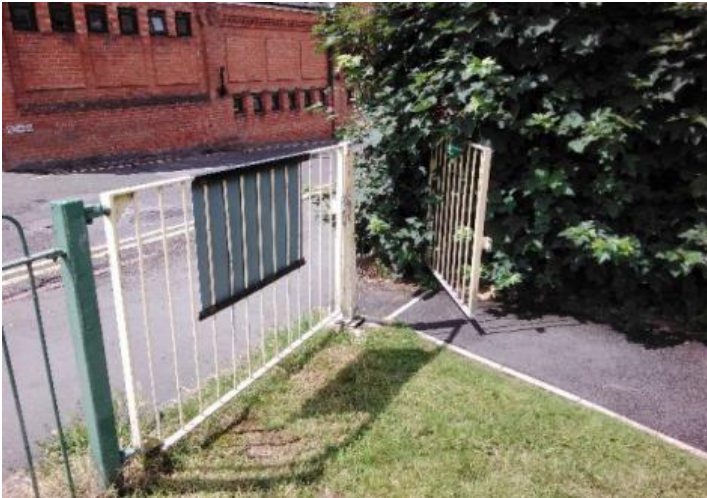
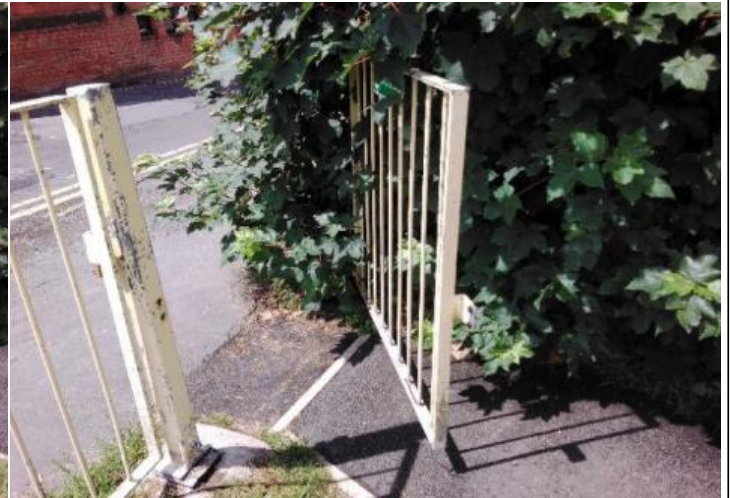
Item: Gates - Gate - Combination
Manufacturer: Owner/Operator

Finding: The gate is not operating correctly

Action: Take effective action to ensure the gate closes between 4 and 8 seconds

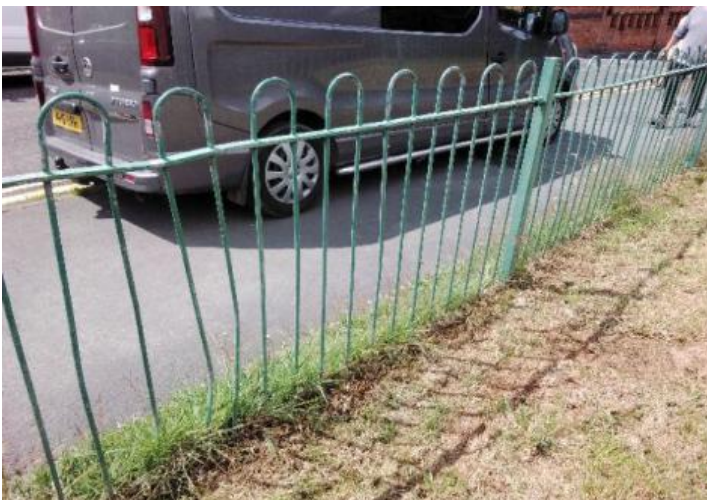
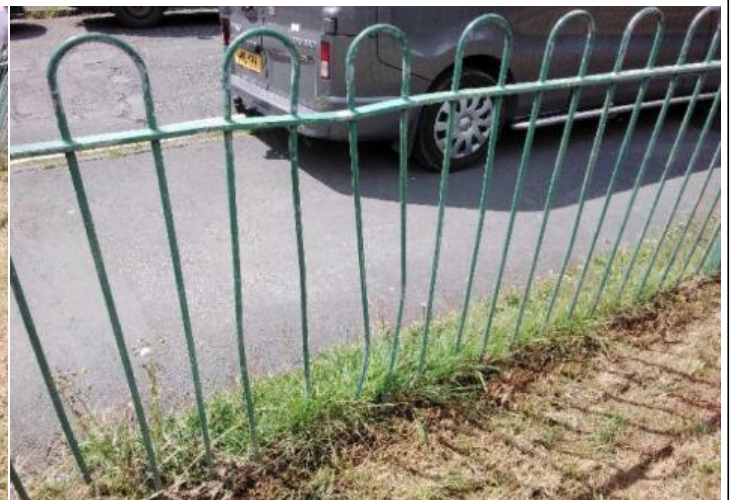
Item: Fences - Fence - Bow Top
Manufacturer: Owner/Operator

Finding: There is some damage to the fence sections

Action: Monitor for any further deterioration and repair as required

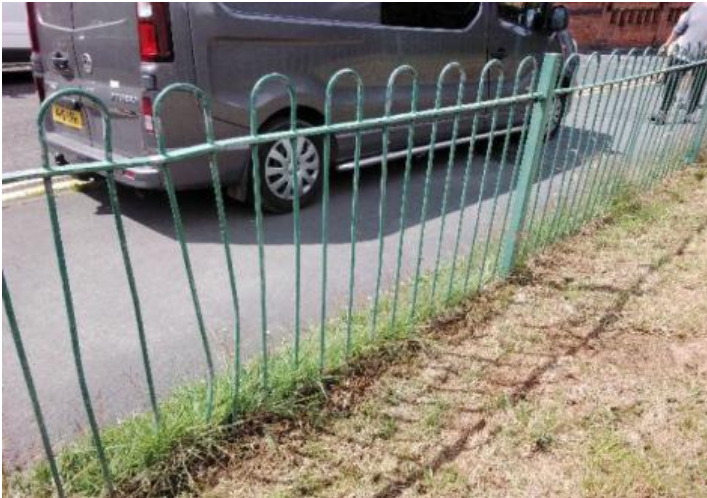
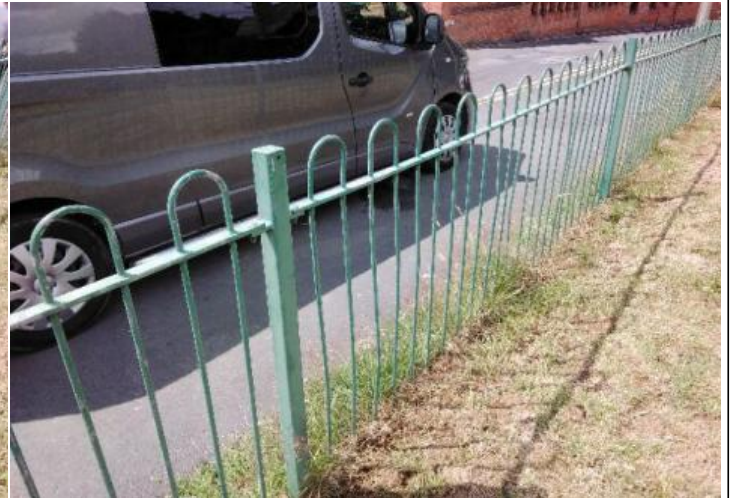
Item: Fences - Fence - Bow Top
Manufacturer: Owner/Operator

Finding: There are a number of loose posts around the fence

Action: Monitor for any further deterioration and reset as required

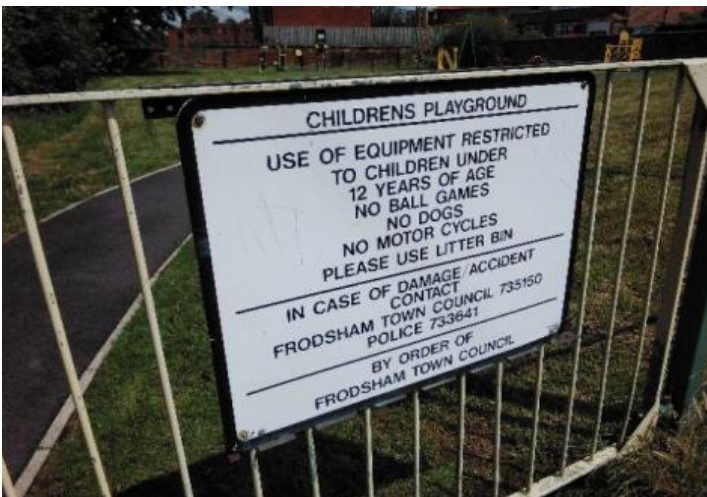
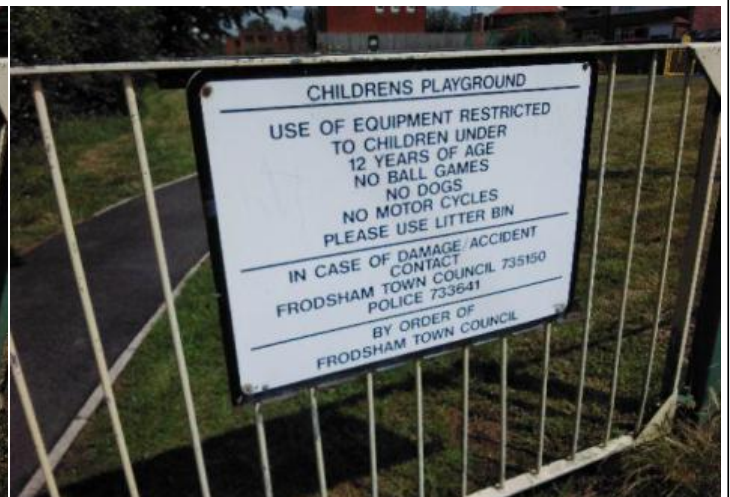
Item: Ancillary Items - Sign
Manufacturer: Owner/Operator

Finding: BS EN 1176 Part 7 recommends that signage shall include the site name / address

Action: Provide additional information

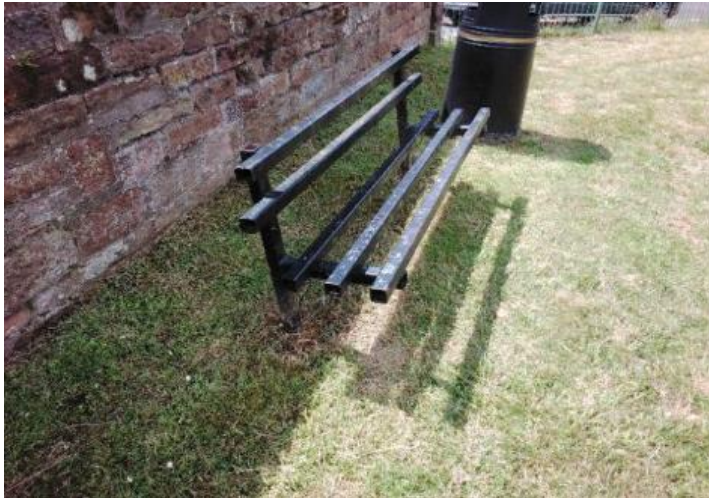
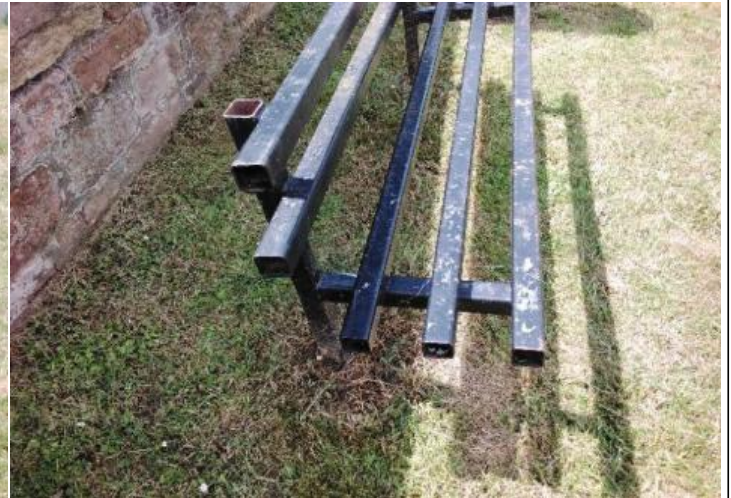
Item: Ancillary Items - Bench
Manufacturer: Owner/Operator

Finding: There are post / end caps missing from the item

Action: Replace missing post caps

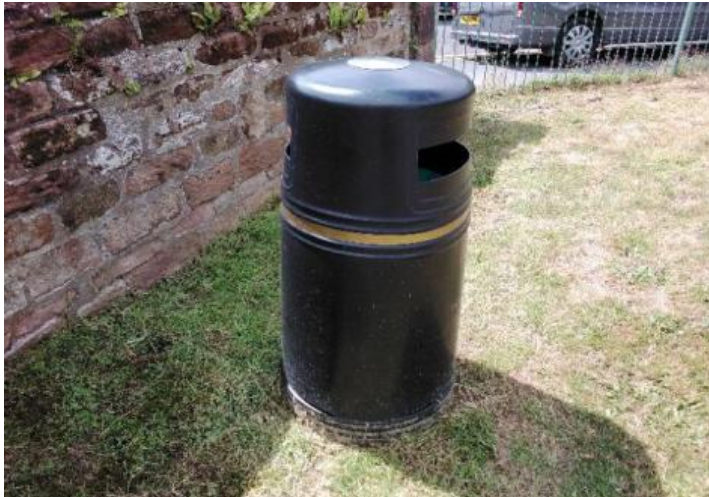
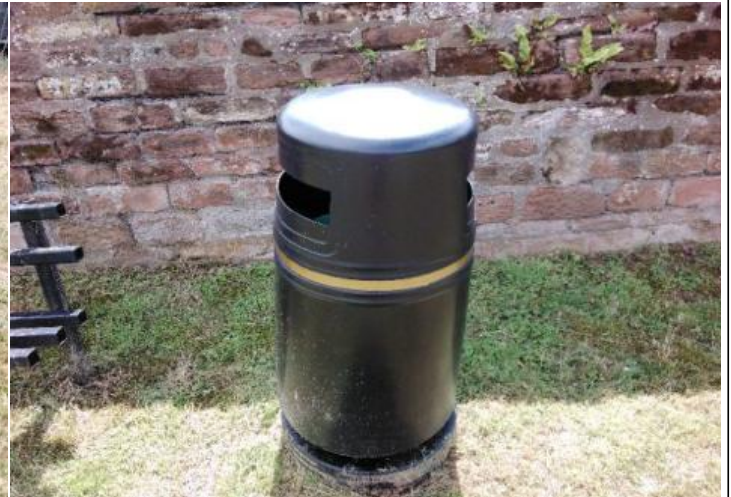
Item: Ancillary Items - Litter Bin
Manufacturer: Owner/Operator

Finding: The lid or door of the litter bin is not secured

Action: Ensure the lid or door is kept locked

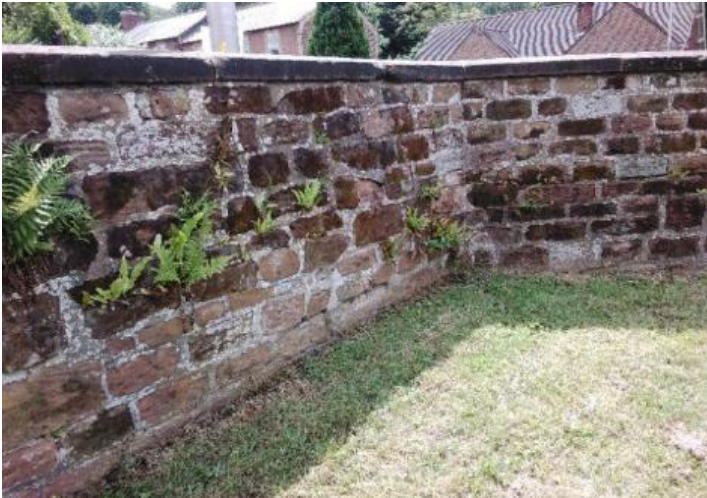
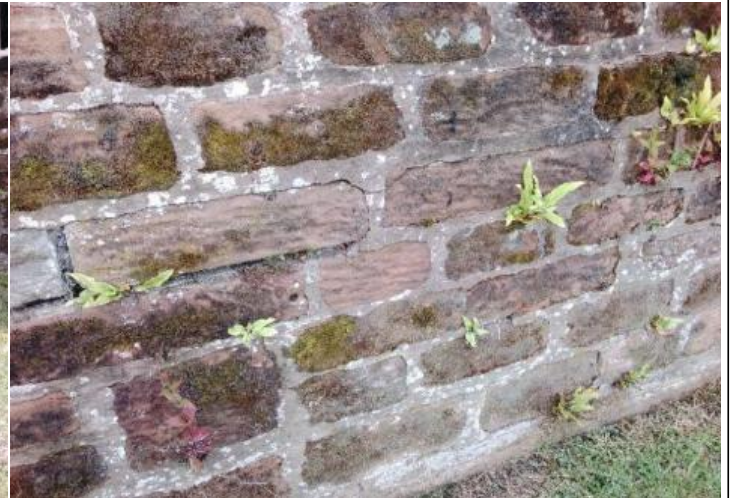
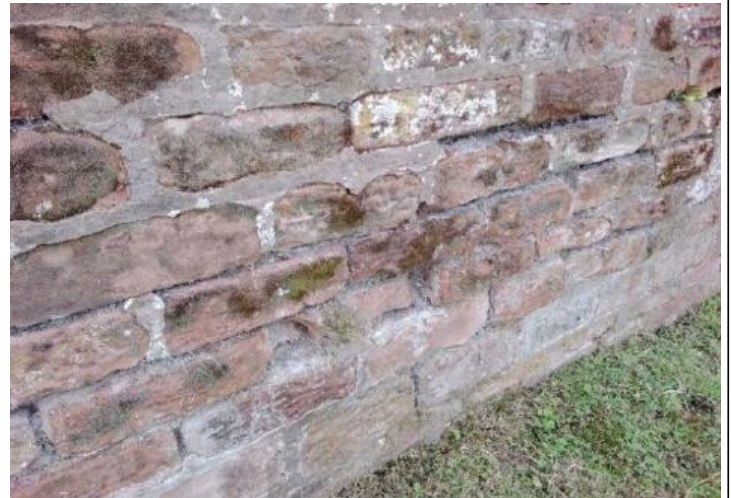
Item: Ancillary Items - Wall
Manufacturer: Owner/Operator

Finding: The brickwork is deteriorating

Action: Monitor for any further deterioration and repair as required

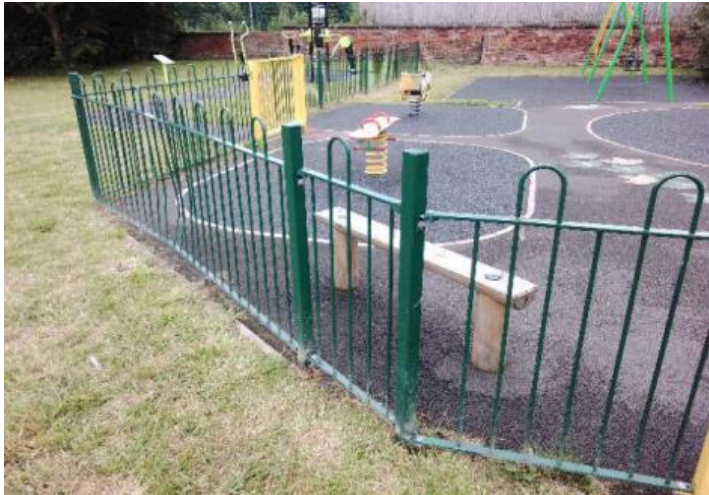
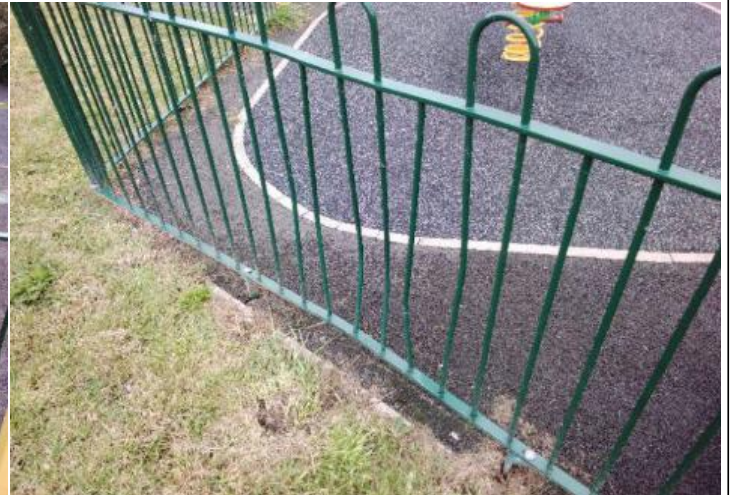
Item: Fences - Fence - Bow Top
Manufacturer: Owner/Operator

Finding: There is some damage to the fence sections

Action: Monitor for any further deterioration and repair as required

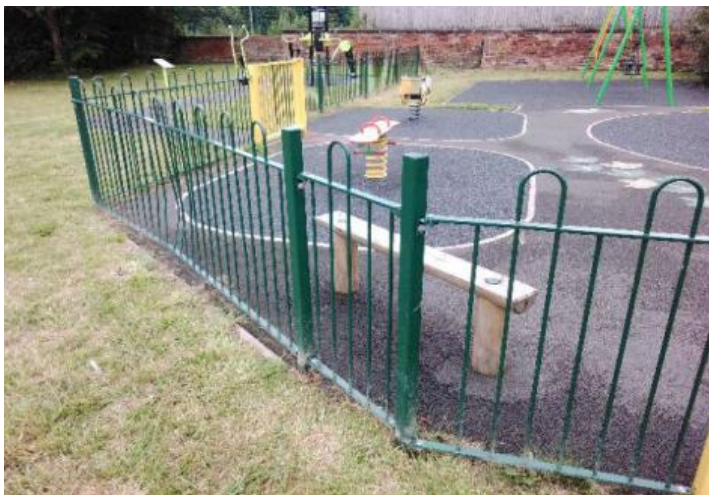
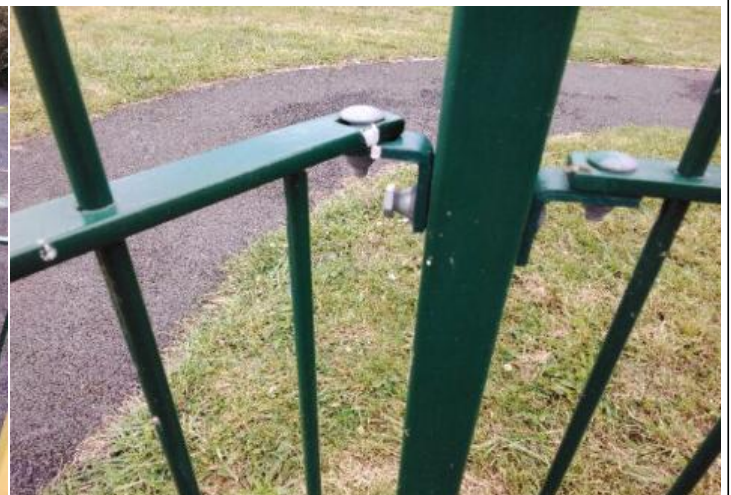
Item: Fences - Fence - Bow Top
Manufacturer: Owner/Operator

Finding: Shear nuts have not been fully tightened and are still present on fixings

Action: Tighten heads on nuts to shear off and secure

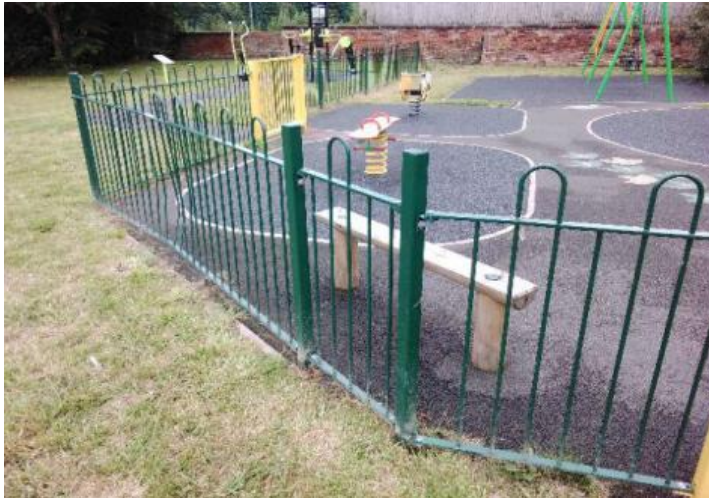
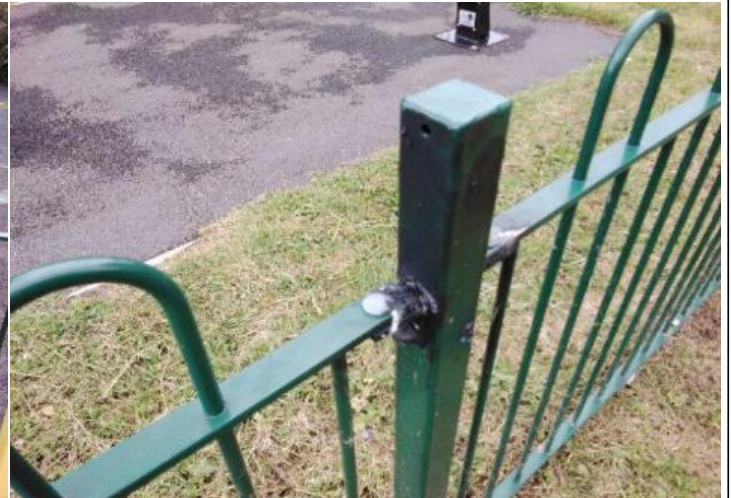
Item: Fences - Fence - Bow Top
Manufacturer: Owner/Operator

Finding: There is some evidence of fire damage to the item **Action:** Monitor for any further deterioration and repair as required

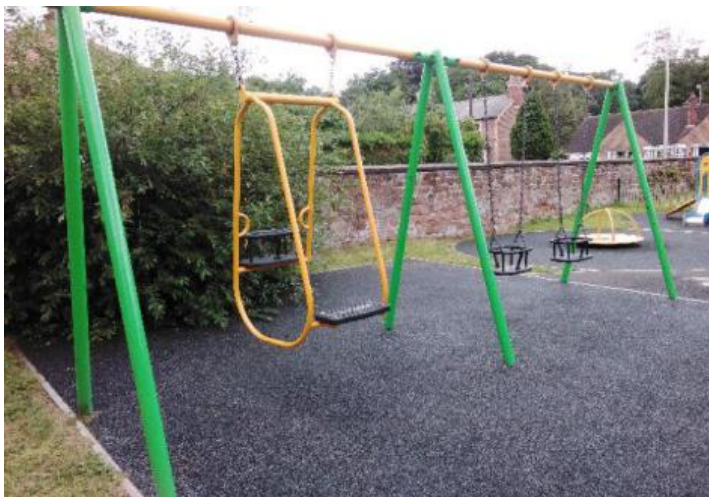
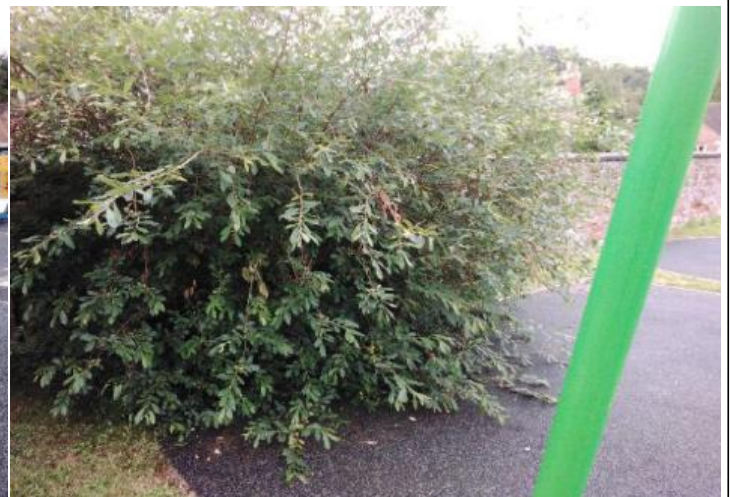
Item: Swings - 2 Bay 2 Cradle 1 Inclusive Seat
Manufacturer: Wicksteed Playgrounds

Finding: Foliage has encroached on the free space of the item **Action:** Cut back foliage ensuring no sharp ends project

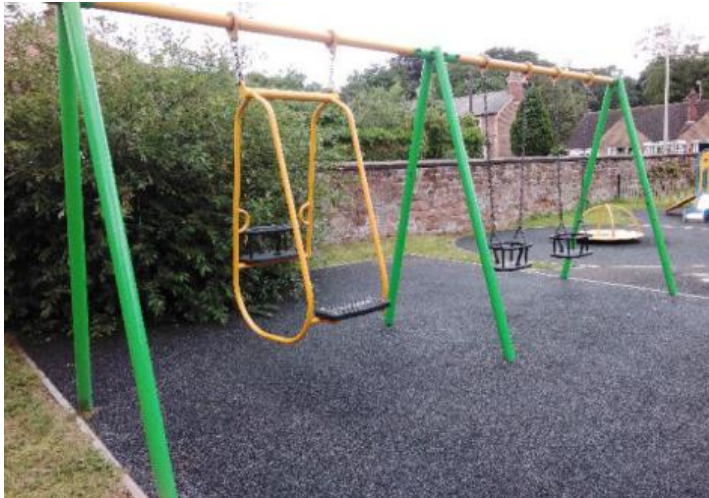
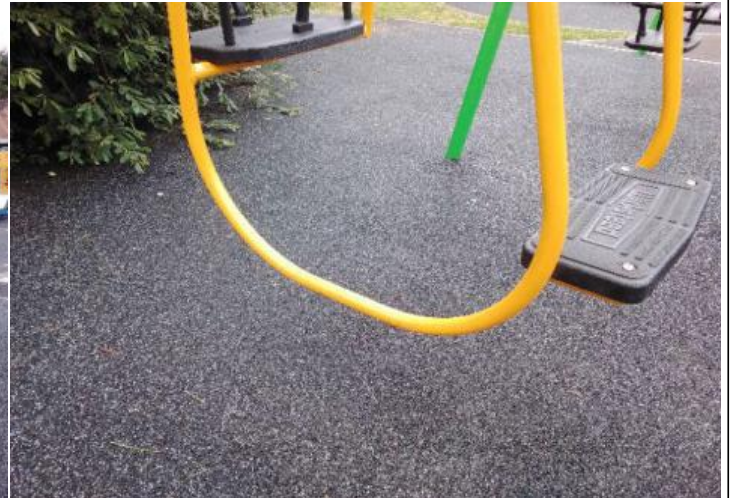
Item: Swings - 2 Bay 2 Cradle 1 Inclusive Seat
Manufacturer: Wicksteed Playgrounds

Finding: Parts of the steel seat frame project outside of the seat and have no impact attenuation properties to protect users passing by or underneath

Action: Refer to the manufacturer for confirmation of design risk assessment

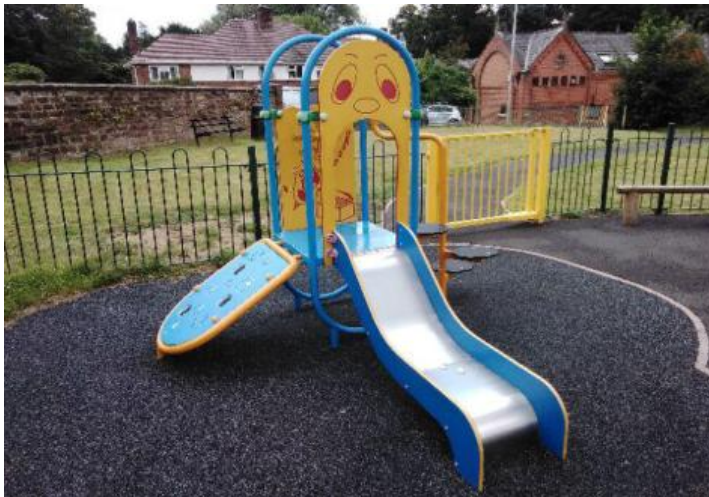
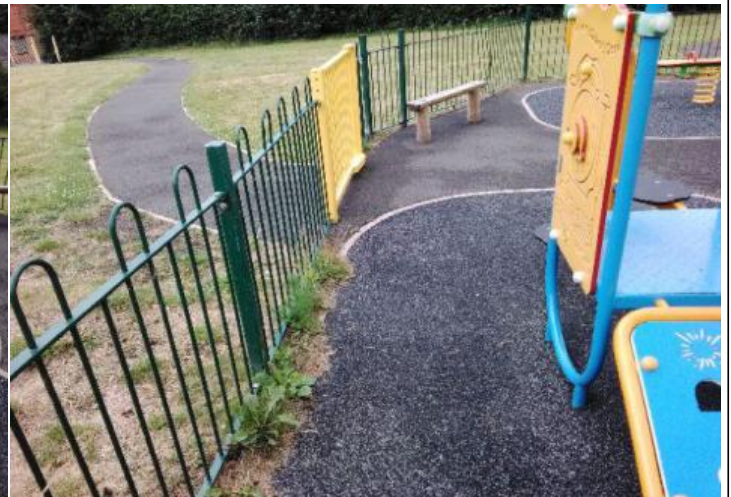
Item: Activity Equipment - Multi Play (Toddler)
Manufacturer: Wicksteed Playgrounds

Finding: The fence forms a hard object within the falling space of the equipment in contravention of the requirements of BS EN 1176 Part 1

Action: Monitor - No remedial work recommended

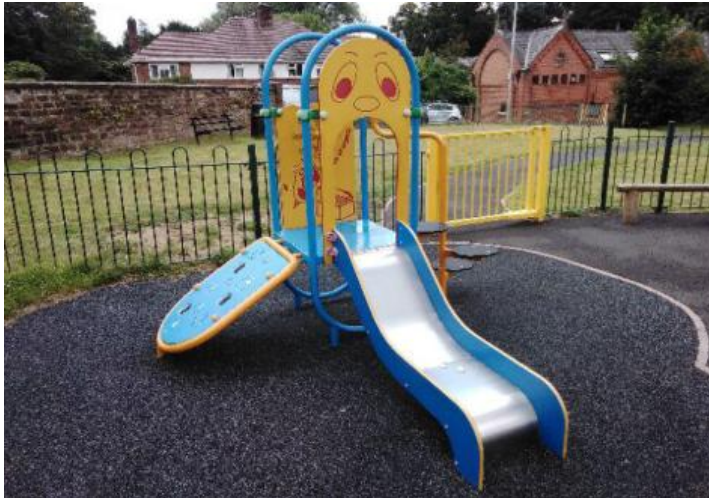
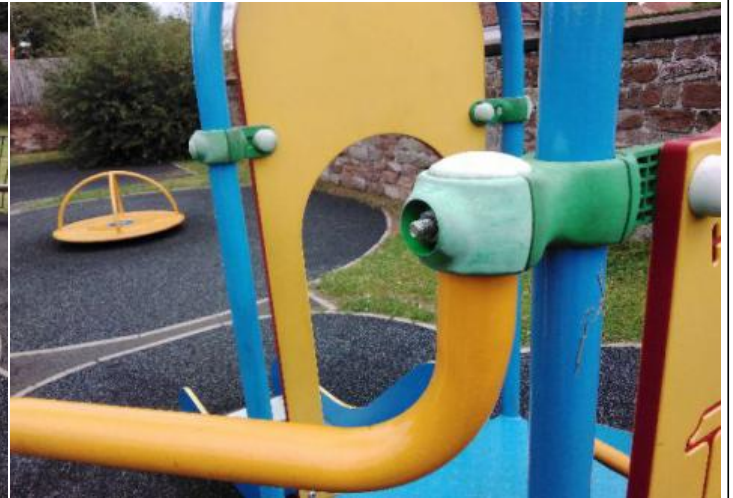
Item: Activity Equipment - Multi Play (Toddler)
Manufacturer: Wicksteed Playgrounds

Finding: There are projecting bolt thread(s) present

Action: Remove excess thread length and deburr or provide cap

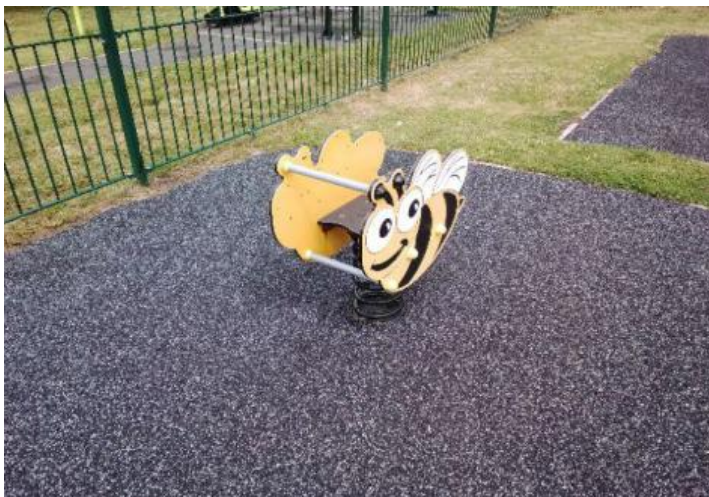
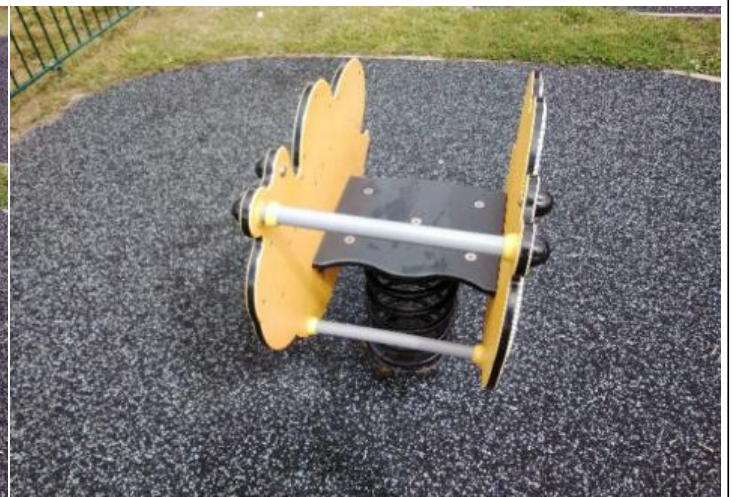
Item: Rocking Equipment - Spring Bee
Manufacturer: Wicksteed Playgrounds

Finding: The Handgrips/Footrests rotate and may cause an unexpected movement for the user

Action: Secure Handgrips/Footrests to prevent rotation.

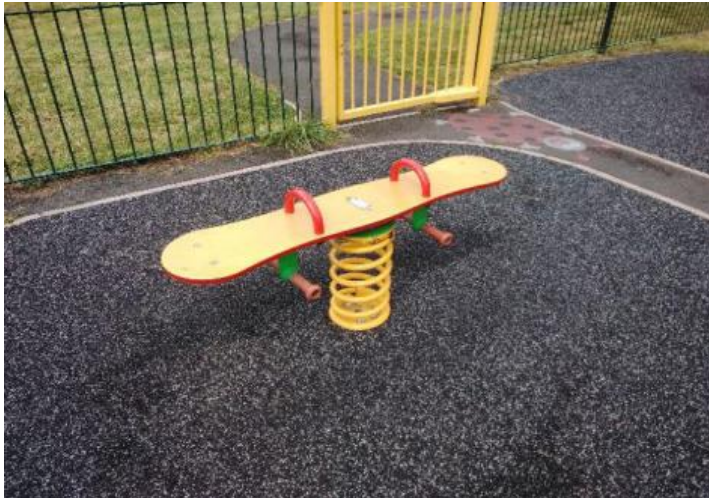
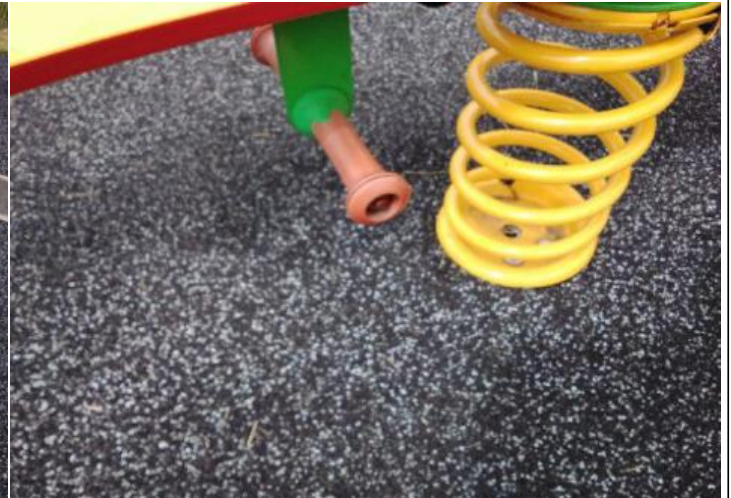
Item: Rocking Equipment - Spring See-Saw
Manufacturer: Wicksteed Playgrounds

Finding: The end caps are missing on the Handgrips/Footrests

Action: Replace missing end caps

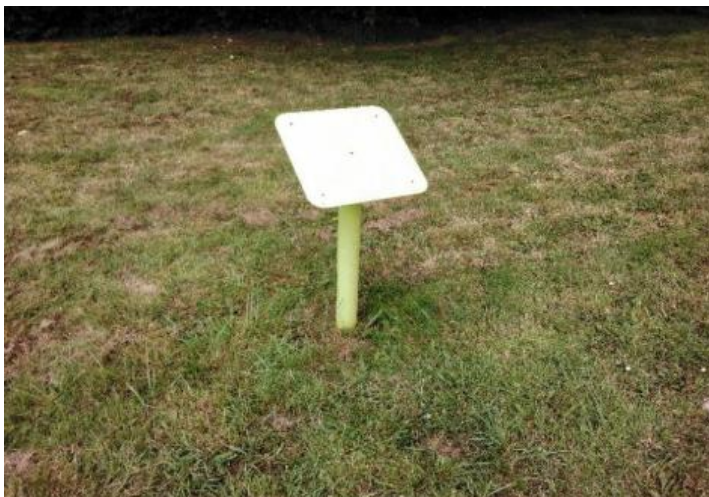
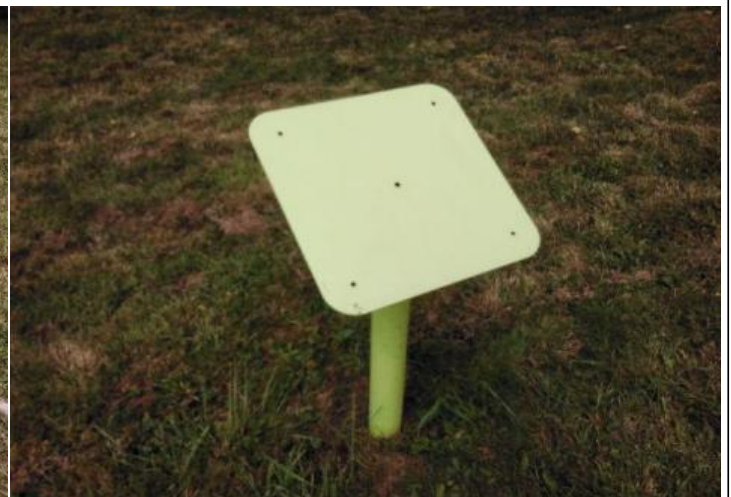
Item: Ancillary Items - Sign
Manufacturer: Owner/Operator

Finding: Signage should be provided for the outdoor fitness equipment in accordance with the requirements of BS EN 16630, key requirements of the sign include, but are not limited to, intended users, medical safety and emergency contact details

Action: Provide appropriate signage

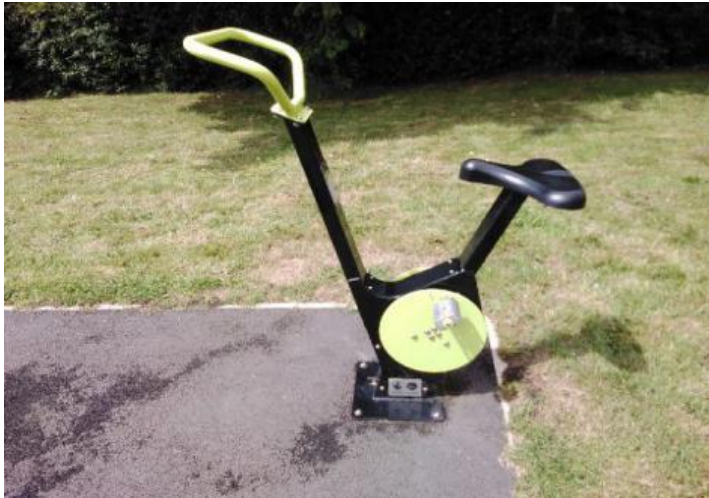
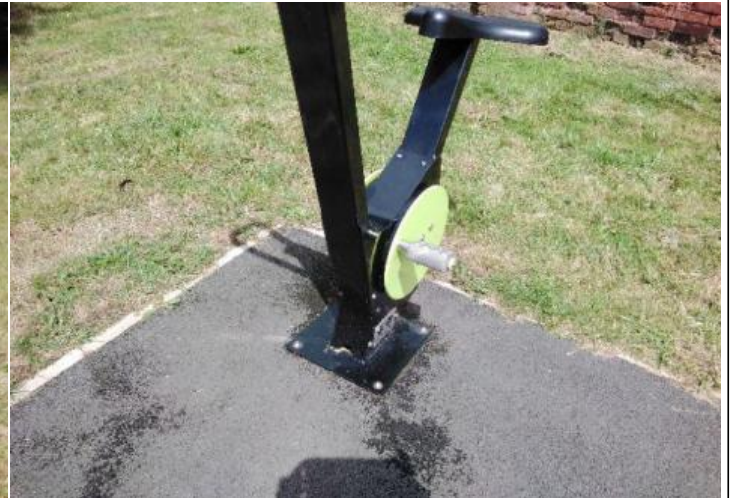
Item: Outdoor Fitness Equipment - Cycle
Manufacturer: The Great Outdoor Gym Company

Finding: Noisy under operation

Action: Rectify

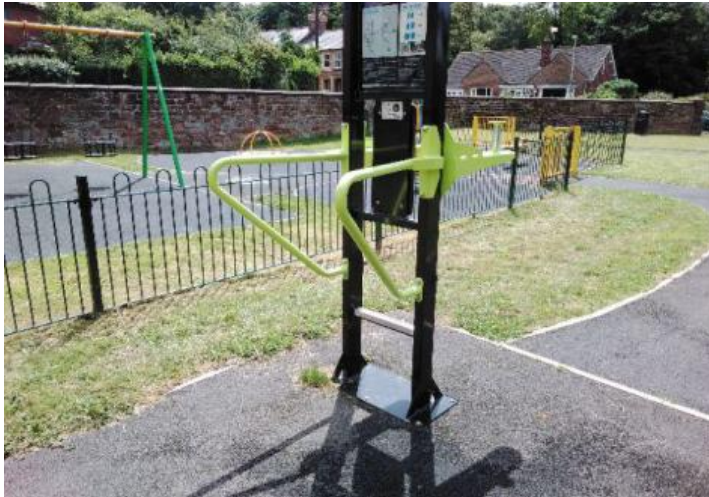
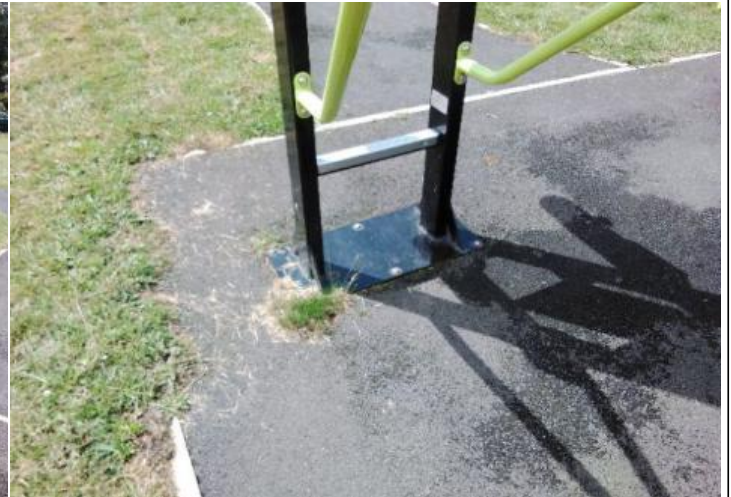
Item: Outdoor Fitness Equipment - Fit Point
Manufacturer: The Great Outdoor Gym Company

Finding: There is weed / vegetation growth on, between, or around the edges of the surfacing

Action: Remove weed / vegetation growth
