## Annual Inspection

Frodsham Town Council

Townfield Lane

Inspection Ref: 1409106

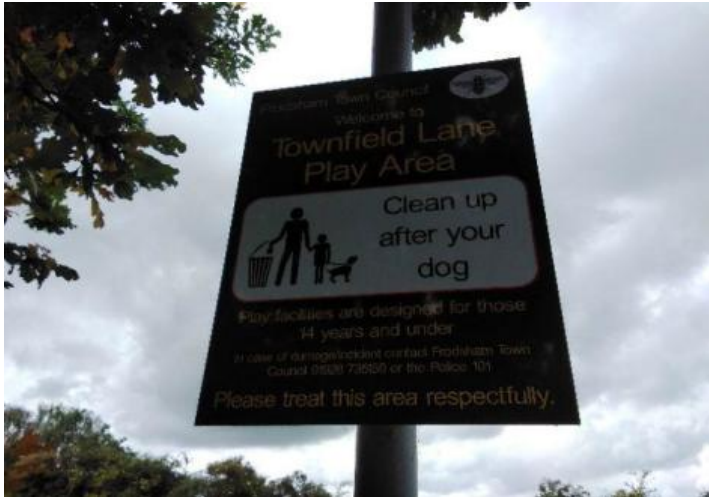
**Finding:** It is recommended that signage, with information including the site address, contact information for maintenance issues and emergency contact details are provided for the facility

**Action:** Provide in accordance with the recommendations

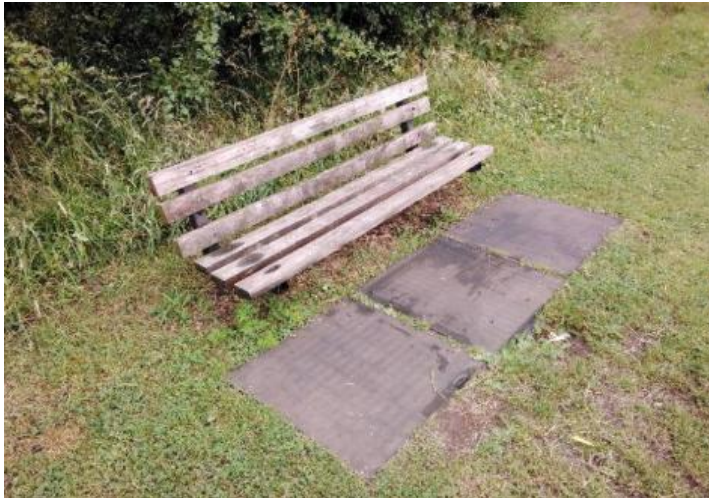
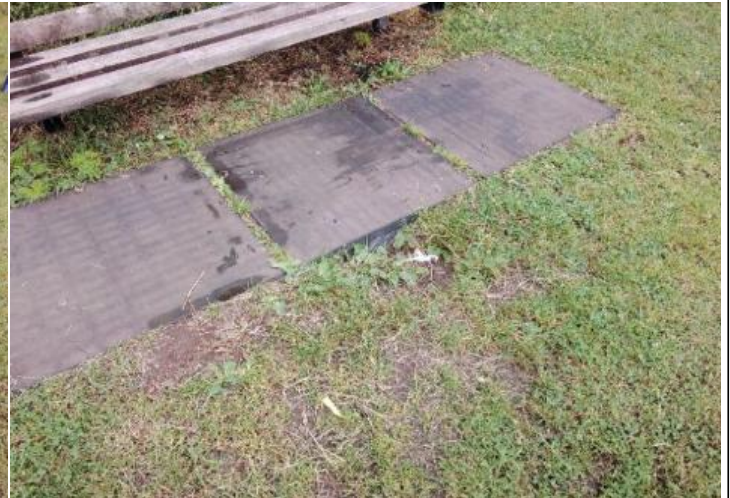
**Finding:** There are trip hazards present

**Action:** Reinstate surrounding surfaces to level to remove the trip points

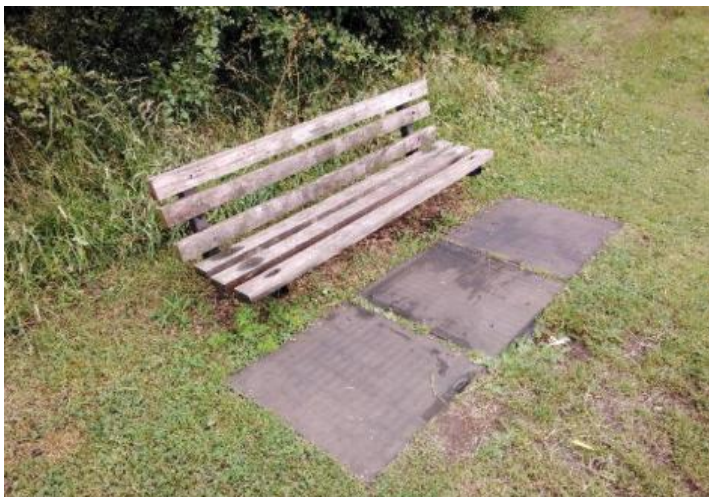
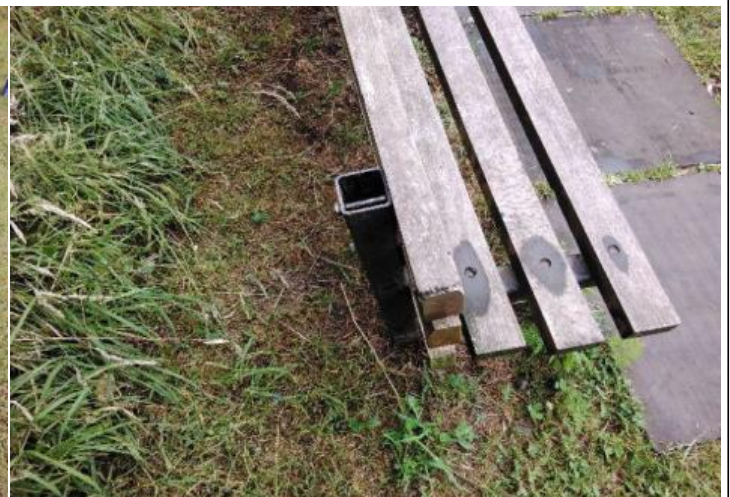
**Finding:** There are post / end caps missing from the item

**Action:** Replace missing post caps

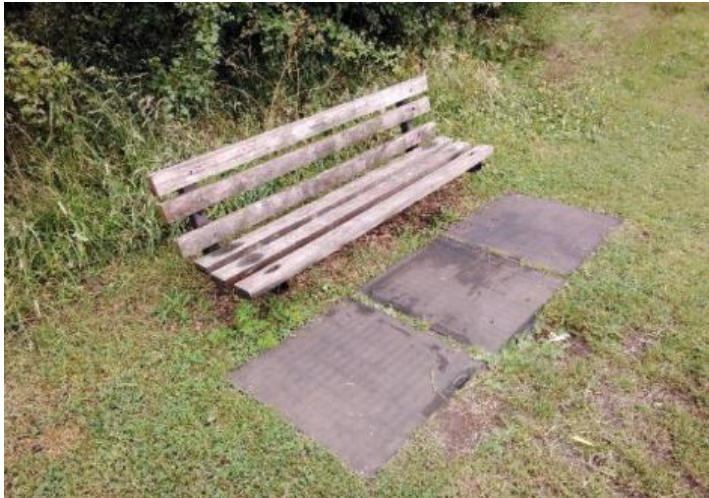
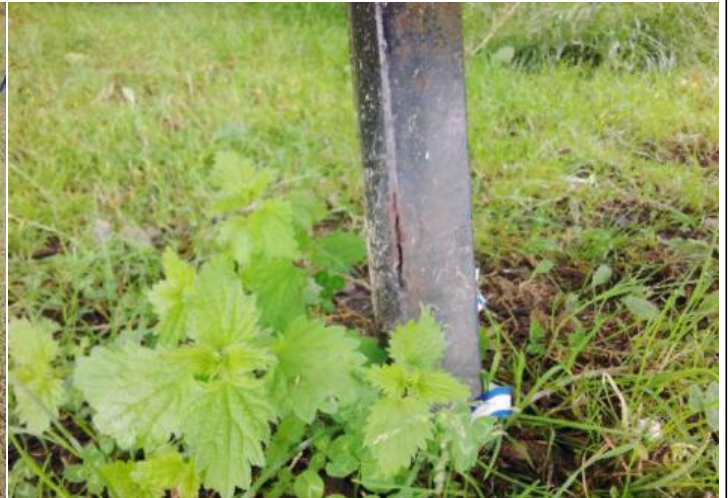
**Finding:** The tube(s) on this item have corroded from the inside and split the steel

**Action:** Replace all affected parts

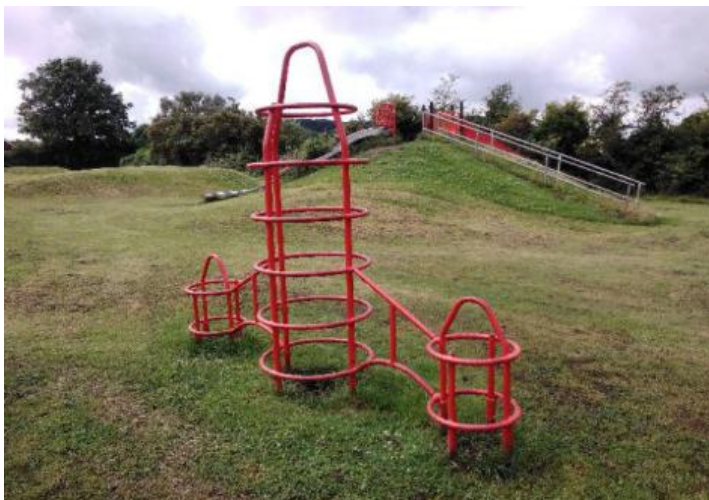
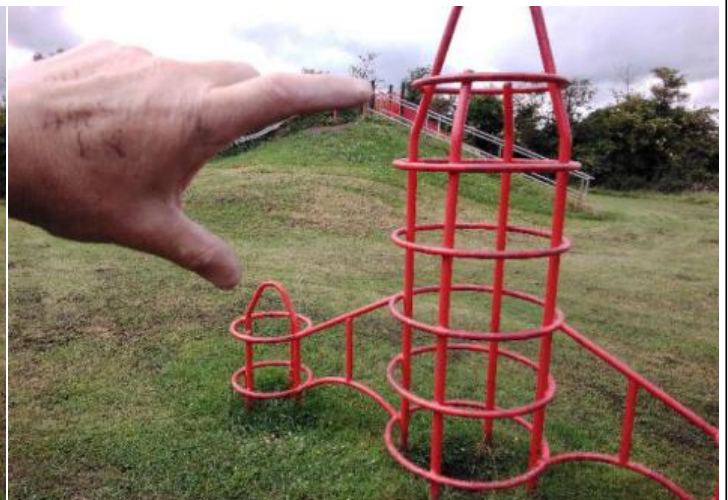
**Finding:** There are falls in excess of 600mm between adjacent components on the structure, in contravention of the recommendations set out in BS EN 1176 Part 1; 4.2.8.4

**Action:** Monitor - No remedial work recommended

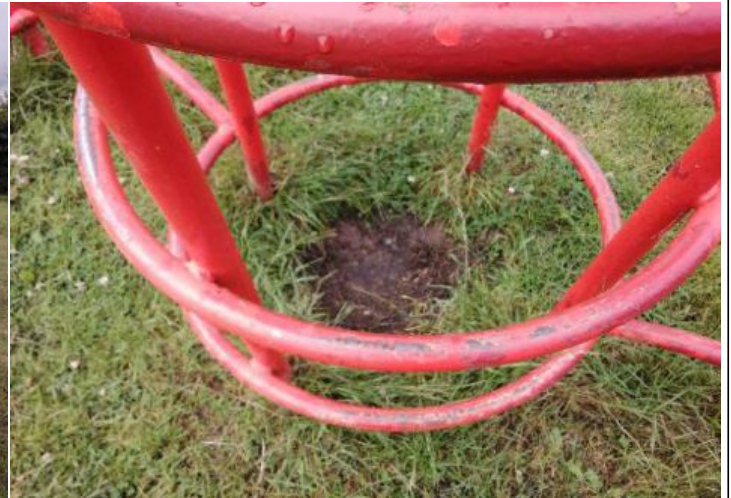
**Finding:** The surface has eroded in some areas

**Action:** Reinststate the surface

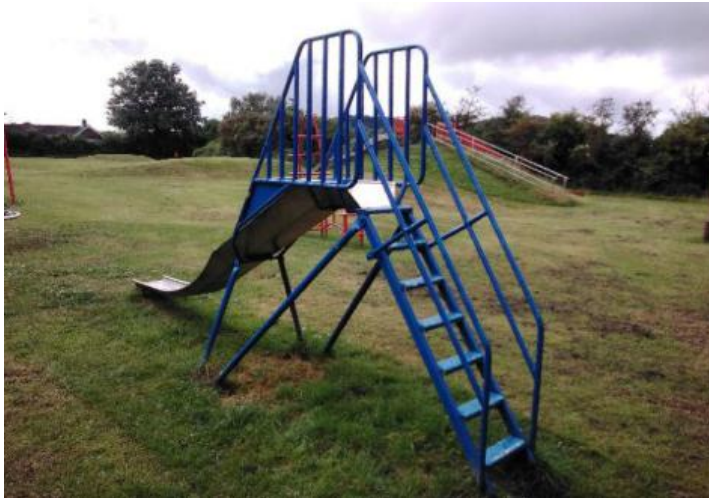
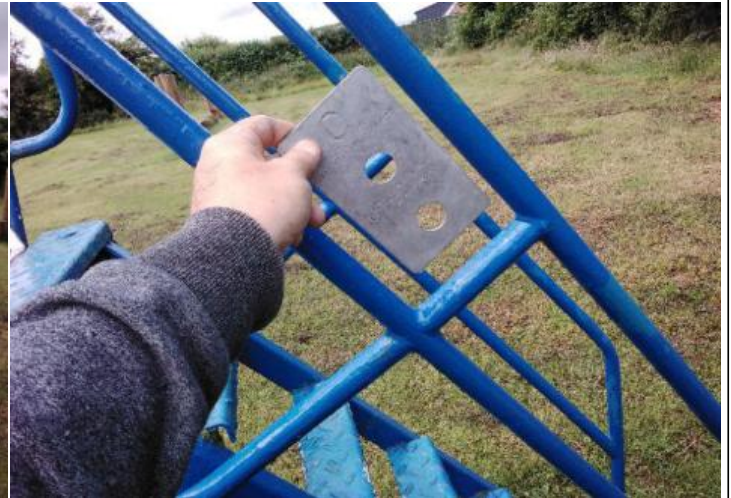
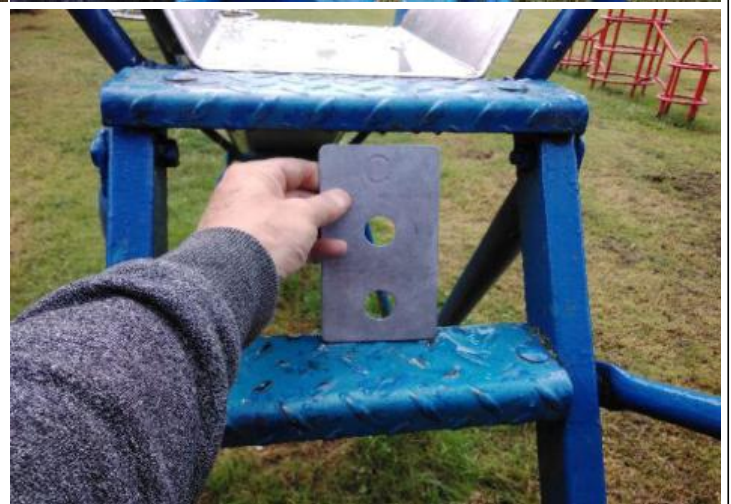
**Finding:** The item fails to meet the requirements of BS EN 1176 Part 1 4.2.7.2 for head and neck entrapment in the framework

**Action:** Monitor - No remedial work recommended

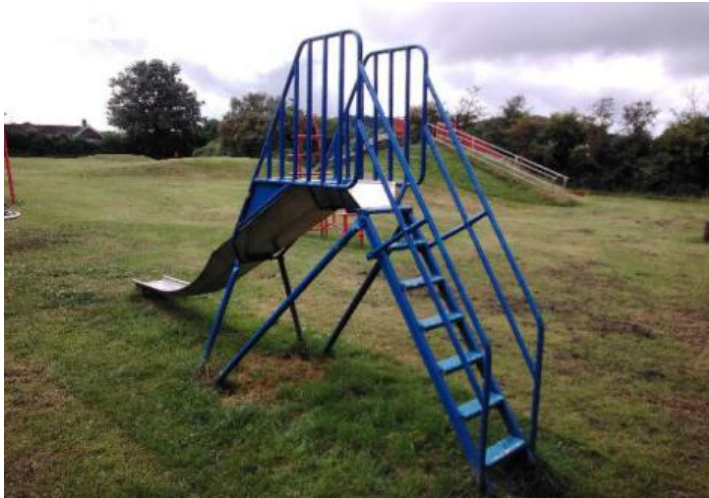
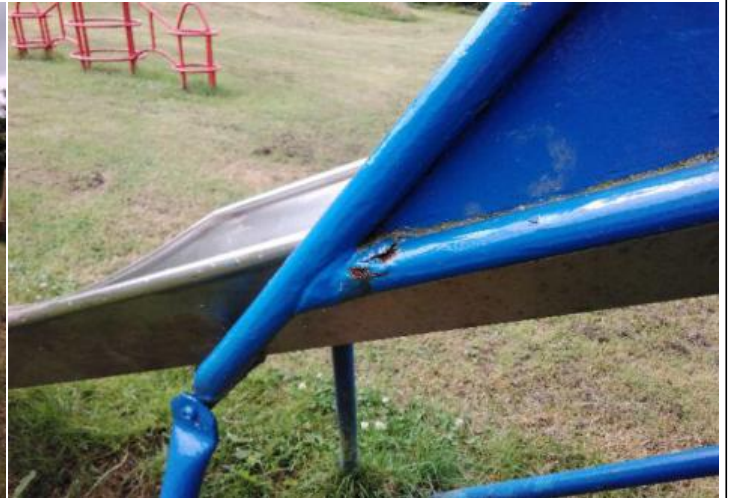
**Finding:** There is surface corrosion present on the item

**Action:** Consider treating the item

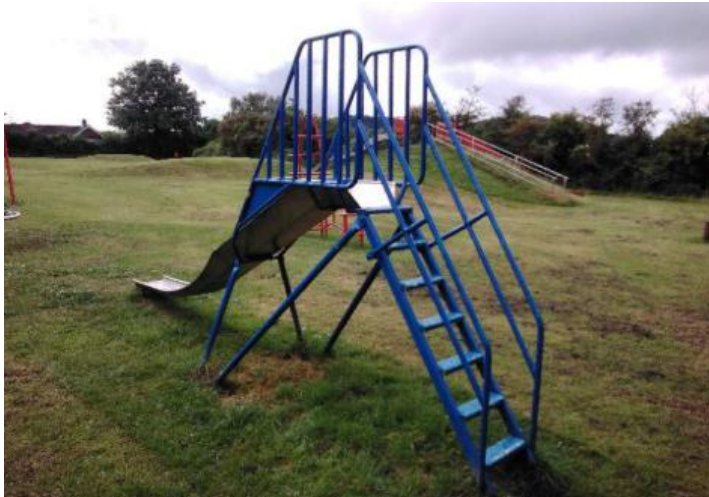
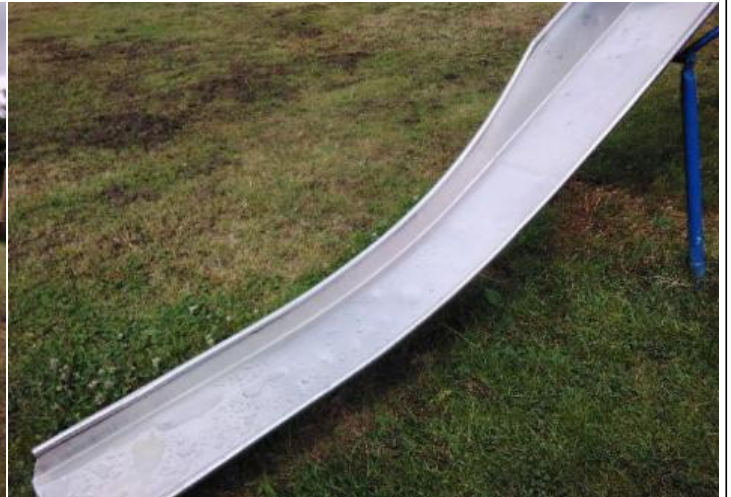
**Finding:** There are a number of dents in the slide surface

**Action:** Monitor for any further deterioration and repair as required

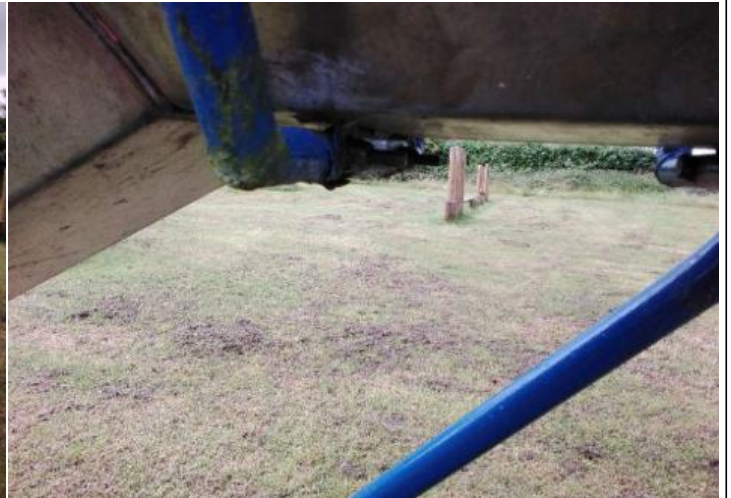
**Finding:** There are projecting bolt thread(s) present

**Action:** Remove excess thread length and deburr or provide cap

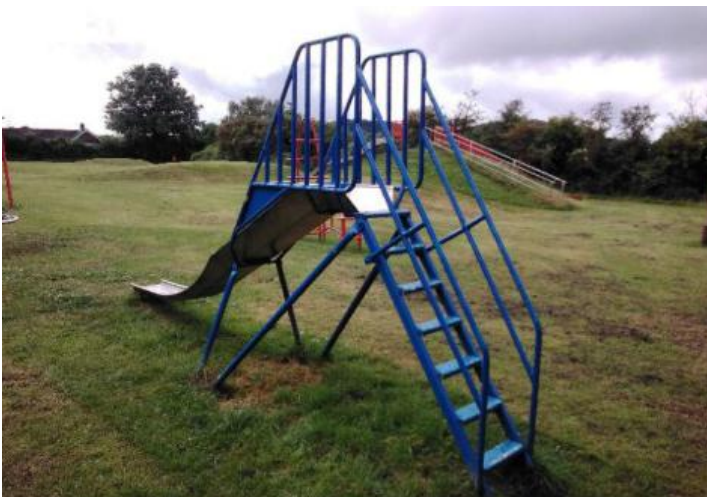
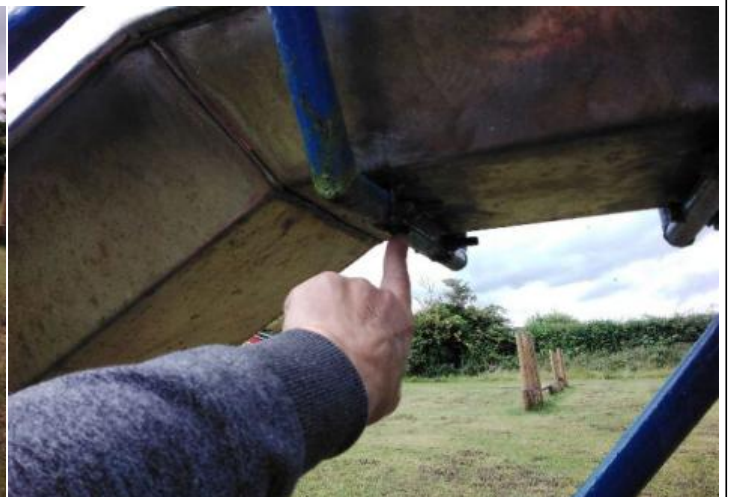
**Finding:** Parts of the steel on this item have corroded excessively and the metal has perforated in places

**Action:** Ensure all affected areas are treated and repaired

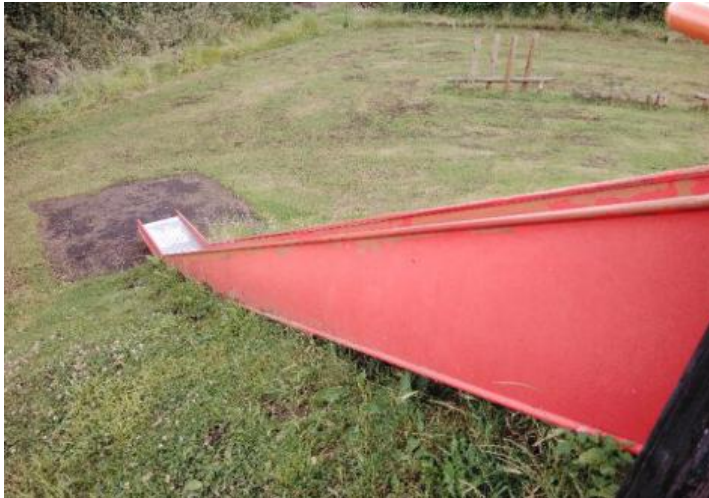
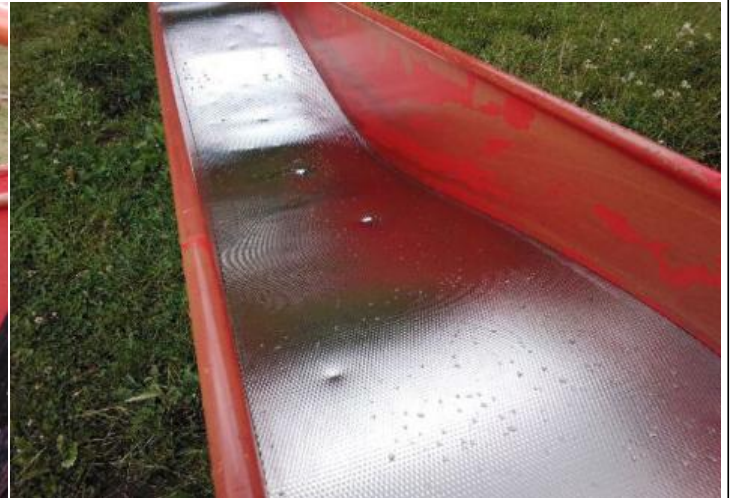
**Finding:** There are a number of dents in the slide surface

**Action:** Monitor for any further deterioration and repair as required

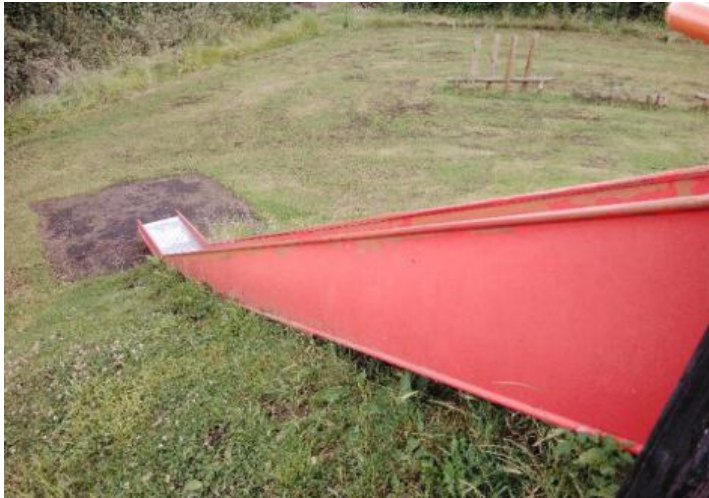
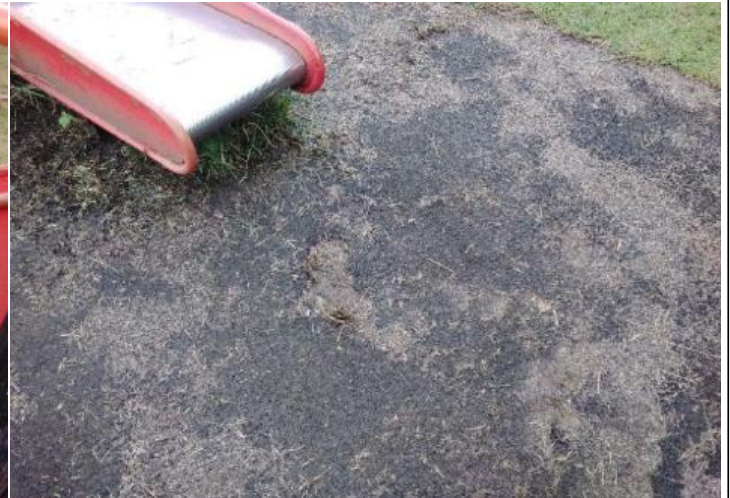
**Finding:** There is some minor damage to the surface

**Action:** Monitor for any further deterioration and repair as required

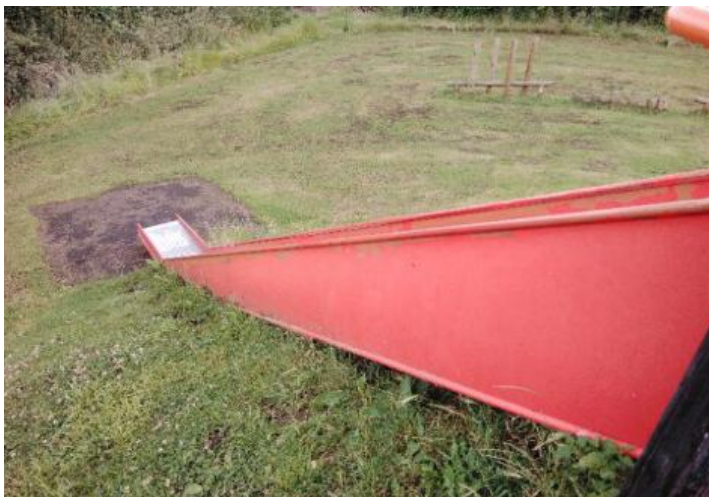
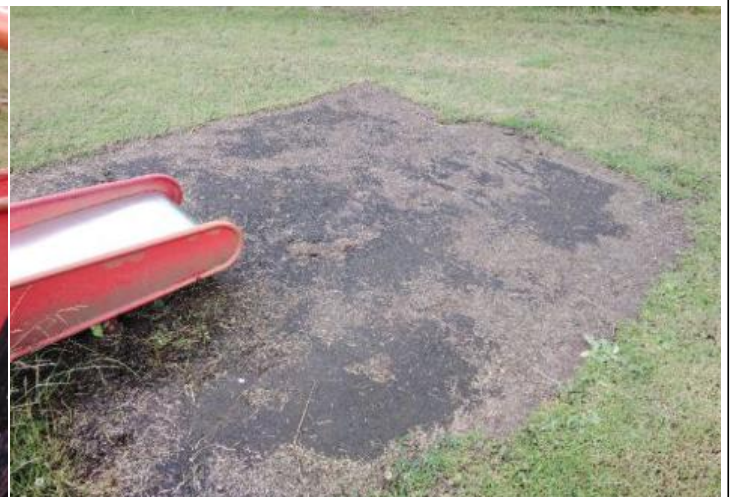
**Finding:** There is grass on the surface making for slippery conditions

**Action:** Clean and maintain

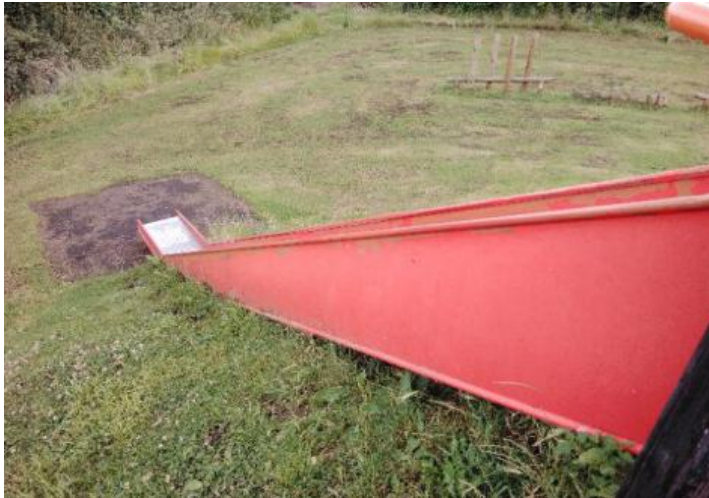
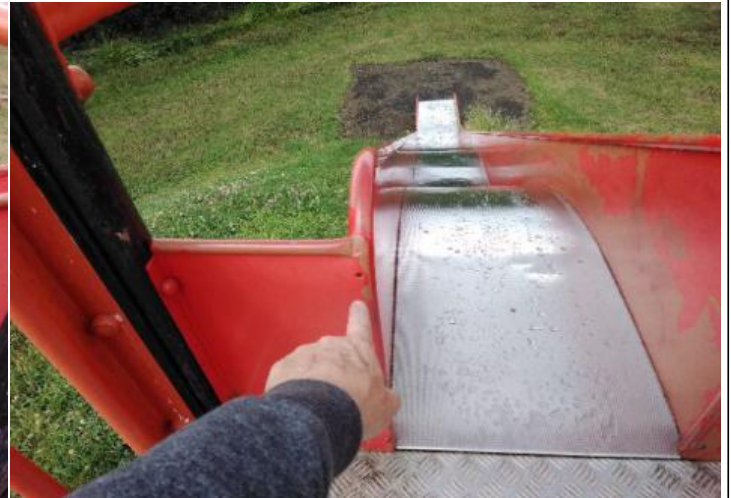
**Finding:** There is or are fixings missing on the item

**Action:** Replace all missing fixings

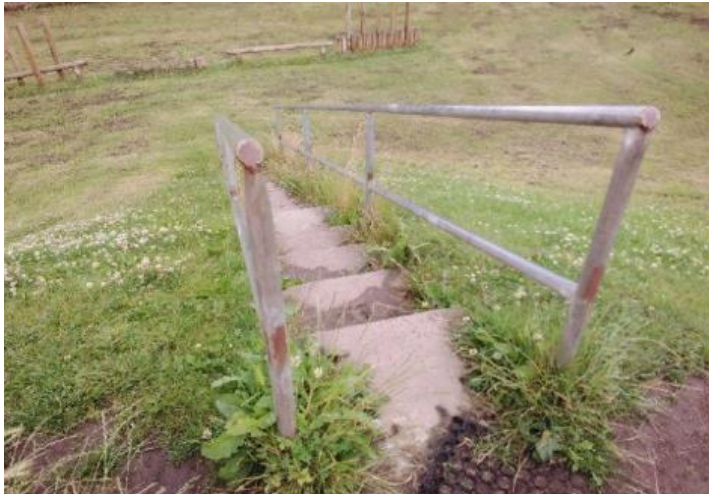
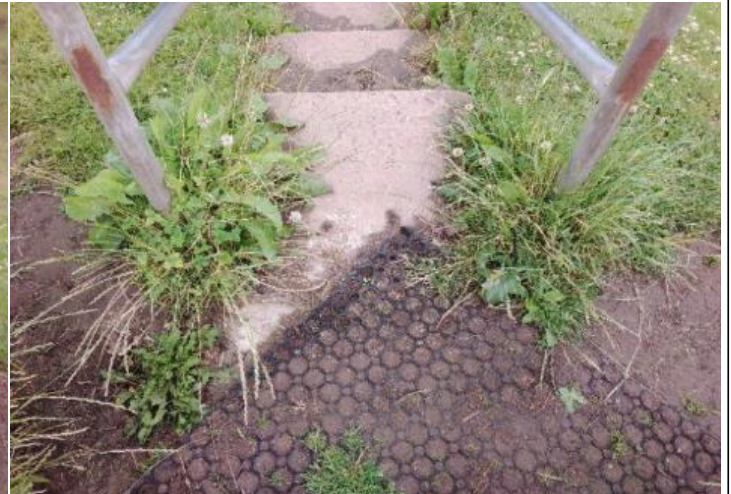
**Finding:** The grass mat is a potential trip hazard

**Action:** cut back grass mat away from the steps and tuck in edge

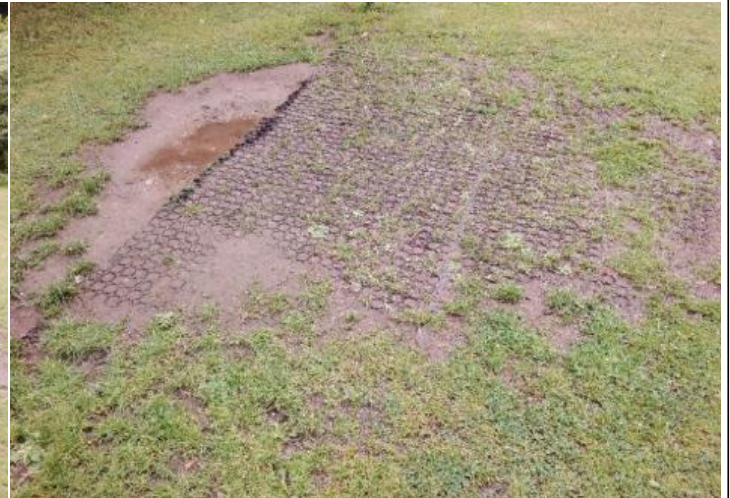
**Finding:** The grass mats are silted up, the soil is compacted and the area will become very slippery when the soil is wet. **Action:** Reinstate as required

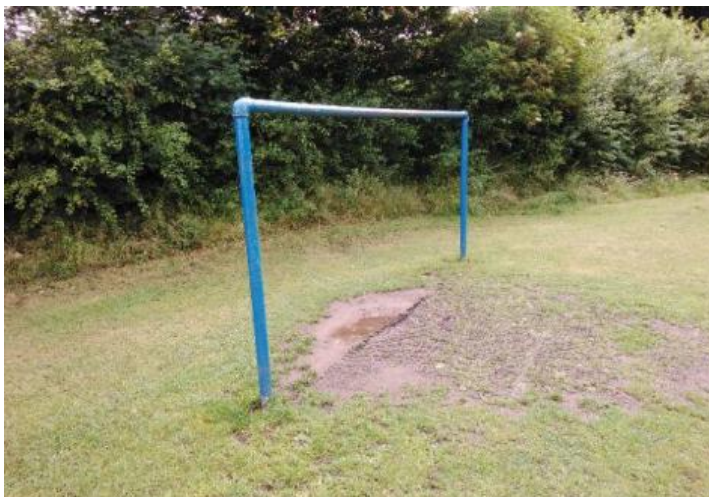
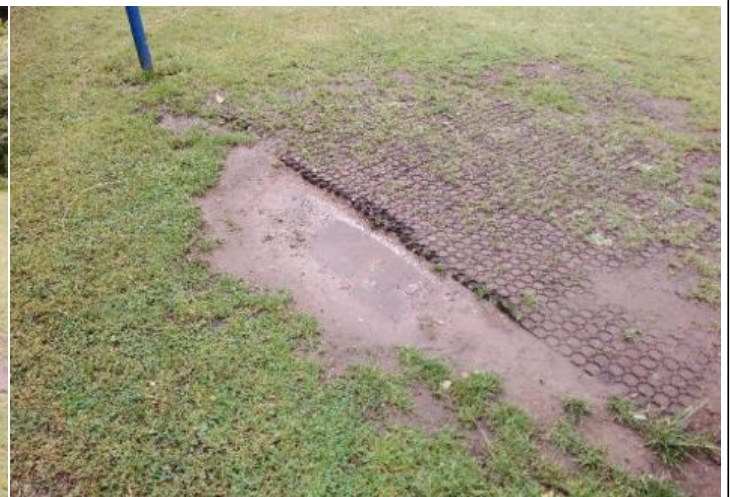
**Finding:** The edges of the grass mat surface have not been installed in accordance with the API Code of Practice **Action:** Tuck in edges of grass mat to remove trip hazards

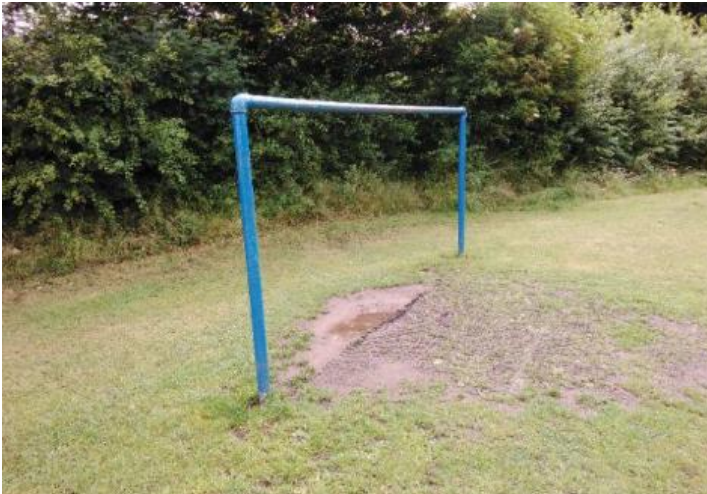
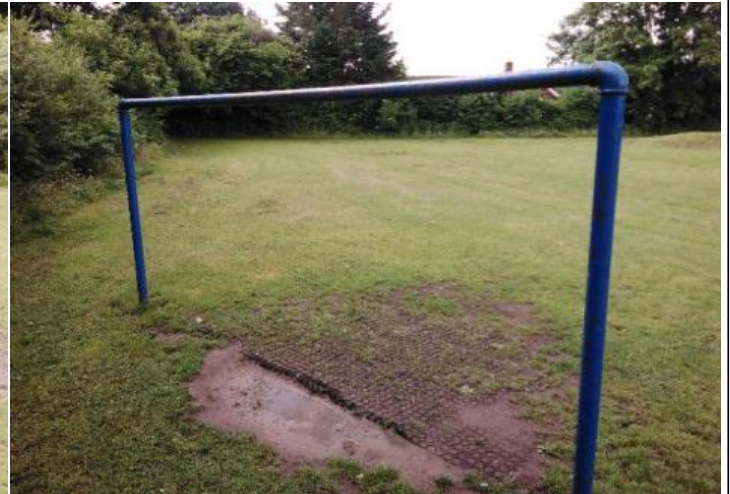
**Finding:** The item is slightly loose in its foundations

**Action:** Monitor for any further deterioration and repair as required

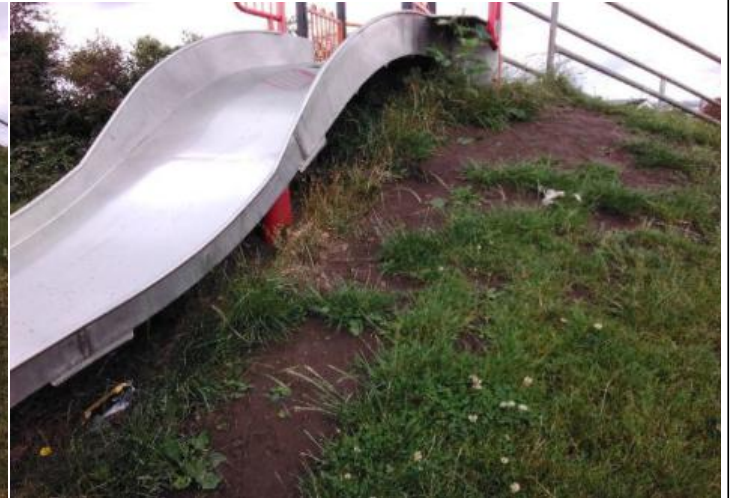
**Finding:** The surface has eroded in some areas

**Action:** Reinststate the surface

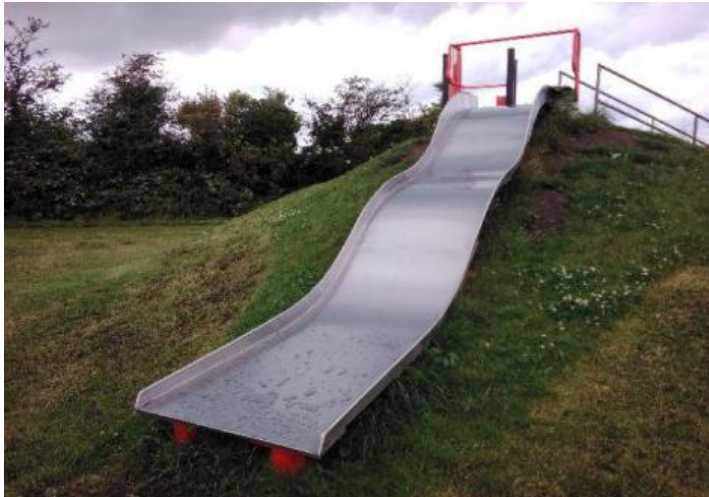
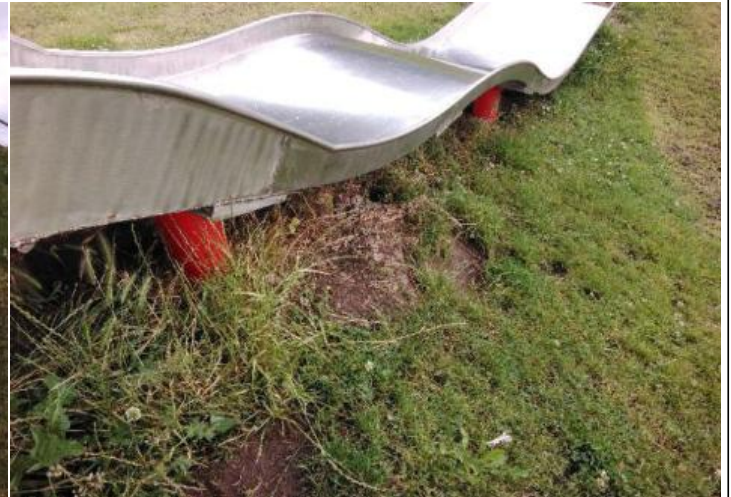
**Finding:** The foundation forms a hard object within the falling space of the equipment in contravention of the requirements of BS EN 1176 Part 1

**Action:** Reinststate a grass surface

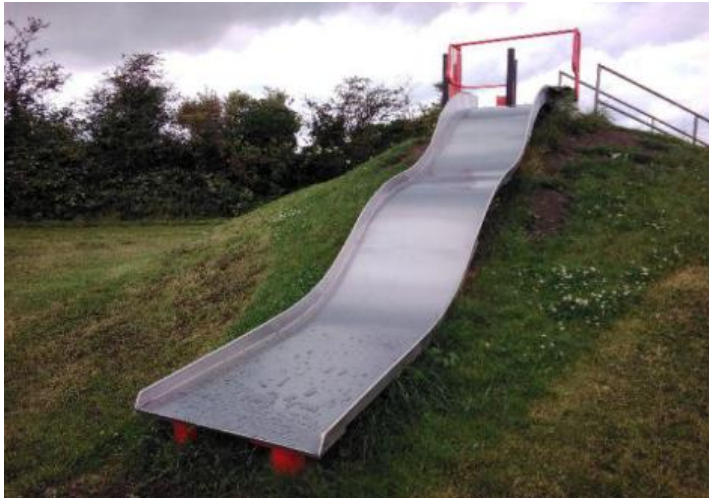
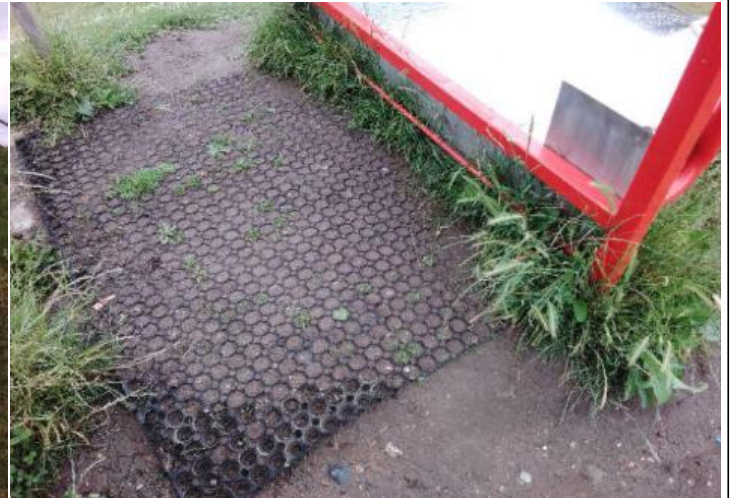
**Finding:** The edges of the grass mat surface have not been installed in accordance with the API Code of Practice  
**Action:** Tuck in edges of grass mat to remove trip hazards

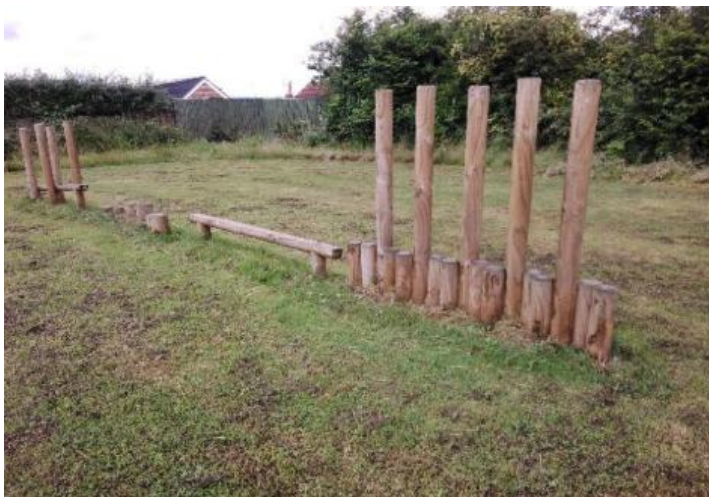
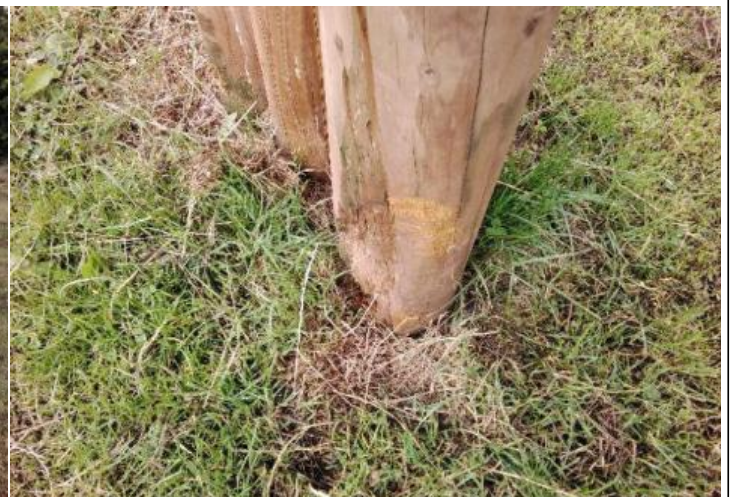
**Finding:** There is some strimmer / machinery damage apparent on the posts, this can penetrate the preservative applied to the timber and accelerate the rotting process  
**Action:** Monitor for any deterioration (rot) and replace as required

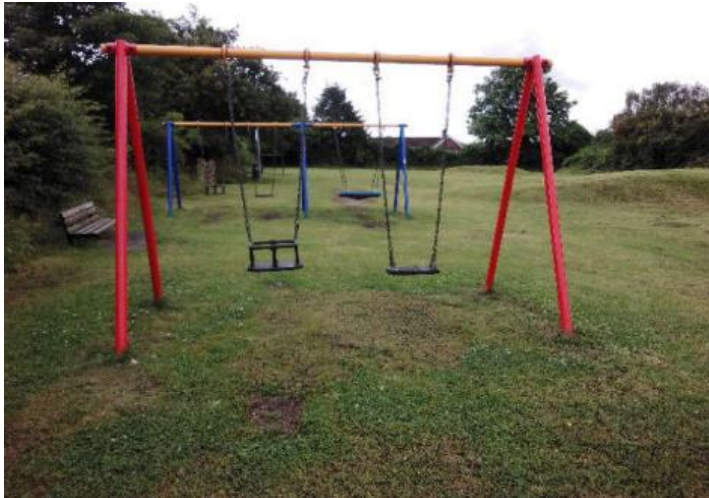
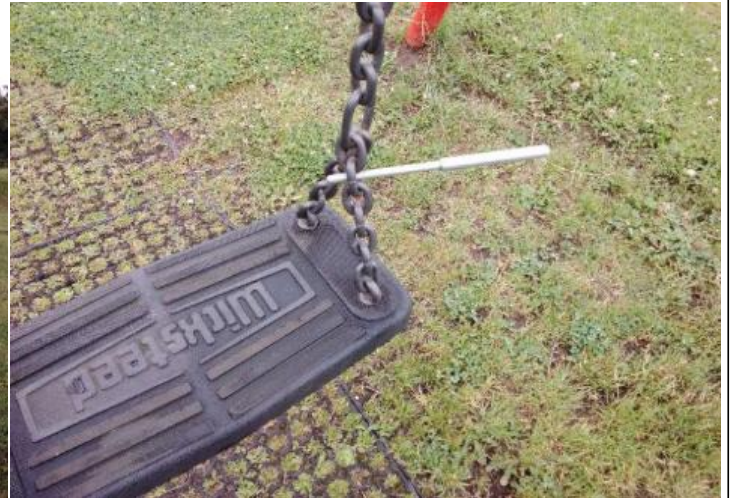
**Finding:** The chain openings are in excess of the 8.6mm as recommended by BS EN 1176 **Action:** Monitor - No remedial work recommended

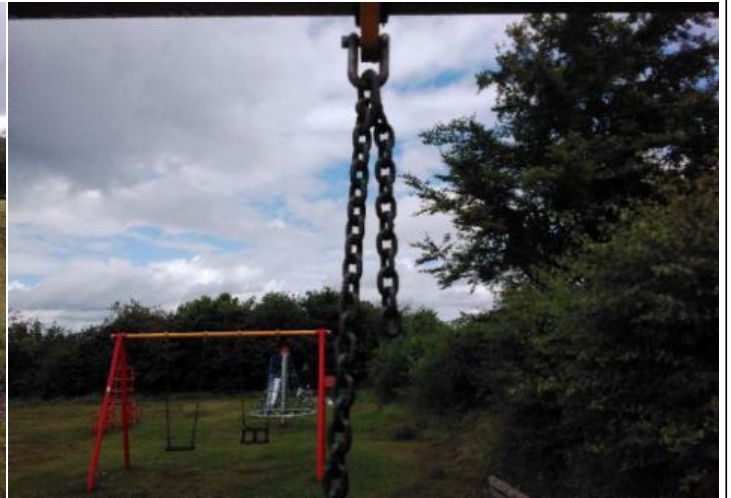
**Finding:** There are excessive chain tails

**Action:** Cut back excessive chain links

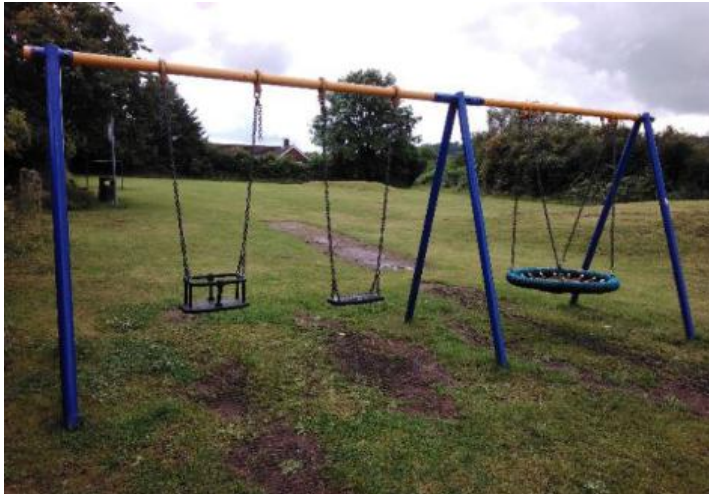
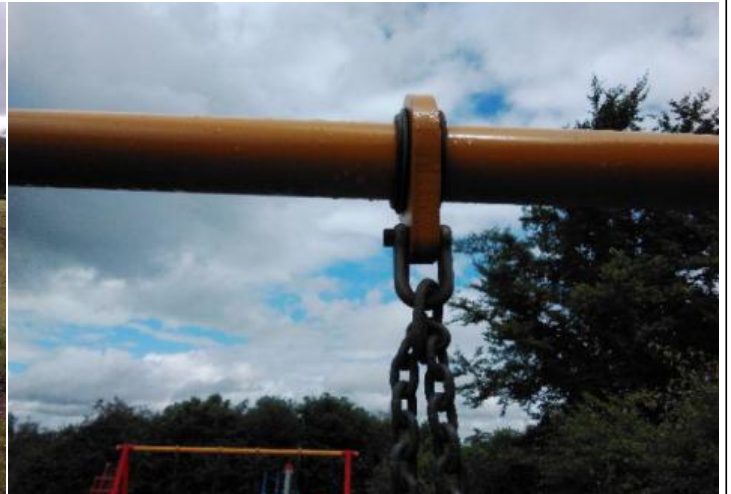
**Finding:** The split pins are missing from the shackles

**Action:** Insert split pins to secure the shackles

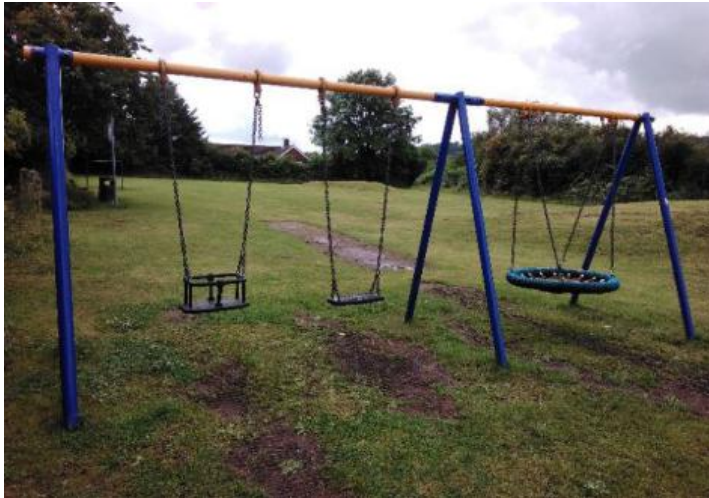
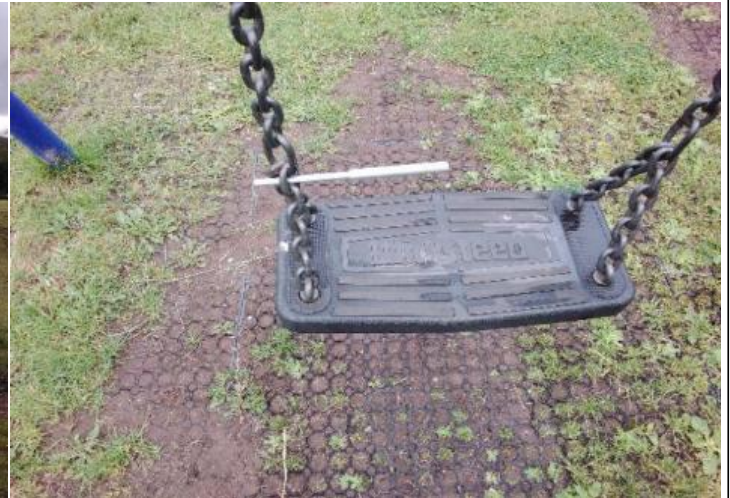
**Finding:** The chain openings are in excess of the 8.6mm as recommended by BS EN 1176 **Action:** Monitor - No remedial work recommended

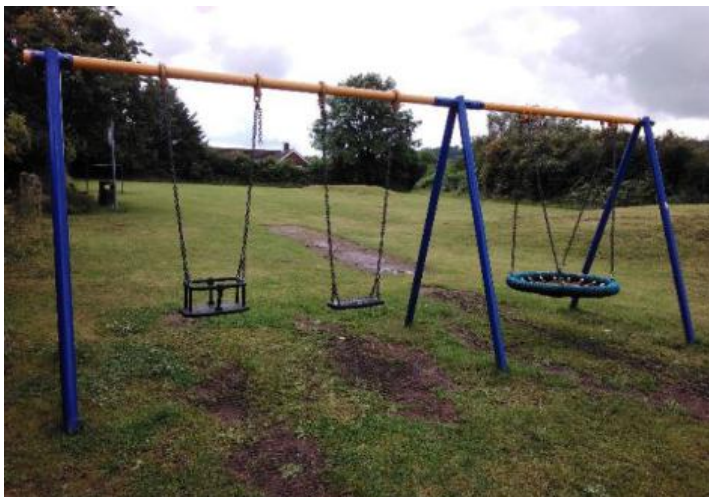
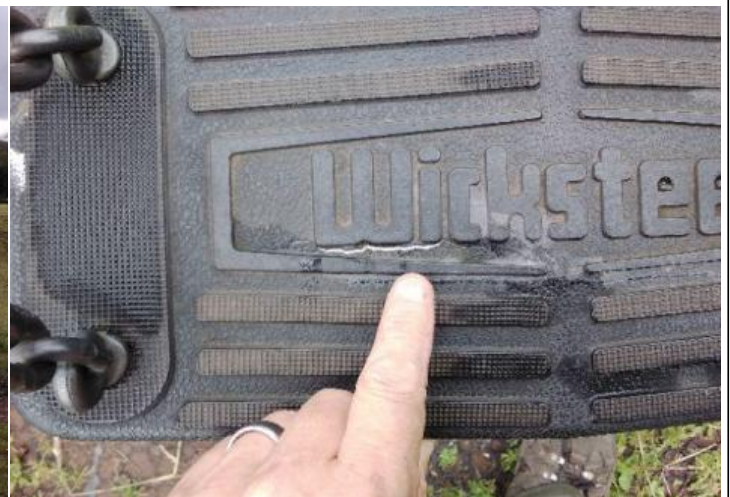
**Finding:** The seat has minor damage or wear **Action:** Monitor for any further deterioration and replace as required

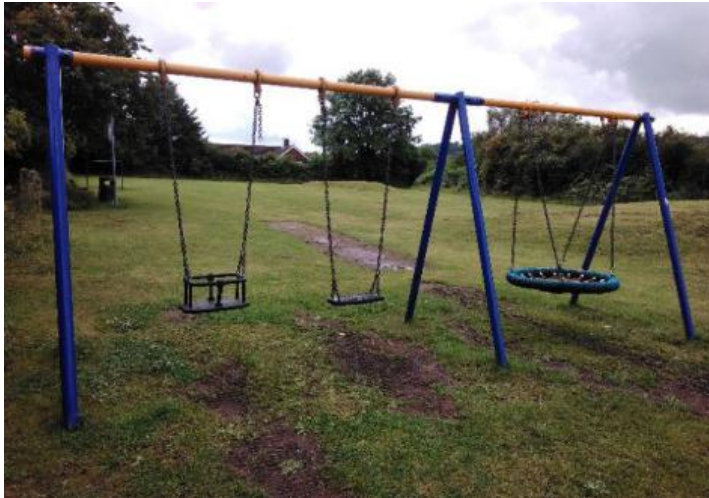
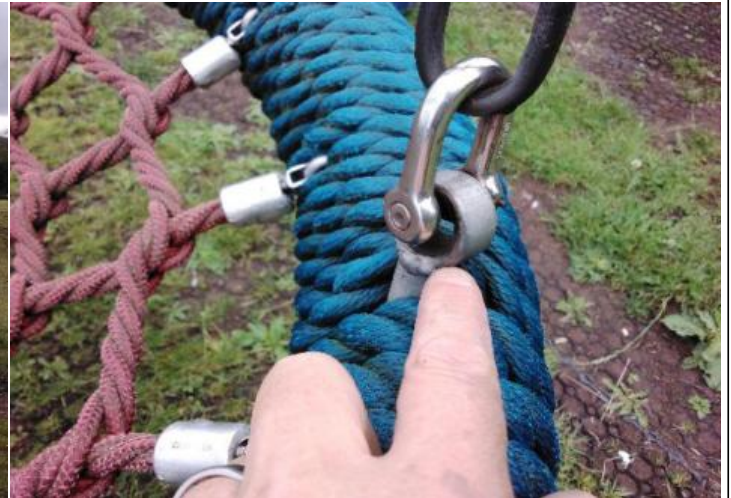
**Finding:** The bushes are worn or missing

**Action:** Replace worn or missing bushes

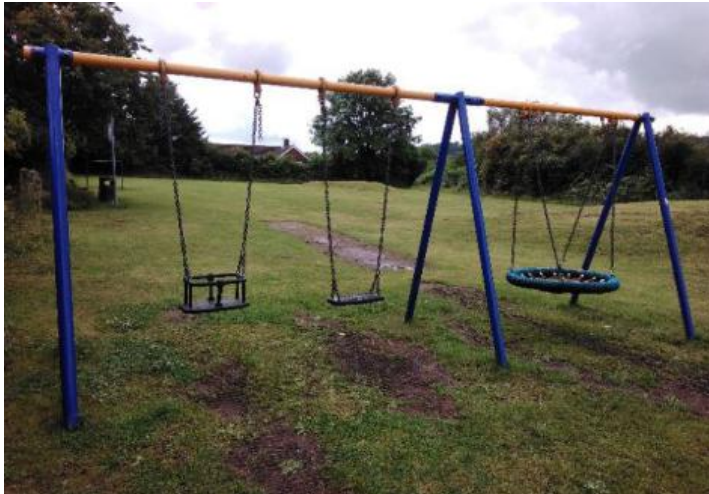
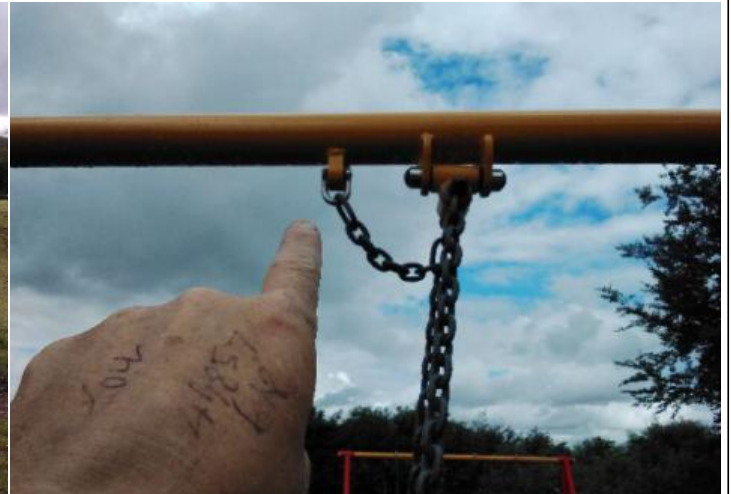
**Finding:** The shackles have been overtightened or seized transferring wear to the chain links below

**Action:** Loosen shackles to ensure free movement at the pivot

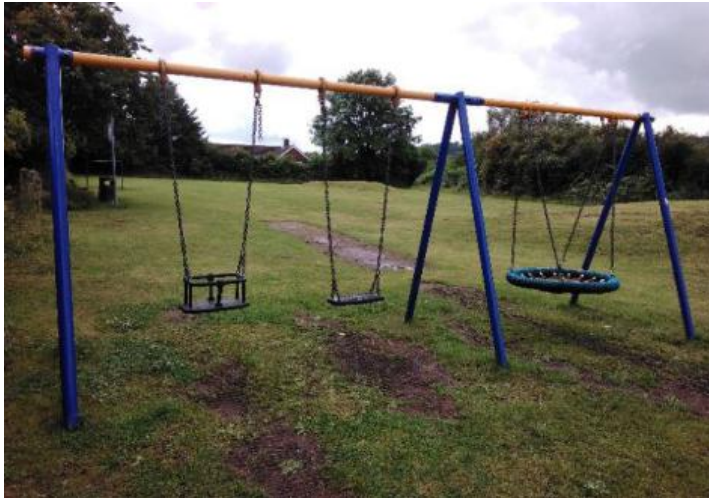
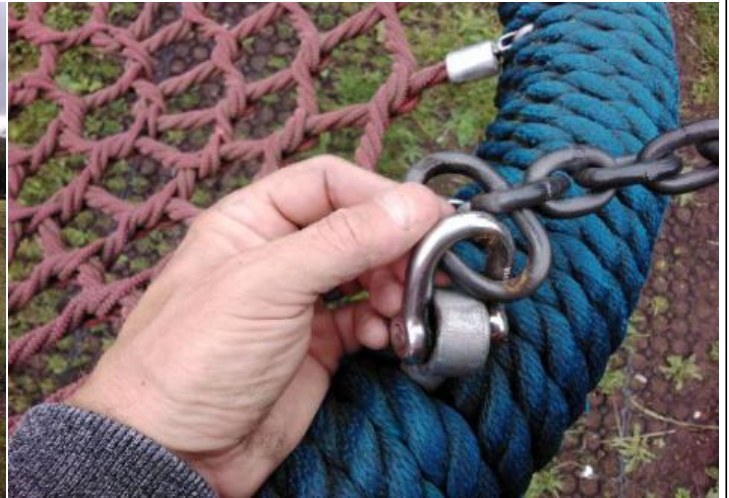
**Finding:** There is some notable evidence of chain wear

**Action:** Monitor for any further deterioration and replace when 40% worn

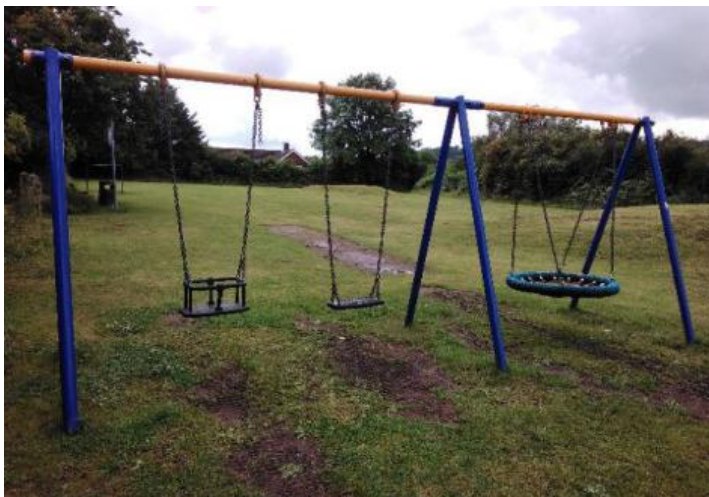
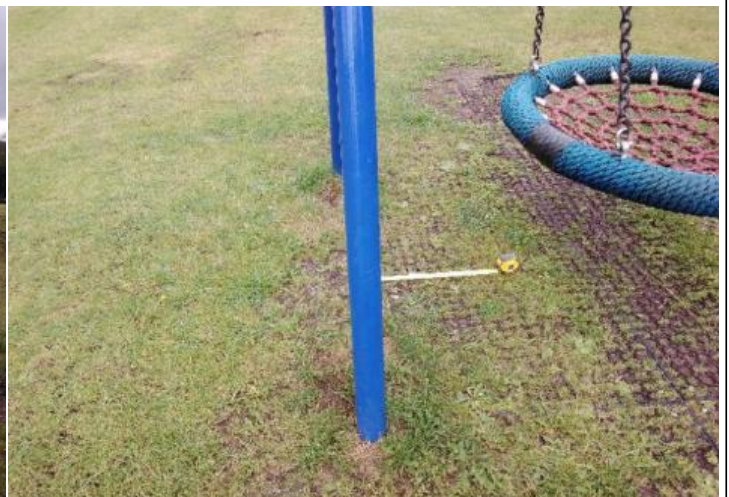
**Finding:** The seats are too close to the frame as defined in BS EN 1176 Part 2; this is a low risk failure and no remedial action is required

**Action:** Monitor - No remedial work recommended

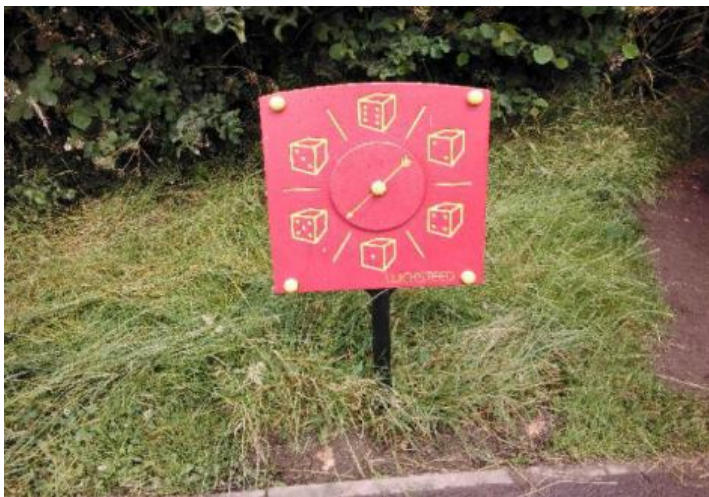
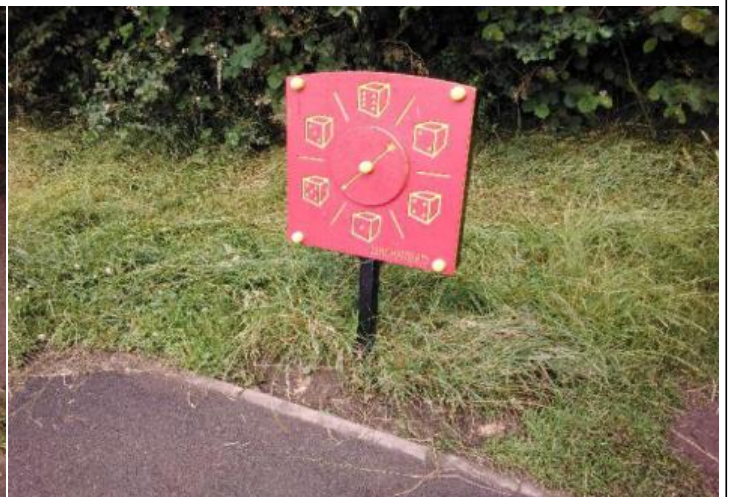
**Finding:** The item is loose in its foundations

**Action:** Reinstall item to secure
