## Annual Inspection

Frodsham Town Council

Townfield Lane

Inspection Ref: 1409106

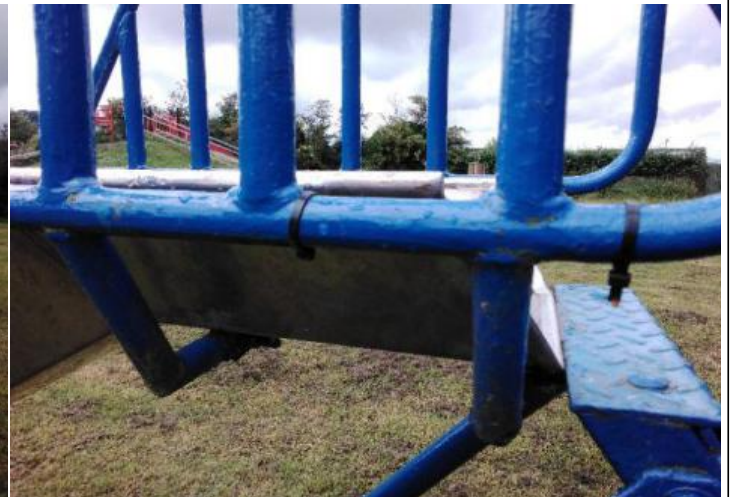
**Finding:** There sharp projecting ties on the equipment

**Action:** Remove ties from equipment
