## **Tree Condition Survey and Management Work Recommendations**

Date – 10/04/2023

Site – Tarvin Road Cemetery, Frodsham

Client – Frodsham Town Council – [townclerk@frodsham.gov.uk](mailto:townclerk@frodsham.gov.uk)

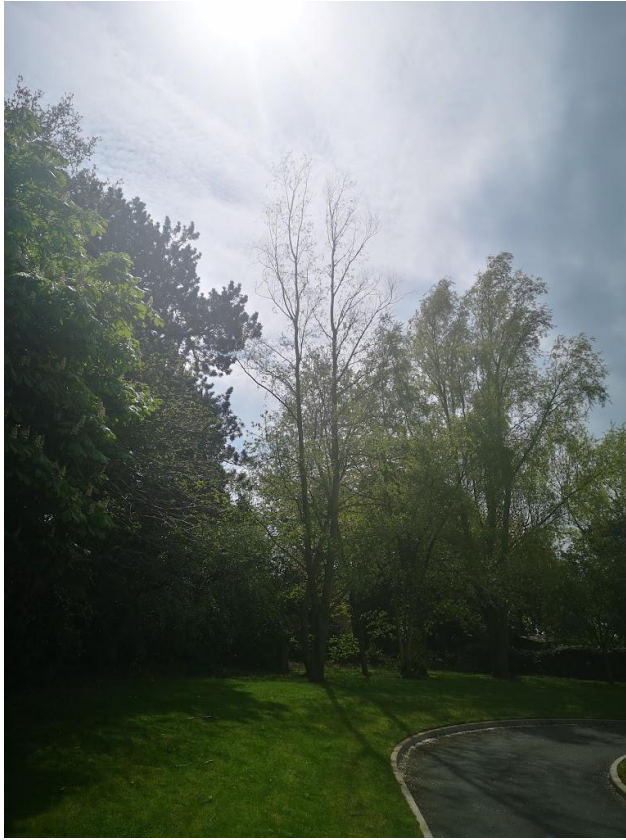
Tree ID	Grid reference	Species	Age class	Comments	Management action	Priority
T31	SJ51097674	Crack Willow <i>Salix sp'</i>	M	Height 20m. 30% dieback in crown, main stem leaning toward road.	Fell to ground level.	H
T32	SJ51097674	Norway Maple ( <i>A.platanoides</i> )	M	Height 7m. Three main stems with leaning growth form away from hedge beneath neighbouring horse chestnut. Squirrel damage throughout.	Fell to ground level.	H
T33b	SJ51097674	Horse Chestnut ( <i>A.hippocastanum</i> )	M	Height 14m. In line of barbed wire fence, several failed limbs with visible brown rot in main stem at 7m.	Fell to ground level.	H
T33a	SJ51097674	Horse Chestnut ( <i>A.hippocastanum</i> )	M	Height 14m. Significant rot in main stem on supporting side of lean, visible cavity of rot from ground to 2m.	Fell to ground level.	H
T64	SJ51027679	Cherry ( <i>Prunus sp'</i> )	M	Height 8m. 50% dieback in canopy, main stem is dead with visible cracking.	Fell to ground level.	H

Figure 1. T31 – 30% dieback in crown.

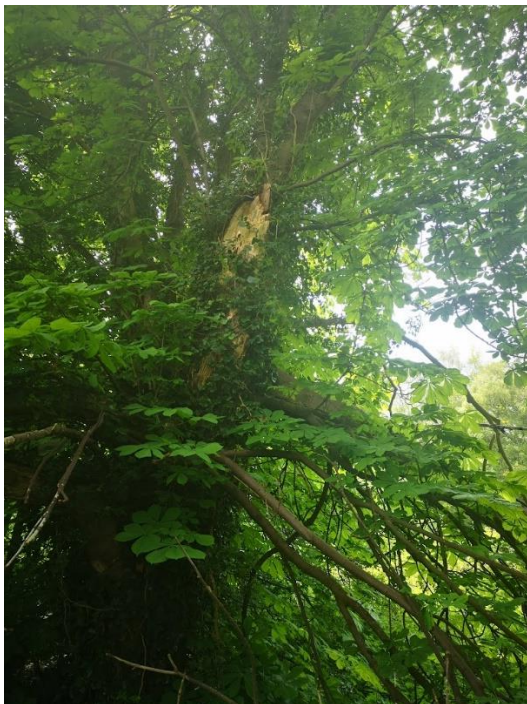
Figure 2. T33 – failed limbs

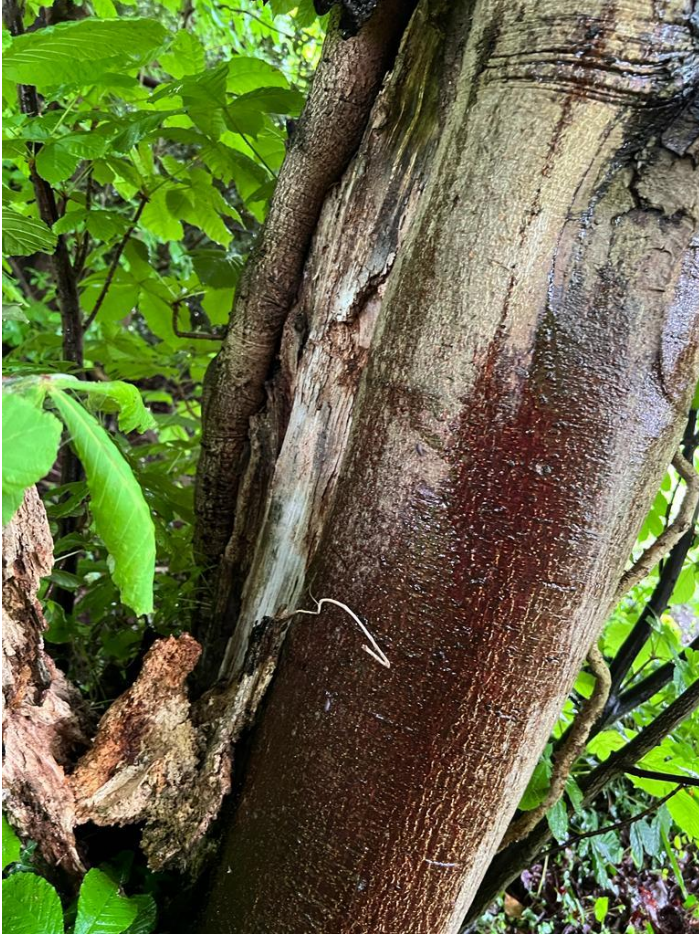
Figure 3. T33a – Significant rot in main stem.
