the **play inspection** company

## Annual Inspection

Frodsham Town Council

Churchfields

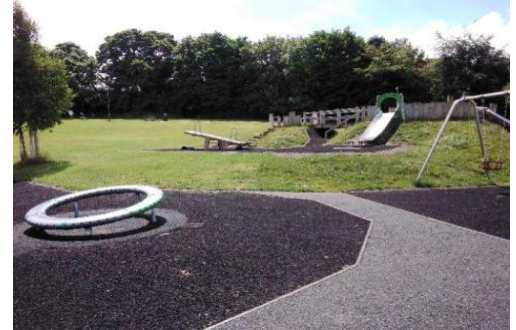
**Item:** Site General  
**Manufacturer:** Owner/Operator  
**Surface Type:** N/A  
**Item Quantity:** 1  
**Equipment Compliance:** N/A  
**Surface Area Compliance:** N/A

The site is accessible to the public during the COVID 19 pandemic. The government have released guidelines for safely re-opening these types of facilities which is available on the government website. - Ensure there is an appropriate risk assessment in place and review regularly

The wetpour is crumbling in areas - Monitor for any further deterioration and repair as required

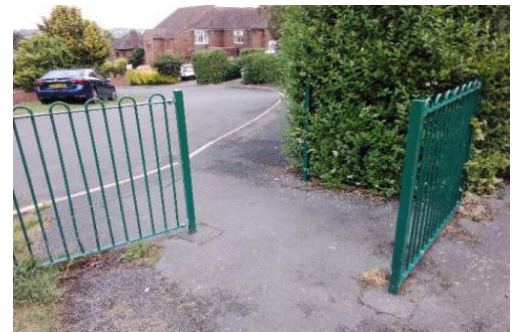
**Item:** Entrance Feature  
**Manufacturer:** Owner/Operator  
**Surface Type:** All Weather Surface  
**Item Quantity:** 1  
**Equipment Compliance:** N/A  
**Surface Area Compliance:** N/A

There is some damage to the fence sections - Monitor for any further deterioration and repair as required

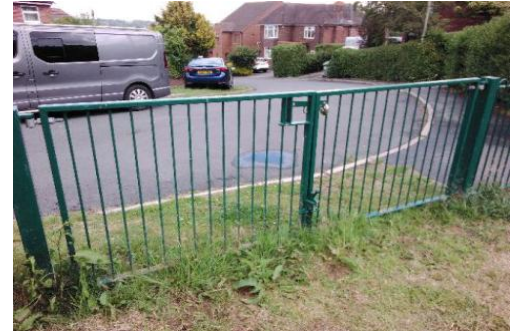
**Item:** Gate - Maintenance  
**Manufacturer:** Owner/Operator  
**Surface Type:** N/A  
**Item Quantity:** 1  
**Equipment Compliance:** N/A  
**Surface Area Compliance:** N/A

The gate has no drop bolt sleeves fitted - Provide drop bolt sleeves and/or drop bolts

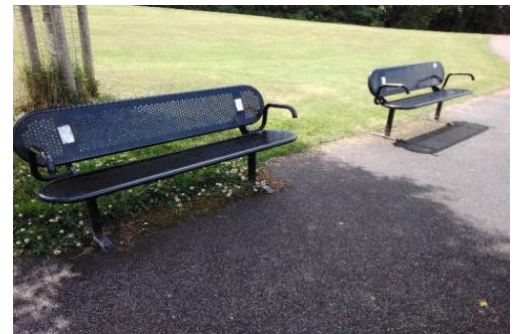
**Item:** Bench  
**Manufacturer:** Not Identified  
**Surface Type:** All Weather Surface  
**Item Quantity:** 3  
**Equipment Compliance:** N/A  
**Surface Area Compliance:** N/A

Ground fixings are slightly loose - Secure fixings

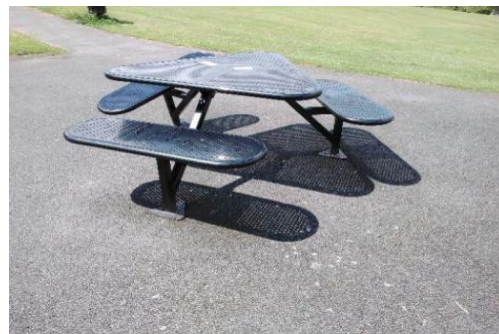
**Item:** Picnic Table  
**Manufacturer:** Not Identified  
**Surface Type:** All Weather Surface  
**Item Quantity:** 1  
**Equipment Compliance:** N/A  
**Surface Area Compliance:** N/A

The bench seat has been distorted - Repair

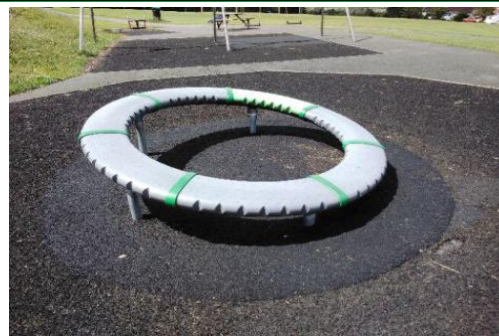
**Item:** Supernova  
**Manufacturer:** Kompan Ltd  
**Surface Type:** Tigermulch  
**Item Quantity:** 1  
**Equipment Compliance:** Yes  
**Surface Area Compliance:** Yes

There is moderate damage to the surface creating potential trip hazards - Repair the damaged areas of surfacing

There are trip hazards at the edges of the surface - Reinstall surrounding surface levels to remove the trip points

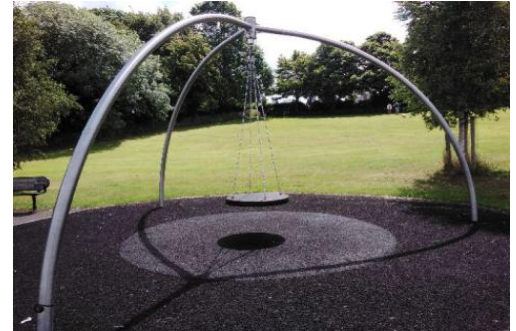
**Item:** Pendulum Swing  
**Manufacturer:** Playdale Playgrounds Ltd  
**Surface Type:** Tigermulch  
**Item Quantity:** 1  
**Equipment Compliance:** No  
**Surface Area Compliance:** Yes

The item is slightly loose in its foundations - Monitor for any further deterioration and repair as required

The chain openings are in excess of the 8.6mm as recommended by BS EN 1176 - Monitor - No remedial work recommended

There is some notable evidence of chain wear - Monitor for any further deterioration and replace when 40% worn

The fixings or components for this item were in excess of 2.5m above the standing surface and could not be fully accessed by the inspector. We have completed a visual inspection of the fixings from ground level but a maintenance inspection should be undertaken to assess the condition, security and wear of the components at intervals in accordance with the manufacturers recommendations. - Inspect in accordance with the manufacturers recommendations

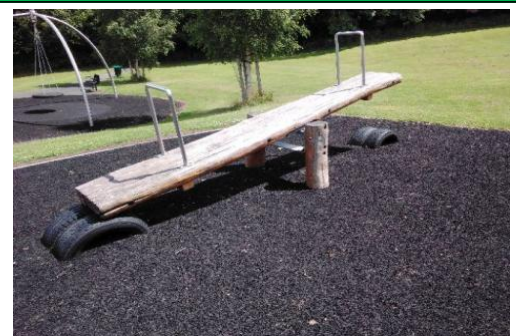
**Item:** See Saw  
**Manufacturer:** Spiel Art  
**Surface Type:** Tigermulch  
**Item Quantity:** 1  
**Equipment Compliance:** Yes  
**Surface Area Compliance:** Yes

There are gaps opening between the surfacing and the edging surround or between the joints in the surfacing - Monitor for any further deterioration and repair as required

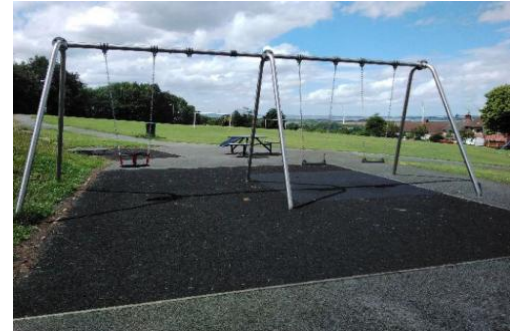
**Item:** 2 Bay (2 Flat, 2 Cradle)  
**Manufacturer:** Playdale Playgrounds Ltd  
**Surface Type:** Tigermulch  
**Item Quantity:** 1  
**Equipment Compliance:** No  
**Surface Area Compliance:** Yes

The seat(s) and suspension were missing at the time of inspection and the inspector was unable to make a full compliance assessment - Replace missing seat(s) and suspension

The swing seat connectors are worn more than 40% and require replacement - Replace swing seat connectors if possible or replace seat

There is some notable evidence of chain wear - Monitor for any further deterioration and replace when 40% worn

The chain openings are in excess of the 8.6mm as recommended by BS EN 1176 - Monitor - No remedial work recommended

The seat has minor damage or wear - Monitor for any further deterioration and replace as required

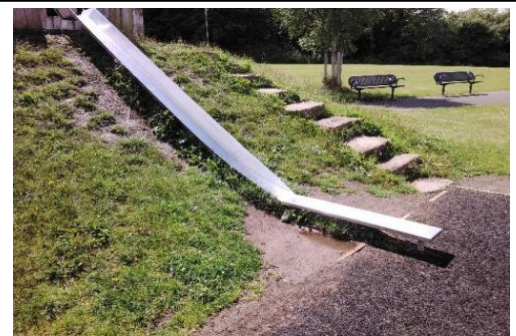
**Item:** Embankment Slide  
**Manufacturer:** Not Identified  
**Surface Type:** Grass Matrix Tiles  
**Item Quantity:** 1  
**Equipment Compliance:** No  
**Surface Area Compliance:** Yes

The timber edge forms a hard object within the falling space of the equipment in contravention of the requirements of BS EN 1176 Part 1 - Monitor - No remedial work recommended

There are trip hazards present on the timber edge - Reinstate surrounding surfaces to level to remove the trip points

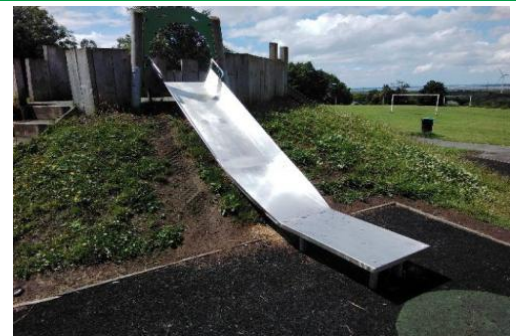
**Item:** Embankment Slide  
**Manufacturer:** Playdale Playgrounds Ltd  
**Surface Type:** Tigermulch  
**Item Quantity:** 1  
**Equipment Compliance:** No  
**Surface Area Compliance:** Yes

There are significant gaps (over 30mm) between the surface and the edging or between the joints in the surface; these are large enough for a small foot to enter - Repair surfacing

The timber edge forms a hard object within the falling space of the equipment in contravention of the requirements of BS EN 1176 Part 1 - Monitor - No remedial work recommended

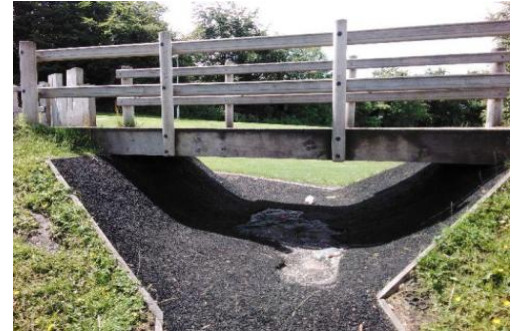
**Item:** Bridge  
**Manufacturer:** Playdale Playgrounds Ltd  
**Surface Type:** All Weather Surface  
**Item Quantity:** 1  
**Equipment Compliance:** N/A  
**Surface Area Compliance:** N/A

The surfacing is severely damaged - Repair damaged areas of surfacing

There are gaps opening between the surfacing and the edging surround or between the joints in the surfacing - Monitor for any further deterioration and repair as required

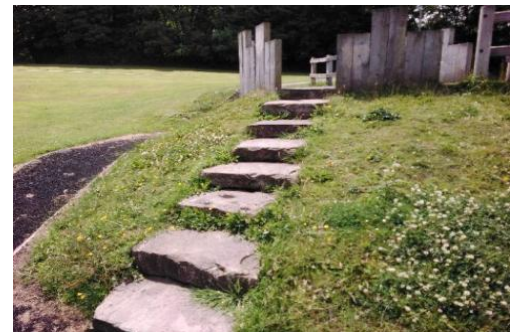
**Item:** Landscape Feature  
**Manufacturer:** Owner/Operator  
**Surface Type:** N/A  
**Item Quantity:** 1  
**Equipment Compliance:** N/A  
**Surface Area Compliance:** N/A

There are areas or parts of the timber on the structure that have rotted - Replace all affected timbers

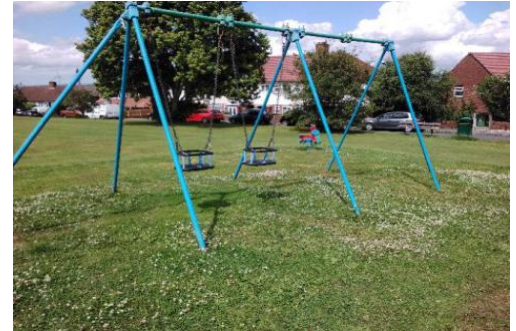
**Item:** 2 Bay 2 Cradle Swing  
**Manufacturer:** Wicksteed Playgrounds  
**Surface Type:** Grass  
**Item Quantity:** 1  
**Equipment Compliance:** No  
**Surface Area Compliance:** No

The seat(s) and suspension were missing at the time of inspection and the inspector was unable to make a full compliance assessment - Replace missing seat(s) and suspension

There is some wear to the shackles. - Monitor for any further deterioration and replace when 40% worn

The fixings have corroded excessively - Replace all corroded fixings

The item of equipment has a fall height exceeding 1.50 metres and grass has been provided as a safety surface - Monitor - no remedial action recommended

The seats are too close to each other as defined in BS EN 1176 Part 2; this is a low risk failure and no remedial action is required - Monitor - No remedial work recommended

The bushes are worn or missing - Replace worn or missing bushes

The seat has minor damage or wear - Monitor for any further deterioration and replace as required

There is some notable evidence of chain wear - Monitor for any further deterioration and replace when 40% worn

The seats are too close to the frame as defined in BS EN 1176 Part 2; this is a low risk failure and no remedial action is required - Monitor - No remedial work recommended

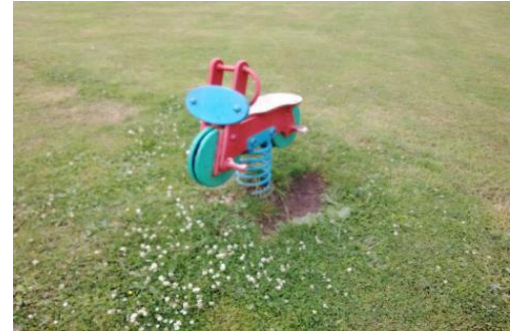
**Item:** Spring Bike  
**Manufacturer:** Owner/Operator  
**Surface Type:** Grass  
**Item Quantity:** 1  
**Equipment Compliance:** No  
**Surface Area Compliance:** Yes

The end of handgrips and/or footrests have a cross section of less than 15cm<sup>2</sup> and fail to meet the requirements of BS EN 1176 Part 6 - Monitor - No remedial work recommended

There is/are bolt cap covers missing or damaged on the item - Replace missing or damaged bolt cap covers

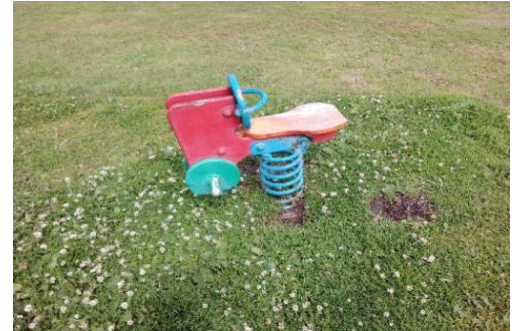
**Item:** Spring Tractor  
**Manufacturer:** Owner/Operator  
**Surface Type:** Grass  
**Item Quantity:** 1  
**Equipment Compliance:** No  
**Surface Area Compliance:** Yes

The end of handgrips and/or footrests have a cross section of less than 15cm<sup>2</sup> and fail to meet the requirements of BS EN 1176 Part 6 - Monitor - No remedial work recommended

There is/are bolt cap covers missing or damaged on the item - Replace missing or damaged bolt cap covers

There is some evidence of rot in the timber - Monitor for any further deterioration and replace as required

The item has missing component(s) - Consider replacing missing components

The paintwork on the spring has been damaged or worn exposing the metal underneath which is rusting - Treat any rusting components and repaint

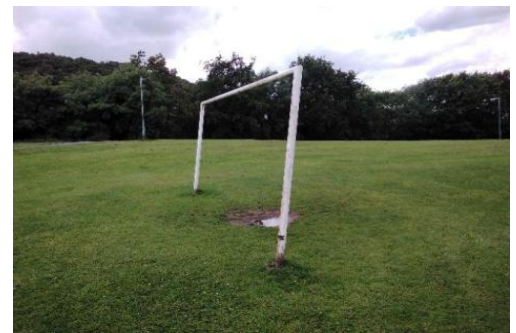
**Item:** Goal End  
**Manufacturer:** Owner/Operator  
**Surface Type:** Grass  
**Item Quantity:** 2  
**Equipment Compliance:** N/A  
**Surface Area Compliance:** N/A

There is surface corrosion present on the item - Consider treating the item

The item is slightly loose in its foundations - Monitor for any further deterioration and repair as required

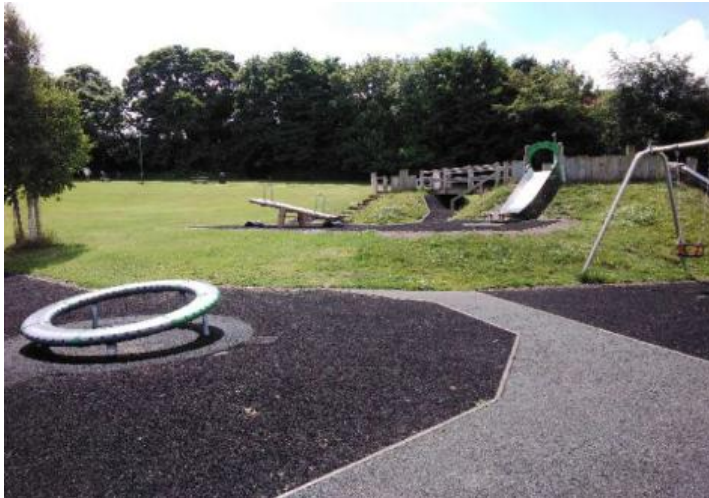
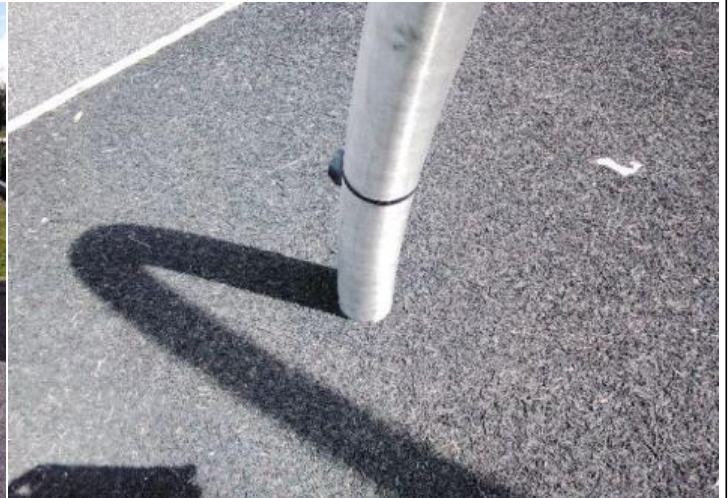
**Item:** Ancillary Items - Site General  
**Manufacturer:** Owner/Operator

**Finding:** There are cable ties on the various items

**Action:** Remove ties

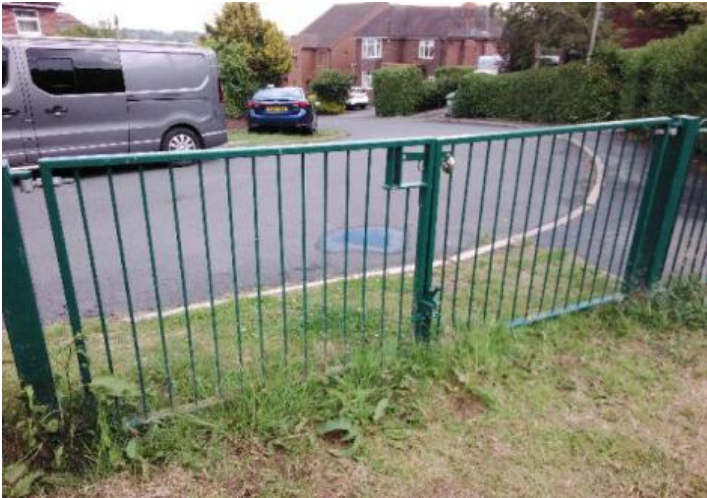
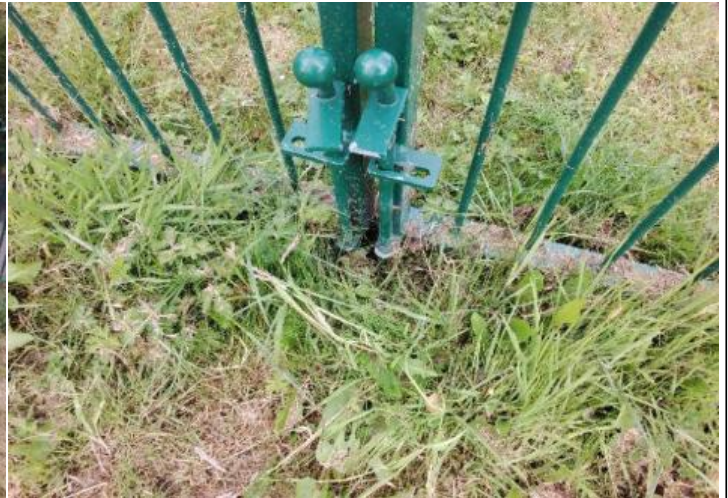
**Item:** Gates - Gate - Maintenance  
**Manufacturer:** Owner/Operator

**Finding:** The gate has no drop bolt sleeves fitted

**Action:** Provide drop bolt sleeves and/or drop bolts

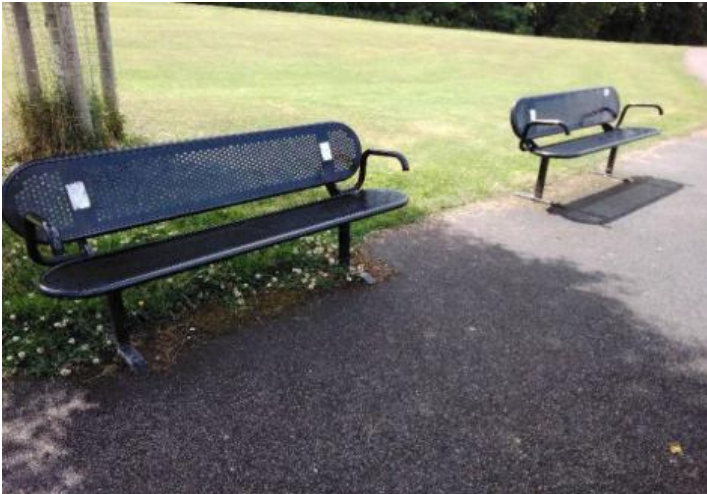
**Item:** Ancillary Items - Bench  
**Manufacturer:** Not Identified

**Finding:** Ground fixings are slightly loose

**Action:** Secure fixings

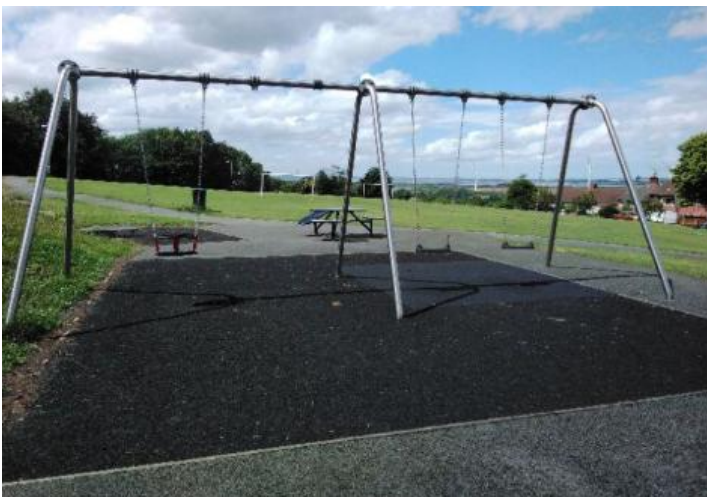
**Item:** Swings - 2 Bay (2 Flat, 2 Cradle)  
**Manufacturer:** Playdale Playgrounds Ltd

**Finding:** There is some notable evidence of chain wear

**Action:** Monitor for any further deterioration and replace when 40% worn

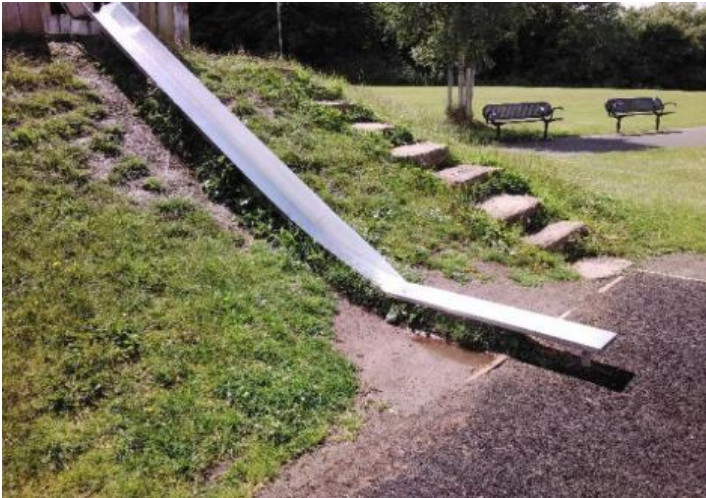
**Item:** Other - Embankment Slide  
**Manufacturer:** Not Identified

**Finding:** The timber edge forms a hard object within the falling space of the equipment in contravention of the requirements of BS EN 1176 Part 1

**Action:** Monitor - No remedial work recommended

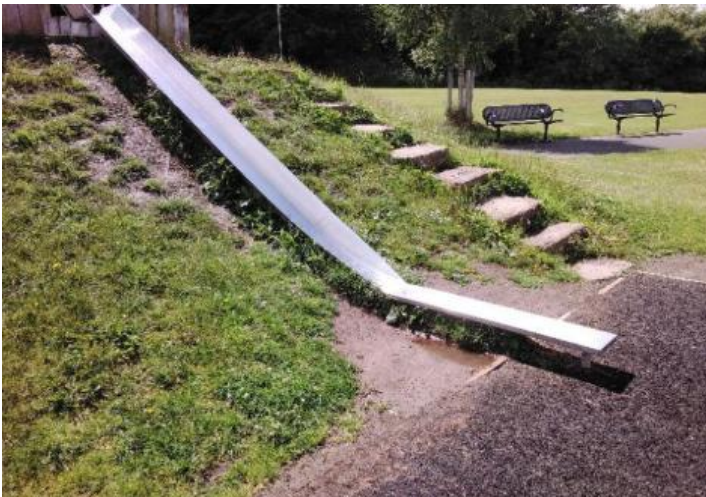
**Item:** Other - Embankment Slide  
**Manufacturer:** Not Identified

**Finding:** There are trip hazards present on the timber edge

**Action:** Reinstall surrounding surfaces to level to remove the trip points

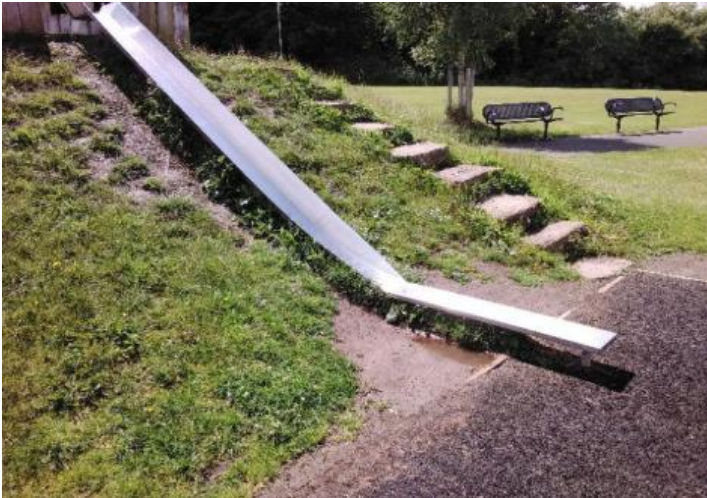
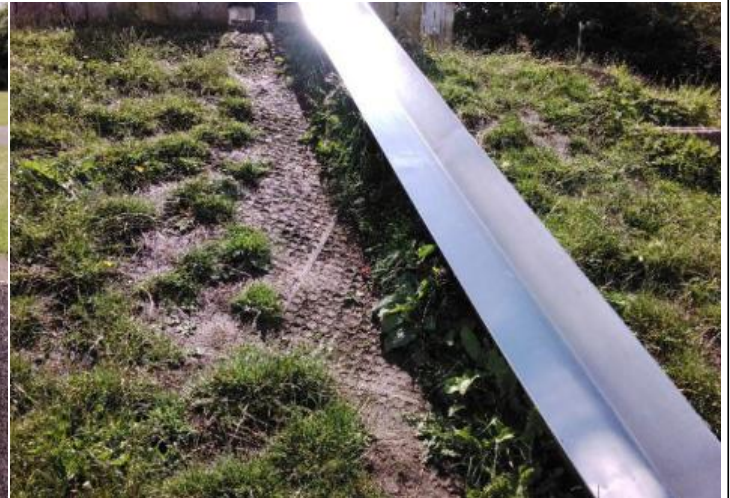
**Item:** Other - Embankment Slide  
**Manufacturer:** Not Identified

**Finding:** The grass mats are silted up, the soil is compacted and the area will become very slippery when the soil is wet. **Action:** Reinstatement as required

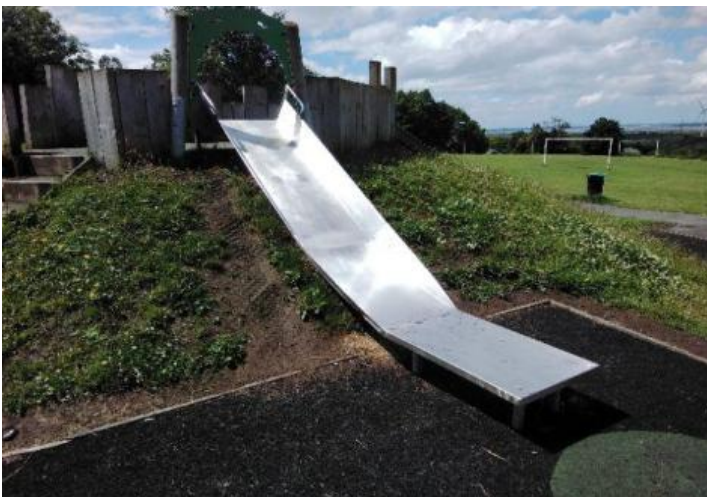
**Item:** Other - Embankment Slide  
**Manufacturer:** Playdale Playgrounds Ltd

**Finding:** There are significant gaps (over 30mm) between the surface and the edging or between the joints in the surface; these are large enough for a small foot to enter. **Action:** Repair surfacing

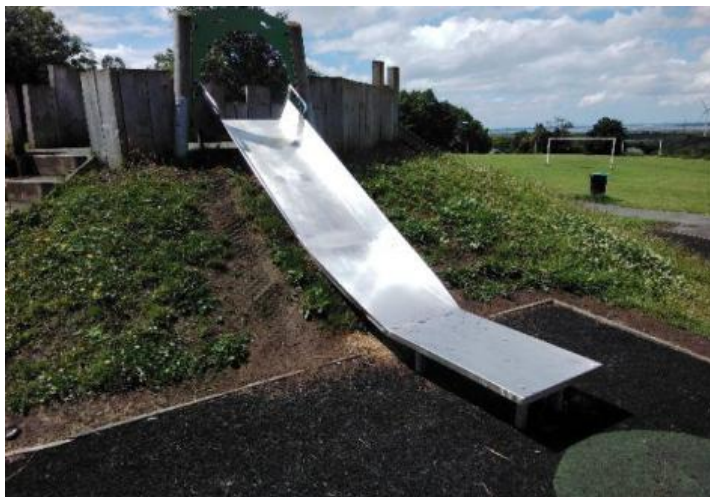
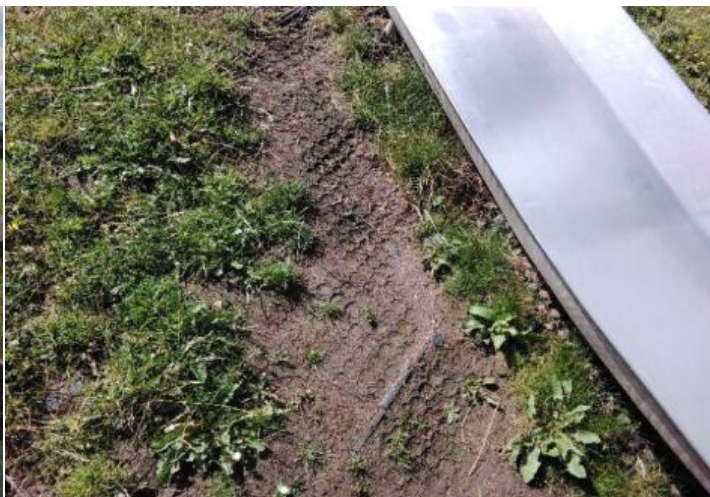
**Item:** Other - Embankment Slide  
**Manufacturer:** Playdale Playgrounds Ltd

**Finding:** The grass mats are silted up, the soil is compacted and the area will become very slippery when the soil is wet.

**Action:** Reinstate as required

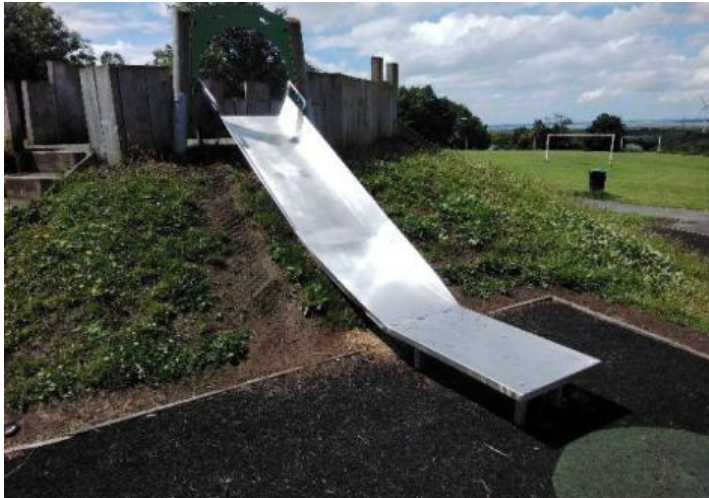
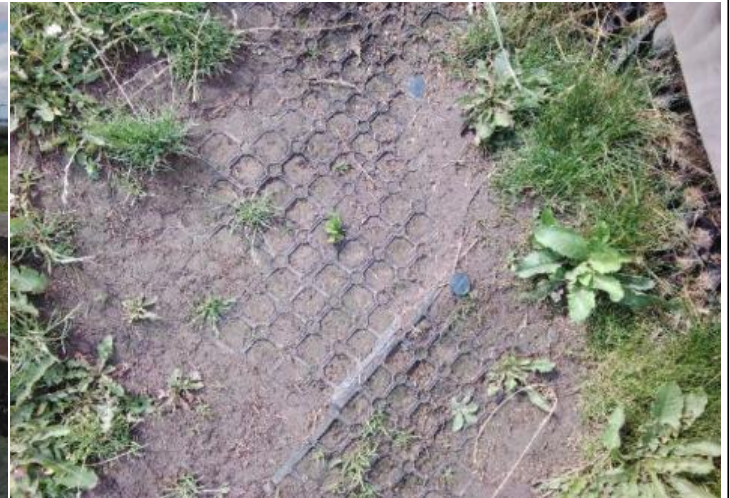
**Item:** Other - Embankment Slide  
**Manufacturer:** Playdale Playgrounds Ltd

**Finding:** Fixing Pins have been installed in the impact areas of the grass mats **Action:** Remove pins from impact areas

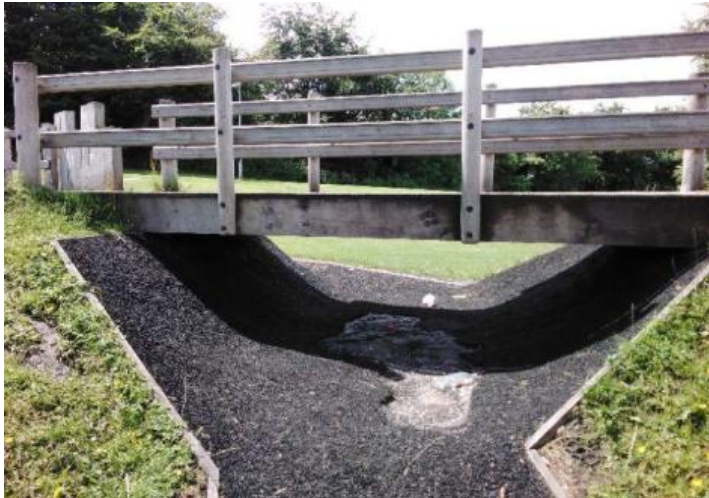
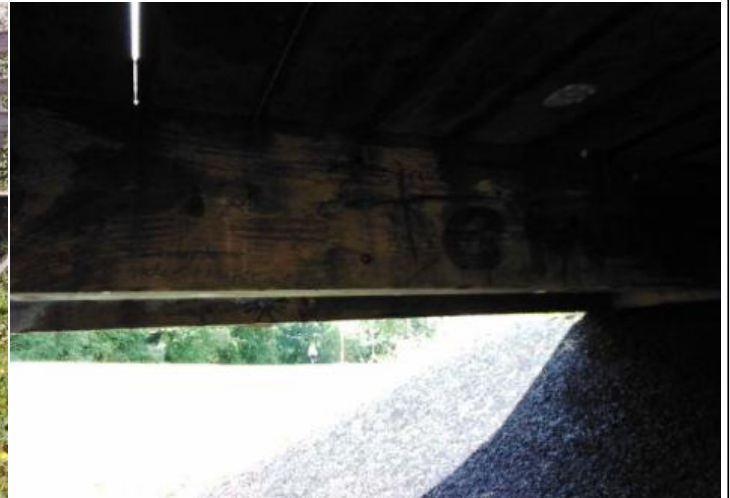
**Item:** Activity Equipment - Bridge  
**Manufacturer:** Playdale Playgrounds Ltd

**Finding:** There is some graffiti present

**Action:** Remove the graffiti

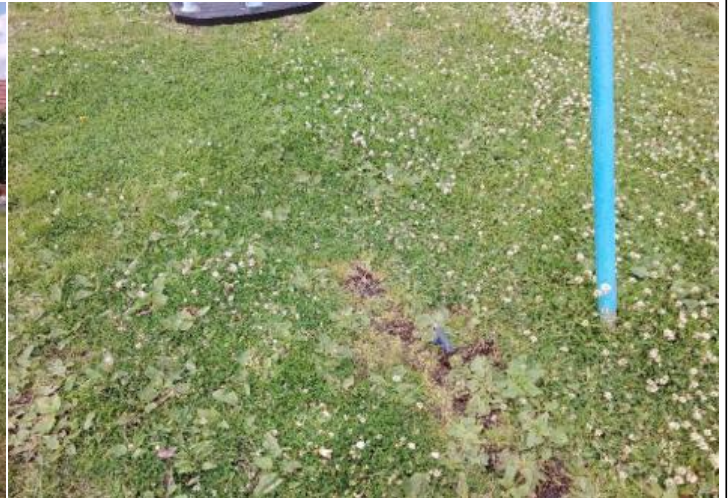
**Item:** Swings - 2 Bay 2 Cradle Swing  
**Manufacturer:** Wicksteed Playgrounds

**Risk Level:** L - Low Risk  
**Surface:** Grass

**Finding:** The soil is thin and there are rocks just under the surface which will not provide the required impact protection

**Action:** Provide an appropriate safety surface

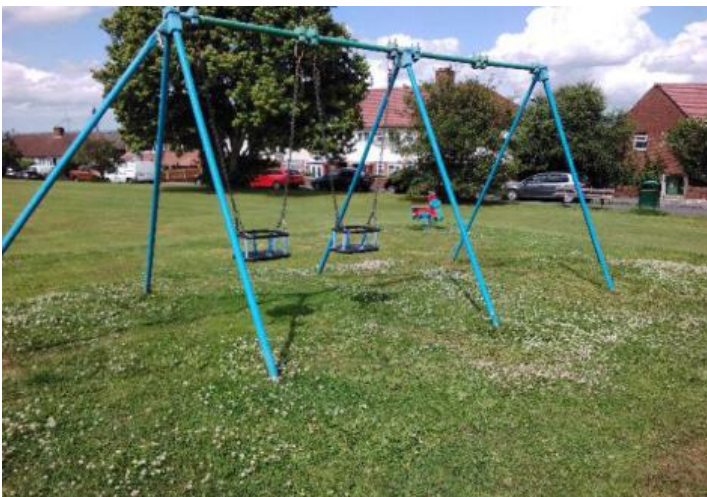
**Item:** Swings - 2 Bay 2 Cradle Swing  
**Manufacturer:** Wicksteed Playgrounds

**Risk Level:** L - Low Risk  
**Surface:** Grass

**Finding:** There is some wear to the shackles.

**Action:** Monitor for any further deterioration and replace when 40% worn

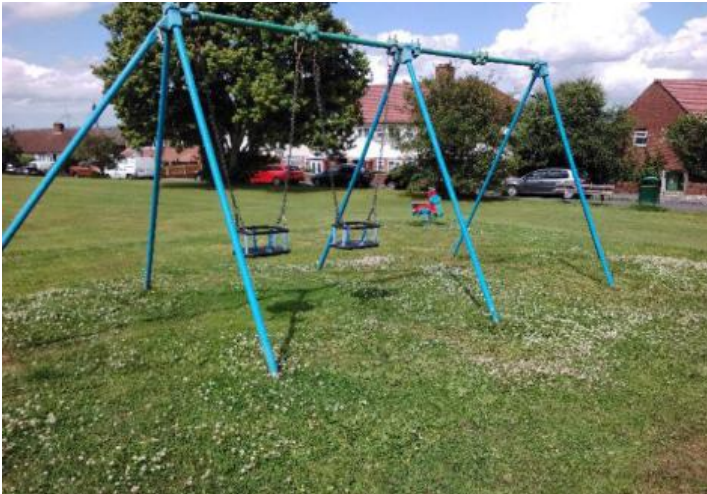
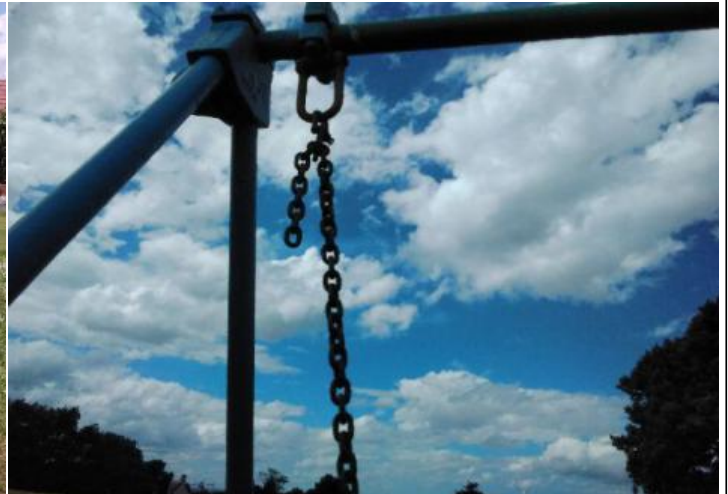
**Item:** Swings - 2 Bay 2 Cradle Swing  
**Manufacturer:** Wicksteed Playgrounds

**Risk Level:** L - Low Risk  
**Surface:** Grass

**Finding:** There are excessive chain tails

**Action:** Cut back excessive chain links

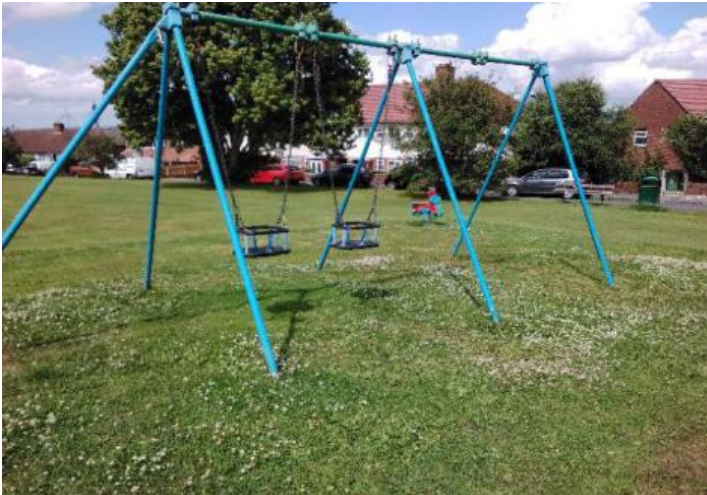
**Item:** Swings - 2 Bay 2 Cradle Swing  
**Manufacturer:** Wicksteed Playgrounds

**Risk Level:** L - Low Risk  
**Surface:** Grass

**Finding:** There is some notable evidence of chain wear

**Action:** Monitor for any further deterioration and replace when 40% worn

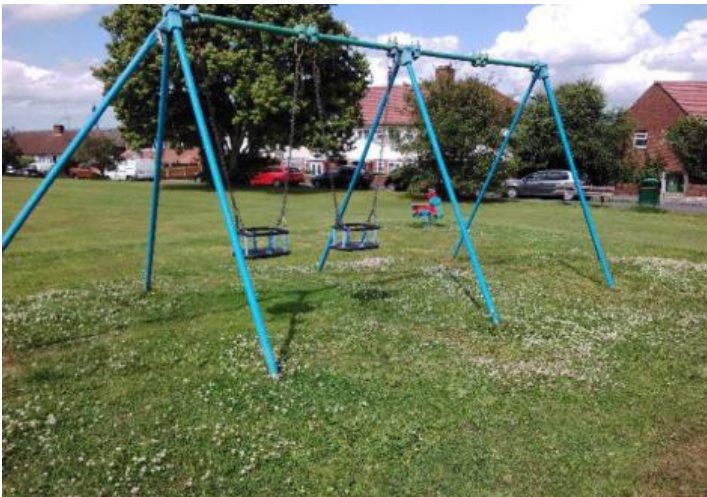
**Item:** Swings - 2 Bay 2 Cradle Swing  
**Manufacturer:** Wicksteed Playgrounds

**Risk Level:** V - Very Low Risk  
**Surface:** Grass

**Finding:** The seats are too close to each other as defined in BS EN 1176 Part 2; this is a low risk failure and no remedial action is required

**Action:** Monitor - No remedial work recommended

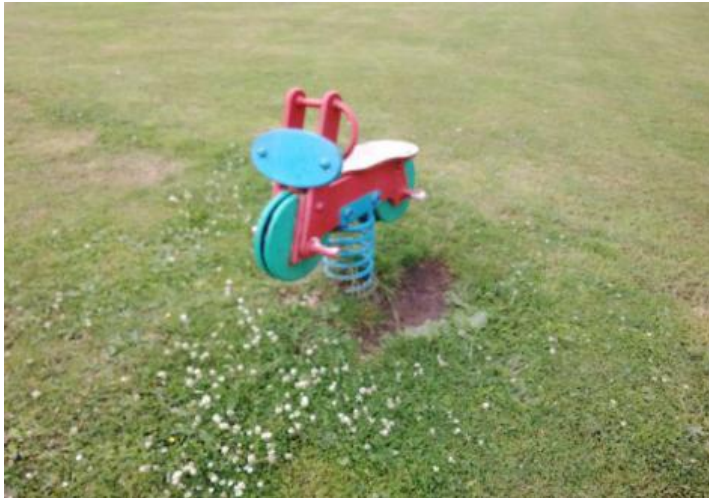
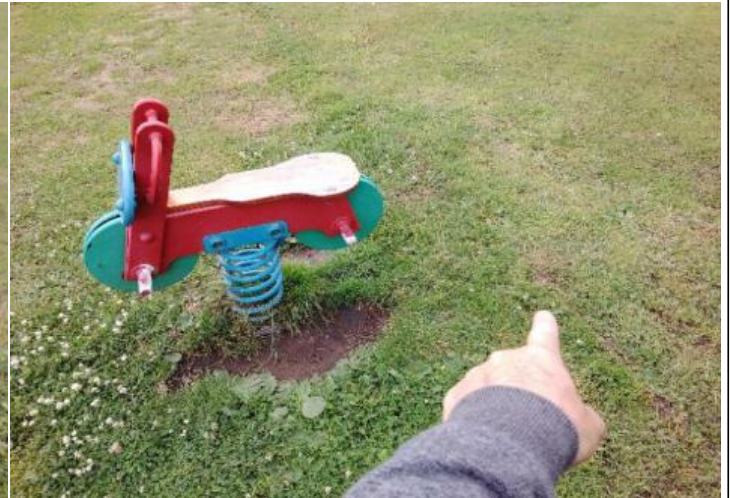
**Item:** Rocking Equipment - Spring Bike  
**Manufacturer:** Owner/Operator

**Risk Level:** V - Very Low Risk  
**Surface:** Grass

**Finding:** The timber edge forms a hard object within the falling space of the equipment in contravention of the requirements of BS EN 1176 Part 1

**Action:** Remove edge

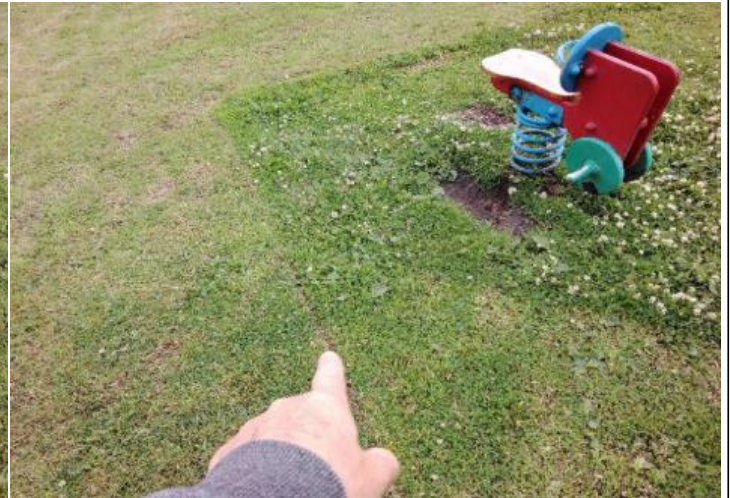
**Item:** Rocking Equipment - Spring Tractor  
**Manufacturer:** Owner/Operator

**Risk Level:** V - Very Low Risk  
**Surface:** Grass

**Finding:** The timber edge forms a hard object within the falling space of the equipment in contravention of the requirements of BS EN 1176 Part 1

**Action:** Remove edge

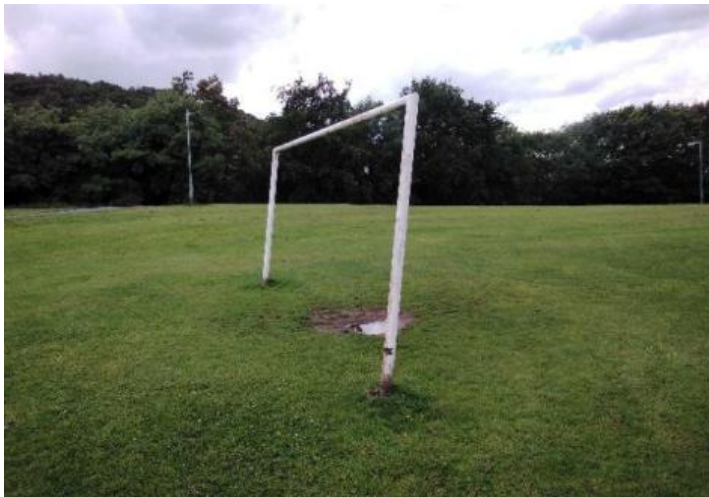
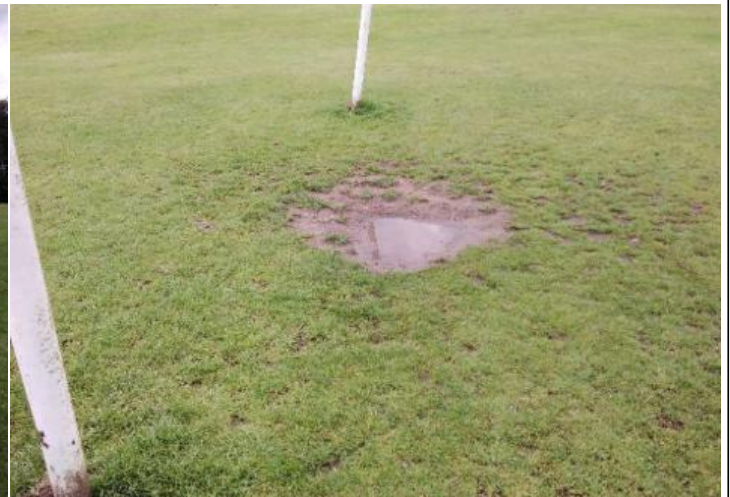
**Item:** Multi Use Games Area - Goal End  
**Manufacturer:** Owner/Operator

**Risk Level:** L - Low Risk  
**Surface:** Grass

**Finding:** The surface has eroded in some areas

**Action:** Reinstate the surface

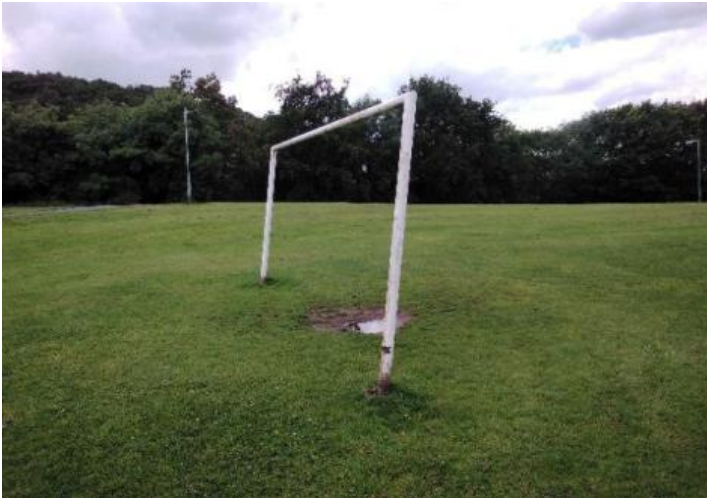
**Item:** Multi Use Games Area - Goal End  
**Manufacturer:** Owner/Operator

**Risk Level:** L - Low Risk  
**Surface:** Grass

**Finding:** The item is slightly loose in its foundations

**Action:** Monitor for any further deterioration and repair as required

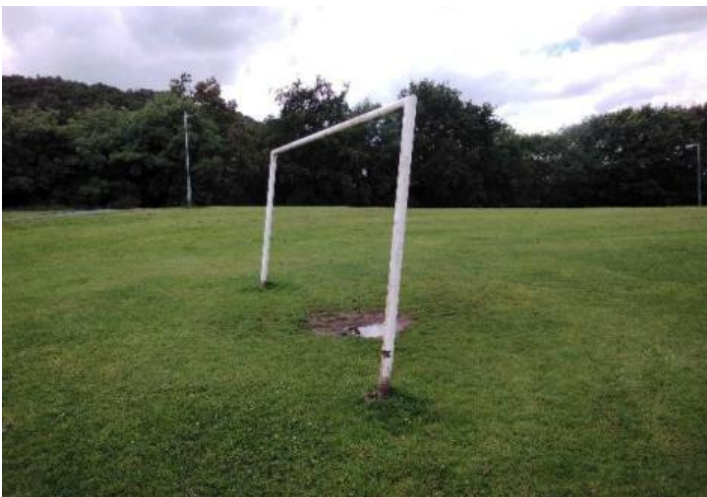
**Item:** Multi Use Games Area - Goal End  
**Manufacturer:** Owner/Operator

**Risk Level:** L - Low Risk  
**Surface:** Grass

**Finding:** There is surface corrosion present on the item

**Action:** Consider treating the item

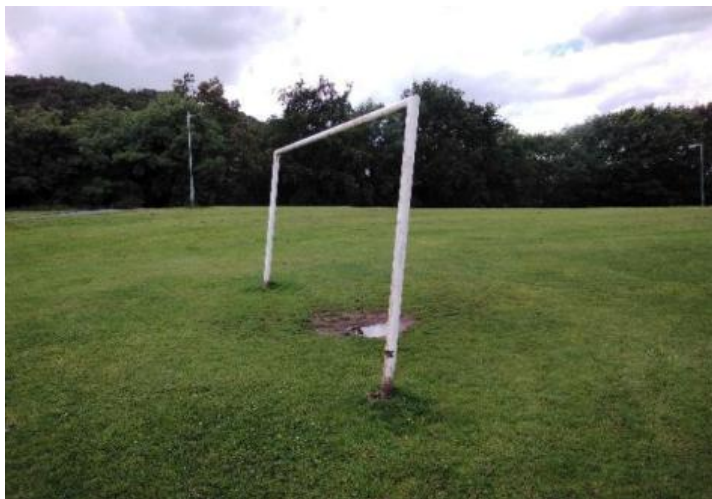
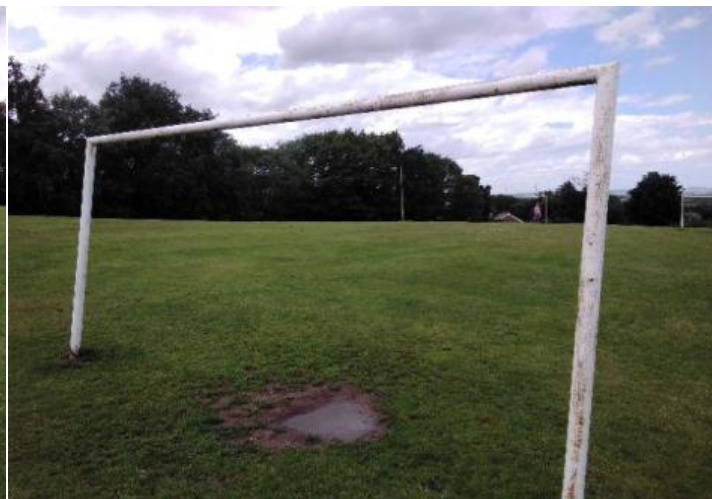
**Item:** Multi Use Games Area - Goal End  
**Manufacturer:** Owner/Operator

**Risk Level:** N - Risk Assessment not Undertaken  
**Surface:** Grass

**Finding:** NB: We have undertaken a maintenance inspection only of the football goal(s); full load testing falls outside the scope of our inspection.

**Action:** Implement load testing as required
