Annual Inspection

Frodsham Town Council

Churchfields

Inspection Ref: 613981

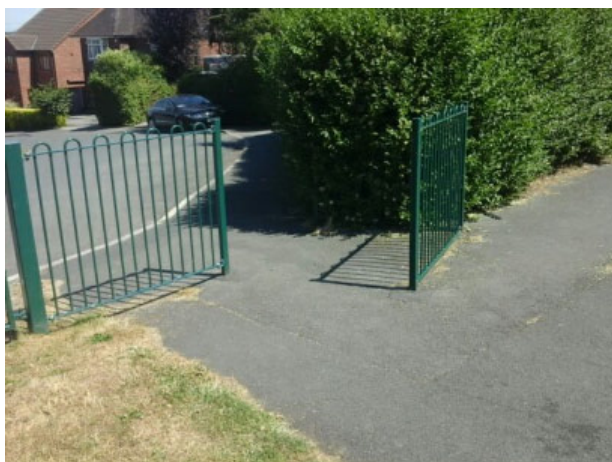
Item: Ancillary Items - Entrance Feature
Manufacturer: Owner/Operator
Surface Type: All Weather Surface
Equipment Compliance: N/A
Surface Area Compliance: N/A
Ref/Part Number:
Total Findings: 1

There is slight damage to the feature - Monitor for any further deterioration and repair as required

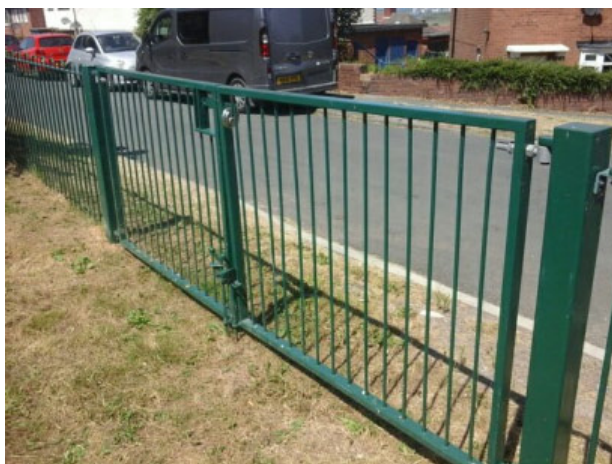
Item: Ancillary Items - Gate - Maintenance
Manufacturer: Owner/Operator
Surface Type: N/A
Equipment Compliance: N/A
Surface Area Compliance: N/A
Ref/Part Number:
Total Findings: 1

This item is satisfactory - no work required

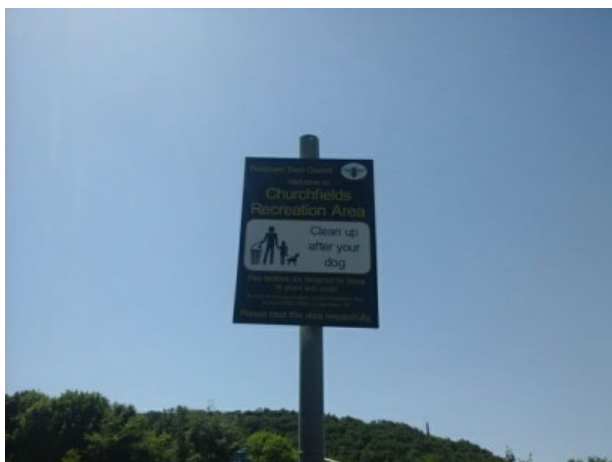
Item: Ancillary Items - Sign
Manufacturer: Owner/Operator
Surface Type: N/A
Equipment Compliance: N/A
Surface Area Compliance: N/A
Ref/Part Number:
Total Findings: 1

This item is satisfactory - no work required

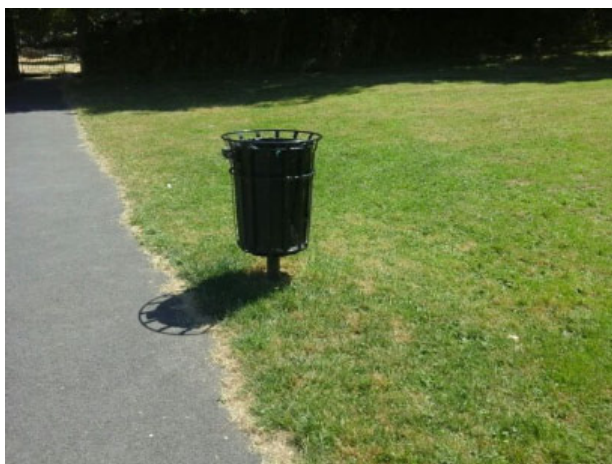
Item: Ancillary Items - Litter Bin
Manufacturer: Owner/Operator
Surface Type: N/A
Equipment Compliance: N/A
Surface Area Compliance: N/A
Ref/Part Number:
Total Findings: 1

This item is satisfactory - no work required

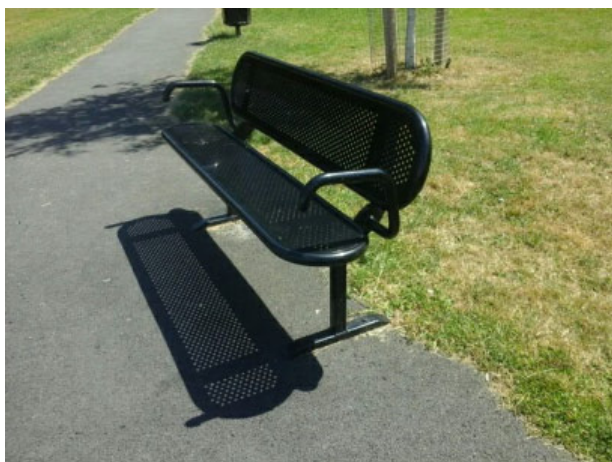
Item: Ancillary Items - Bench
Manufacturer: Not Identified
Surface Type: All Weather Surface
Equipment Compliance: N/A
Surface Area Compliance: N/A
Ref/Part Number:
Total Findings: 1

The ground fixings are slightly loose - Secure fixings

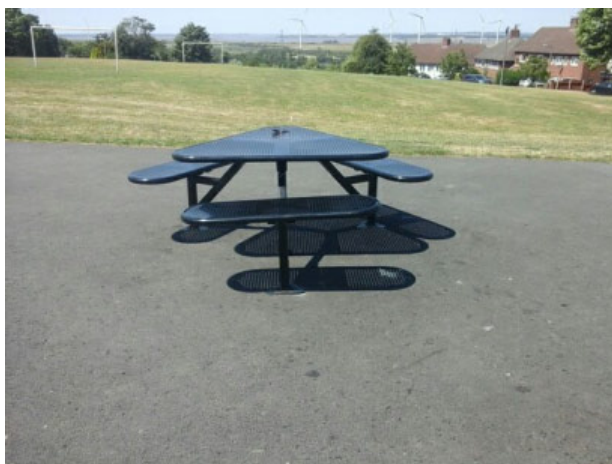
Item: Ancillary Items - Picnic Table
Manufacturer: Not Identified
Surface Type: All Weather Surface
Equipment Compliance: N/A
Surface Area Compliance: N/A
Ref/Part Number:
Total Findings: 1

There are projecting bolt thread(s) present - Remove excess thread length and deburr or provide cap

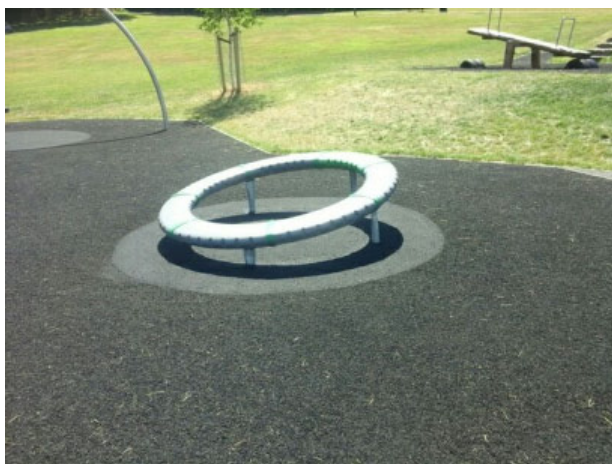
Item: Rotor Play - Supanova
Manufacturer: Kompan Ltd
Surface Type: Tigermulch
Equipment Compliance: Yes
Surface Area Compliance: Yes
Ref/Part Number:
Total Findings: 2

The wet pour is crumbling in areas - Monitor for any further deterioration and repair as required

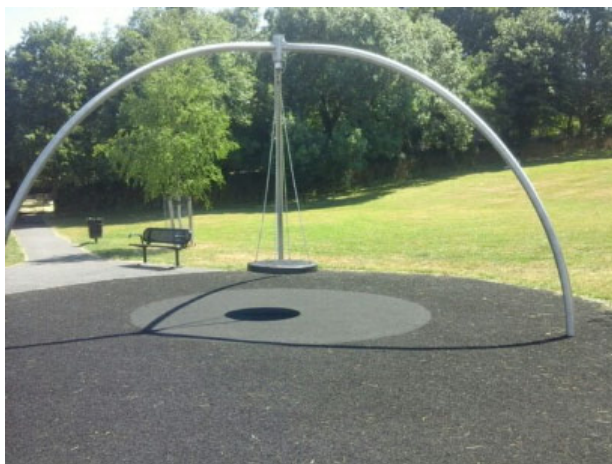
Item: Swings - Pendulum Swing
Manufacturer: Playdale Playgrounds Ltd
Surface Type: Tigermulch
Equipment Compliance: Yes
Surface Area Compliance: Yes
Ref/Part Number:
Total Findings: 3

The wet pour is crumbling in areas - Monitor for any further deterioration and repair as required

There is some notable evidence of chain wear - Monitor for any further deterioration and replace when 40% worn

The fixings for this item were in excess of 2.5m above the standing surface and could not be fully accessed by the inspector, a maintenance inspection should be undertaken to assess wear and tear of the components - Implement a maintenance inspection for this item

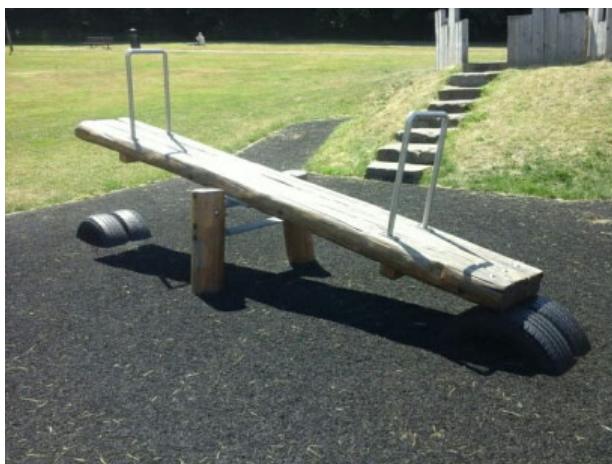
Item: Rocking Equipment - See Saw
Manufacturer: Spiel Art
Surface Type: Tigermulch
Equipment Compliance: Yes
Surface Area Compliance: Yes
Ref/Part Number:
Total Findings: 3

The wet pour is crumbling in areas - Monitor for any further deterioration and repair as required

There are gaps opening between the surfacing and the edging surround or between the joints in the surfacing - Monitor for any further deterioration and repair as required

There are trip hazards at the edges of the surface - Reinstate surrounding surface levels to remove the trip points

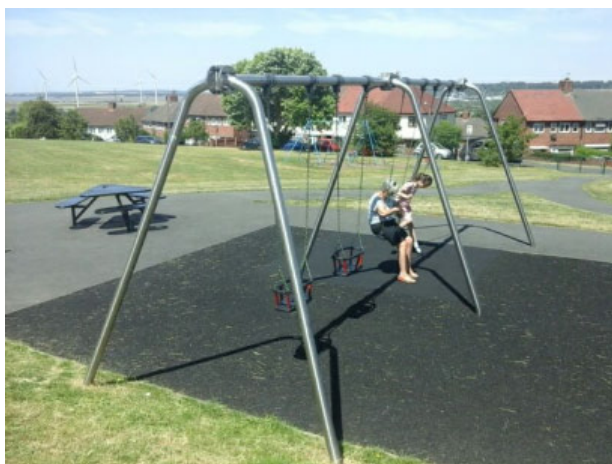
Item: Swings - 2 Bay (2 Flat, 2 Cradle)
Manufacturer: Playdale Playgrounds Ltd
Surface Type: Tigermulch
Equipment Compliance: Yes
Surface Area Compliance: Yes
Ref/Part Number:
Total Findings: 3

There are gaps opening between the surfacing and the edging surround or between the joints in the surfacing - Monitor for any further deterioration and repair as required

The wet pour is crumbling in areas - Monitor for any further deterioration and repair as required

The seat has minor damage or wear - Monitor for any further deterioration and replace as required

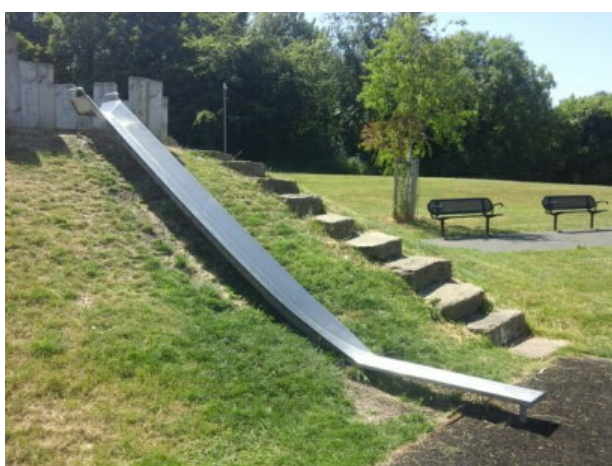
Item: Other - Embankment Slide
Manufacturer: Not Identified
Surface Type: Grass Matrix Tiles
Equipment Compliance: No
Surface Area Compliance: Yes
Ref/Part Number:
Total Findings: 2

There are trip hazards at the edges of the surface - Reinststate surrounding surface levels to remove the trip points

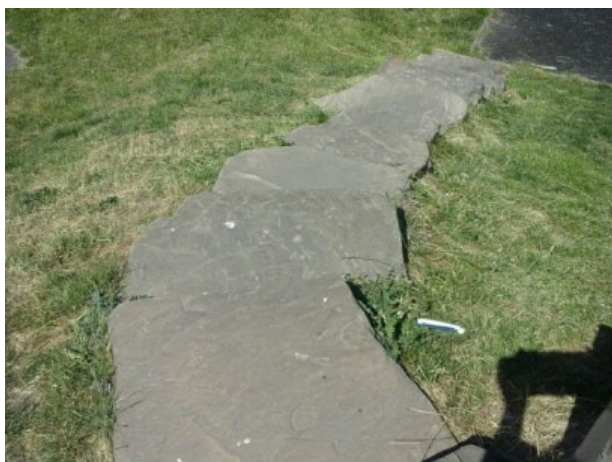
Item: Ancillary Items - Steps
Manufacturer: Owner/Operator
Surface Type: All Weather Surface
Equipment Compliance: N/A
Surface Area Compliance: N/A
Ref/Part Number:
Total Findings: 1

The use of boulders in the play area presents a risk to users of falling onto hard objects - Monitor use

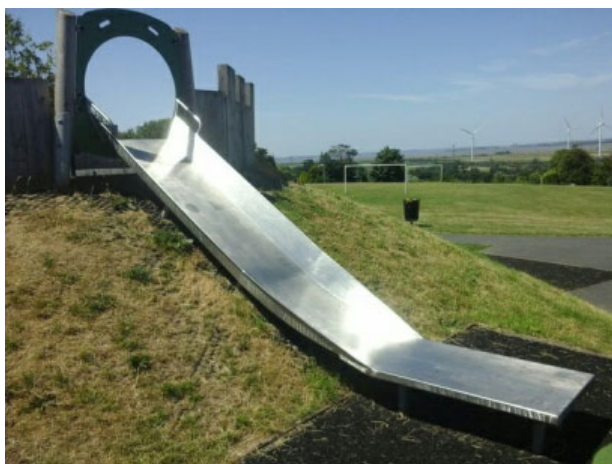
Item: Other - Embankment Slide
Manufacturer: Playdale Playgrounds Ltd
Surface Type: Tiger mulch
Equipment Compliance: No
Surface Area Compliance: Yes
Ref/Part Number:
Total Findings: 4

The timber edge forms a hard object within the falling space of the equipment in contravention of the requirements of BS EN 1176 Part 1 - Monitor use

There are gaps opening between the surfacing and the edging surround or between the joints in the surfacing - Monitor for any further deterioration and repair as required

There are trip hazards at the edges of the surface - Reinstate surrounding surface levels to remove the trip points

There is/are finger entrapment/s in the slide start and the item fails to meet the requirements of BS EN 1176:2008 Part 1 4.2.7.6 Entrapment of fingers - Monitor use

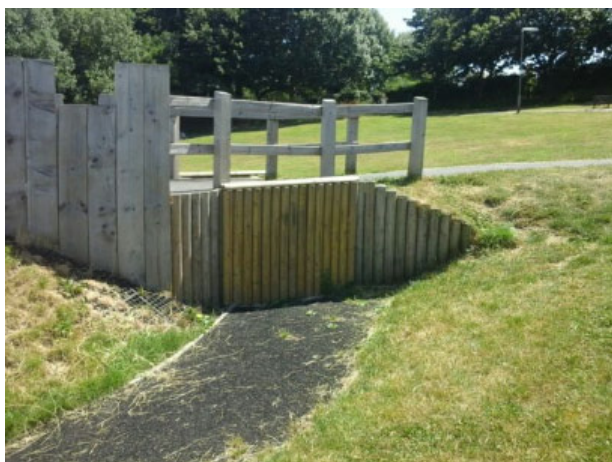
Item: Activity Equipment - Crawling Tunnel
Manufacturer: Playdale Playgrounds Ltd
Surface Type: Tigermulch
Equipment Compliance: N/A
Surface Area Compliance: N/A
Ref/Part Number:
Total Findings: 1

The tunnel has been blanked off - Reinstate as required

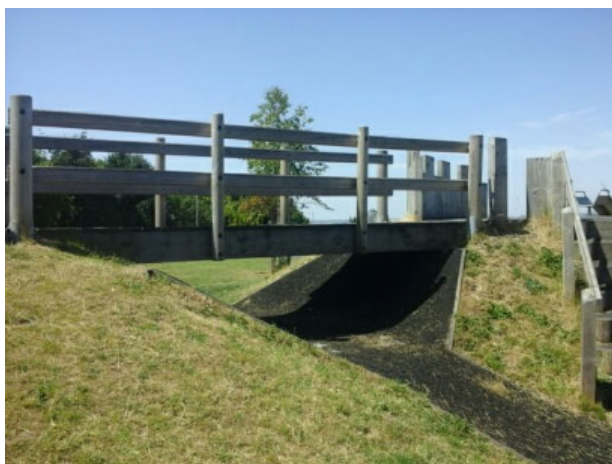
Item: Activity Equipment - Bridge
Manufacturer: Playdale Playgrounds Ltd
Surface Type: All Weather Surface
Equipment Compliance: N/A
Surface Area Compliance: N/A
Ref/Part Number:
Total Findings: 2

The surfacing around the item is damaged and is creating a potential trip hazard - Repair the damaged areas of surfacing

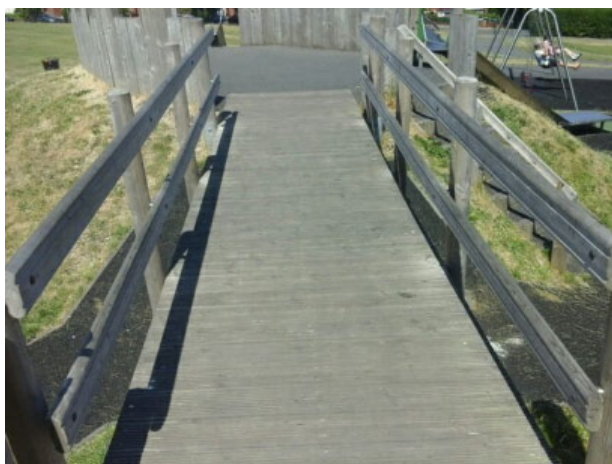
Item: Ancillary Items - Landscape Feature
Manufacturer: Owner/Operator
Surface Type: N/A
Equipment Compliance: N/A
Surface Area Compliance: N/A
Ref/Part Number:
Total Findings: 1

The timber has a number of air cracks apparent, the splits will have penetrated the preservative applied to the timber and allow water ingress to the unprotected areas - Monitor for any deterioration (rot) and replace as required

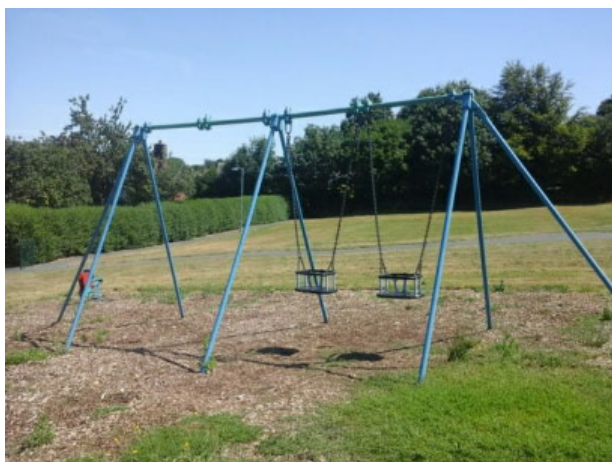
Item: Swings - 2 Bay 2 Cradle Swing
Manufacturer: Wicksteed Playgrounds
Surface Type: Bark Mulch
Equipment Compliance: No
Surface Area Compliance: Yes
Ref/Part Number:
Total Findings: 11

The loose fill safety surfacing has become compacted and degraded to mulch - Rake and fork over to aerate the surface

There are trip hazards at the edges of the surface - Reinstate surrounding surface levels to remove the trip points

The edging timbers are damaged - Repair

There are excessive chain tails - Cut back excessive chain links (two links through the quick link connector are recommended)

The bushes are worn or missing - Replace worn or missing bushes

The level of loose fill surfacing has fallen significantly below the minimum 200mm recommended by BS EN 1176 Part 1 - Top up loose fill surfacing to recommended levels.

The seats are too close to the frame as defined in BS EN 1176 Part 2; this is a low risk failure and no remedial action is required - Monitor use

The seats are too close to each other as defined in BS EN 1176 Part 2; this is a low risk failure and no remedial action is required - Monitor use

The seat(s) and suspension were missing at the time of inspection and the inspector was unable to make a full compliance assessment - Replace missing seat(s) and suspension

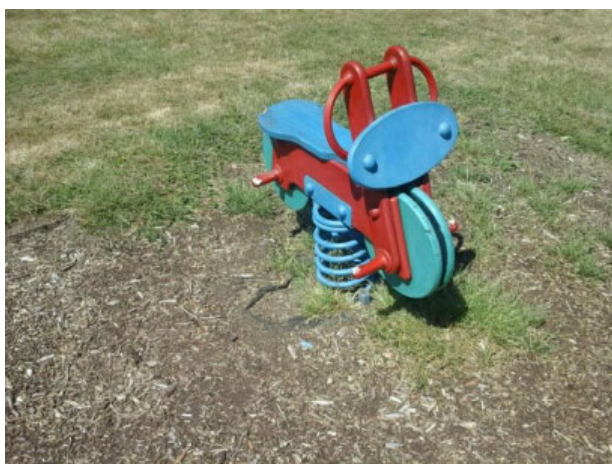
Item: Rocking Equipment - Spring Bike
Manufacturer: Owner/Operator
Surface Type: Bark Mulch
Equipment Compliance: No
Surface Area Compliance: Yes
Ref/Part Number:
Total Findings: 9

The loose fill safety surfacing has become compacted and degraded to mulch - Rake and fork over to aerate the surface

The level of loose fill surfacing has fallen significantly below the minimum 200mm recommended by BS EN 1176 Part 1 - Top up loose fill surfacing to recommended levels.

The end of handgrips and/or footrests have a cross section of less than 15cm² and fail to meet the requirements of BS EN 1176 Part 6 - This is a relatively low risk failure and no remedial action is recommended

There is some evidence of rot in the timber - Monitor for any further deterioration and replace as required

The item is slightly loose in its foundations - Monitor for any further deterioration and repair as required

There is/are bolt cap covers missing or damaged on the item - Replace missing or damaged bolt cap covers

The seat is loose - Re secure seat

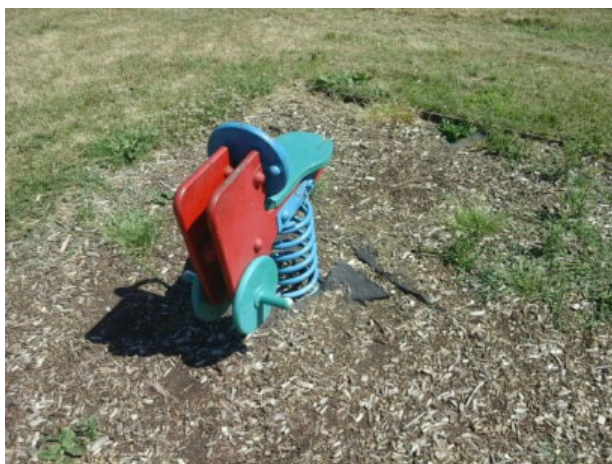
Item: Rocking Equipment - Spring Tractor
Manufacturer: Owner/Operator
Surface Type: Bark Mulch
Equipment Compliance: No
Surface Area Compliance: Yes
Ref/Part Number:
Total Findings: 9

The loose fill safety surfacing has become compacted and degraded to mulch - Rake and fork over to aerate the surface

The level of loose fill surfacing has fallen significantly below the minimum 200mm recommended by BS EN 1176 Part 1 - Top up loose fill surfacing to recommended levels.

There is/are bolt cap covers missing or damaged on the item - Replace missing or damaged bolt cap covers

There is some evidence of rot in the timber - Monitor for any further deterioration and replace as required

The item is slightly loose in its foundations - Monitor for any further deterioration and repair as required

The item has missing component(s) - Consider replacing missing components

The end of handgrips and/or footrests have a cross section of less than 15cm² and fail to meet the requirements of BS EN 1176 Part 6 - This is a relatively low risk failure and no remedial action is recommended

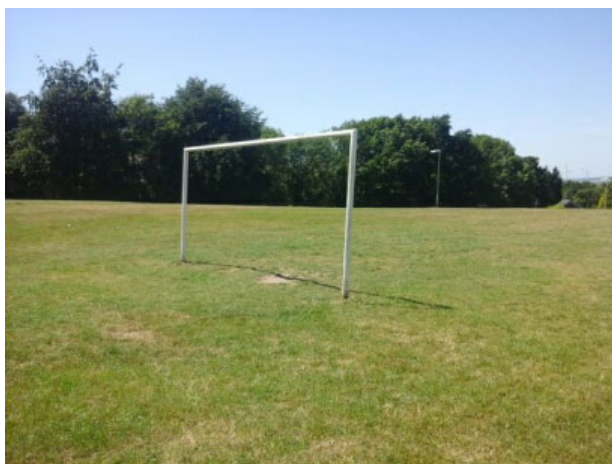
Item: Multi Use Games Area - Goal End
Manufacturer: Owner/Operator
Surface Type: Grass
Equipment Compliance: N/A
Surface Area Compliance: N/A
Ref/Part Number:
Total Findings: 2

The surface has eroded in some areas - Reinststate the surface

The paintwork on this item has been damaged or worn exposing the metal underneath which is rusting - Treat any rusting components and repaint

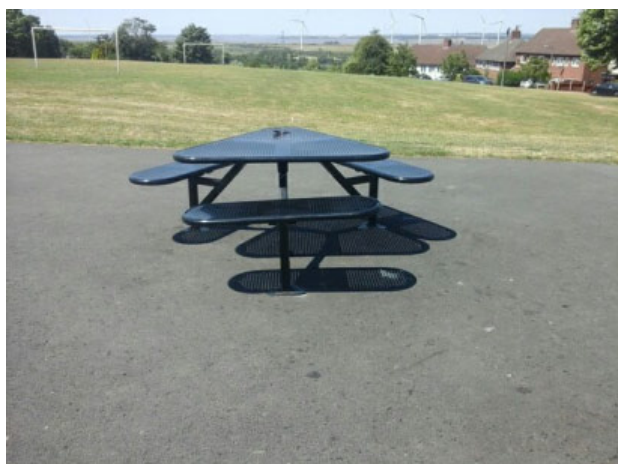
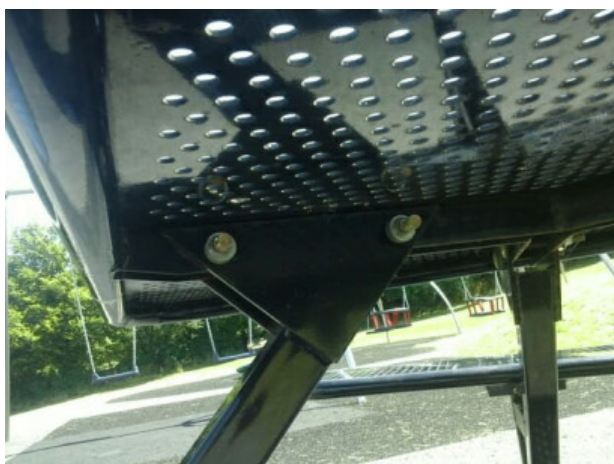
Item: Ancillary Items - Picnic Table
Manufacturer: Not Identified

Finding: There are projecting bolt thread(s) present

Action: Remove excess thread length and deburr or provide cap

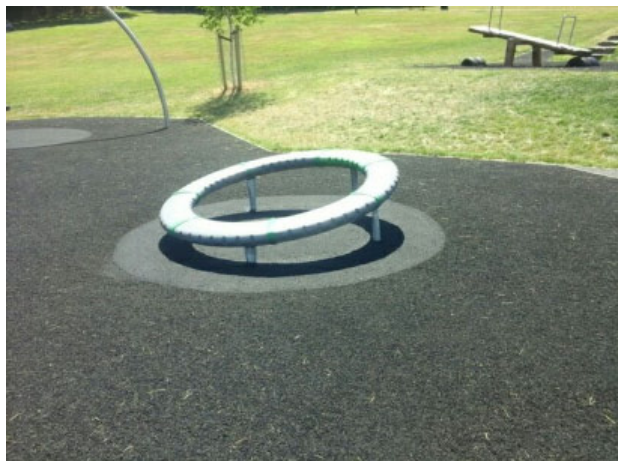
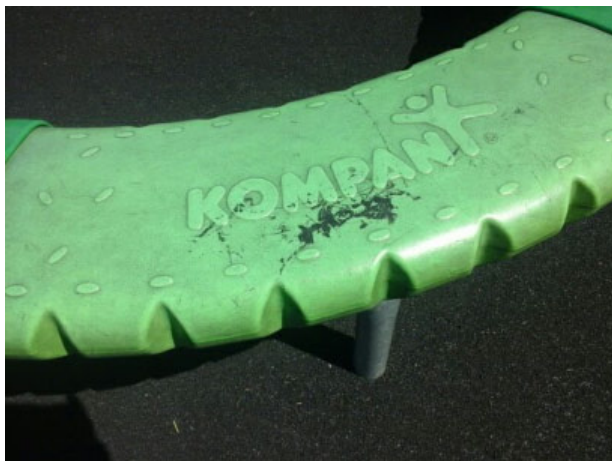
Item: Rotor Play - Supanova
Manufacturer: Kompan Ltd

Finding: There is some graffiti present

Action: Remove the graffiti

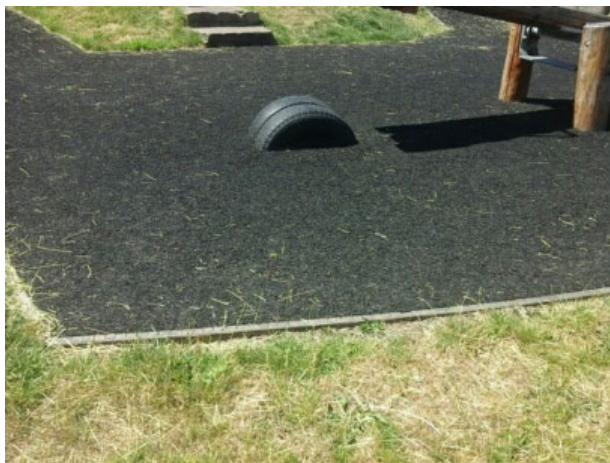
Item: Rocking Equipment - See Saw
Manufacturer: Spiel Art

Finding: There are trip hazards at the edges of the surface

Action: Reinstate surrounding surface levels to remove the trip points

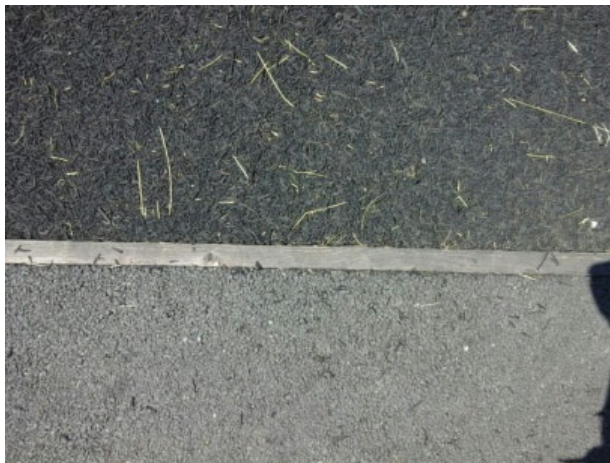
Item: Swings - 2 Bay (2 Flat, 2 Cradle)
Manufacturer: Playdale Playgrounds Ltd

Finding: There are gaps opening between the surfacing and the edging surround or between the joints in the surfacing

Action: Monitor for any further deterioration and repair as required

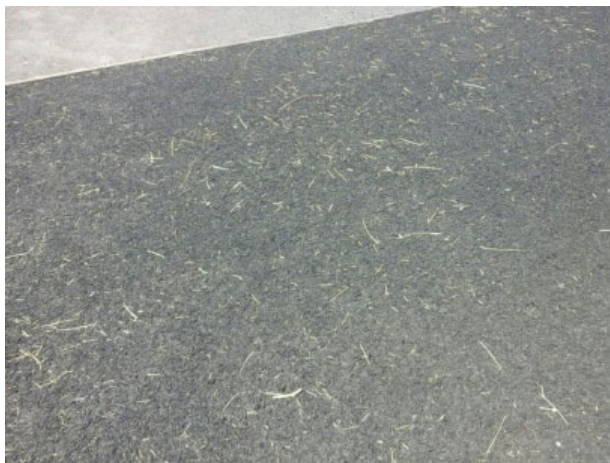
Item: Swings - 2 Bay (2 Flat, 2 Cradle)
Manufacturer: Playdale Playgrounds Ltd

Finding: The wet pour is crumbing in areas

Action: Monitor for any further deterioration and repair as required

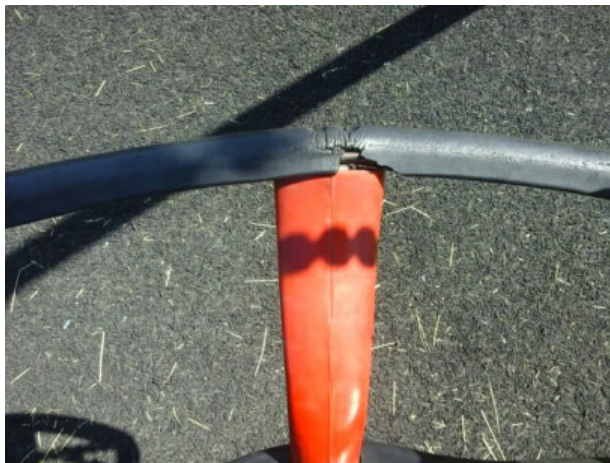
Item: Swings - 2 Bay (2 Flat, 2 Cradle)
Manufacturer: Playdale Playgrounds Ltd

Finding: The seat has minor damage or wear

Action: Monitor for any further deterioration and replace as required

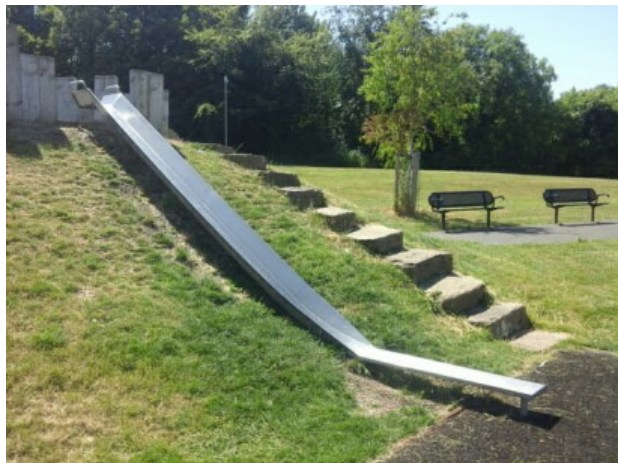
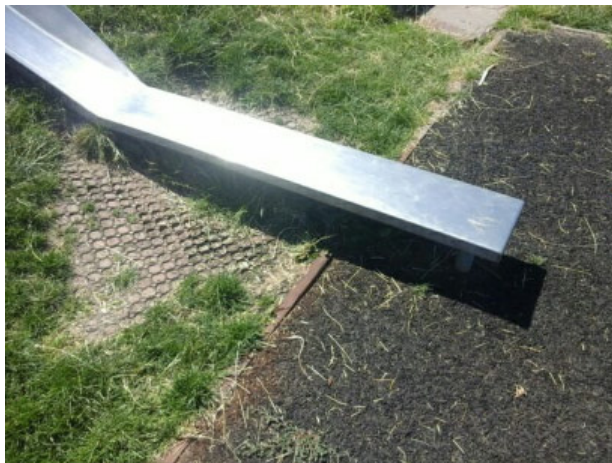
Item: Other - Embankment Slide
Manufacturer: Not Identified

Finding: The timber edge forms a hard object within the falling space of the equipment in contravention of the requirements of BS EN 1176 Part 1

Action: Monitor use

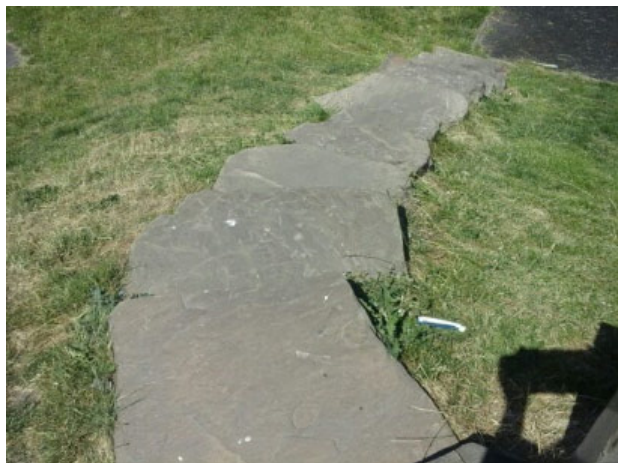
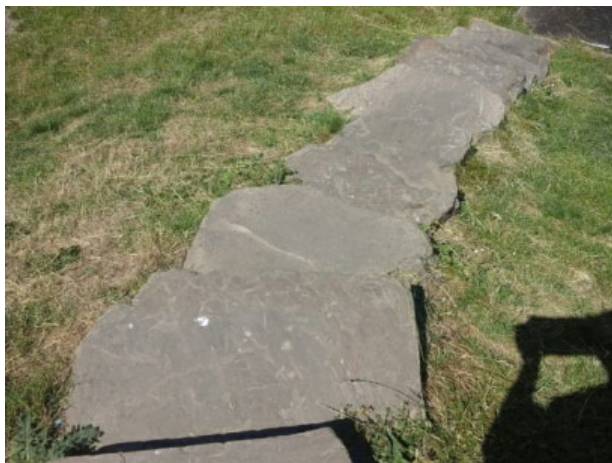
Item: Ancillary Items - Steps
Manufacturer: Owner/Operator

Finding: The use of boulders in the play area presents a risk to users of falling onto hard objects
Action: Monitor use

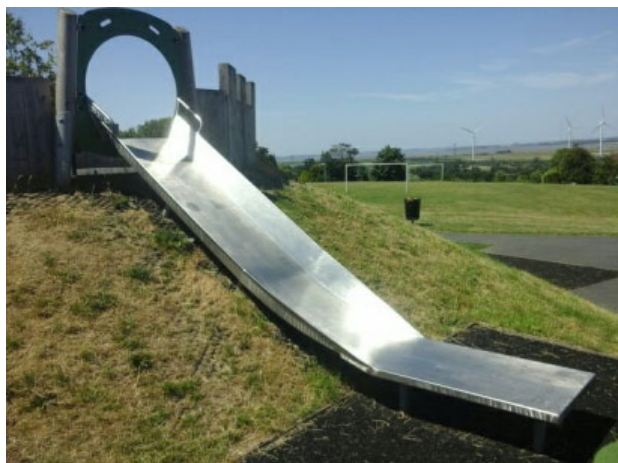
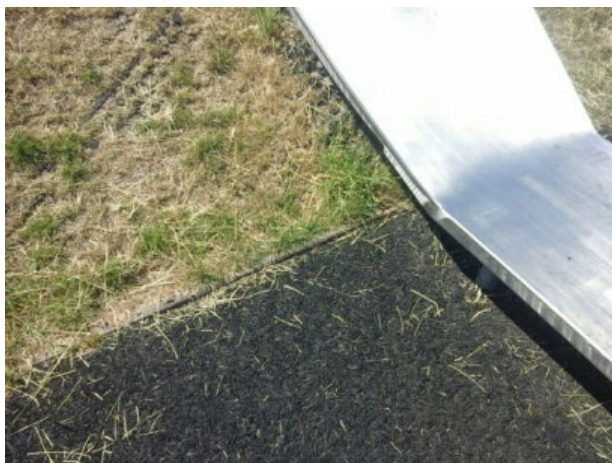
Item: Other - Embankment Slide
Manufacturer: Playdale Playgrounds Ltd

Finding: The timber edge forms a hard object within the falling space of the equipment in contravention of the requirements of BS EN 1176 Part 1
Action: Monitor use

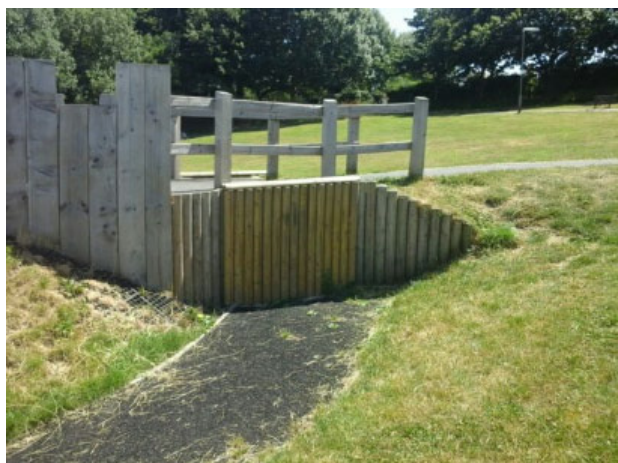
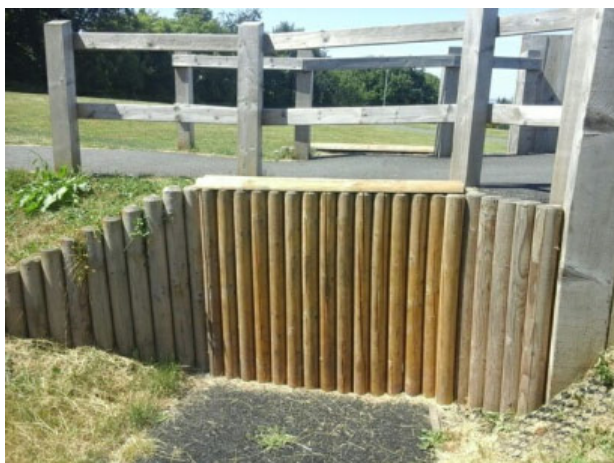
Item: Activity Equipment - Crawling Tunnel
Manufacturer: Playdale Playgrounds Ltd

Finding: The tunnel has been blanked off

Action: Reinstate as required

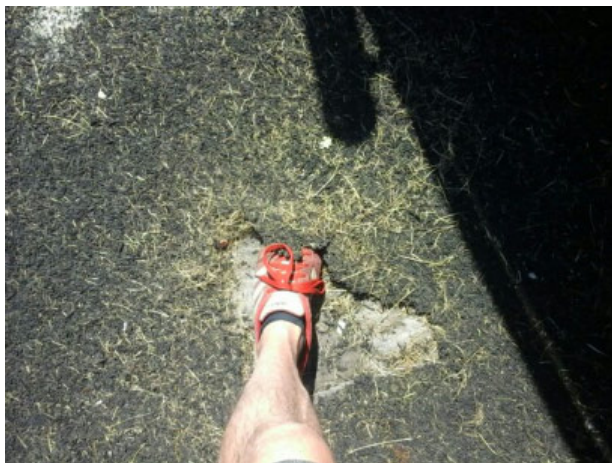
Item: Activity Equipment - Bridge
Manufacturer: Playdale Playgrounds Ltd

Finding: The surfacing around the item is damaged and is creating a potential trip hazard

Action: Repair the damaged areas of surfacing

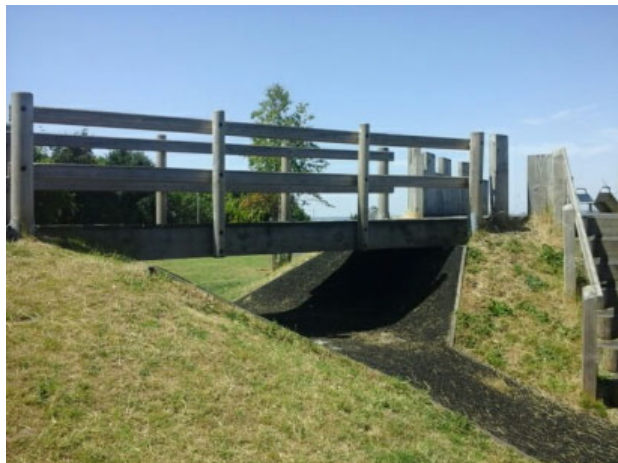
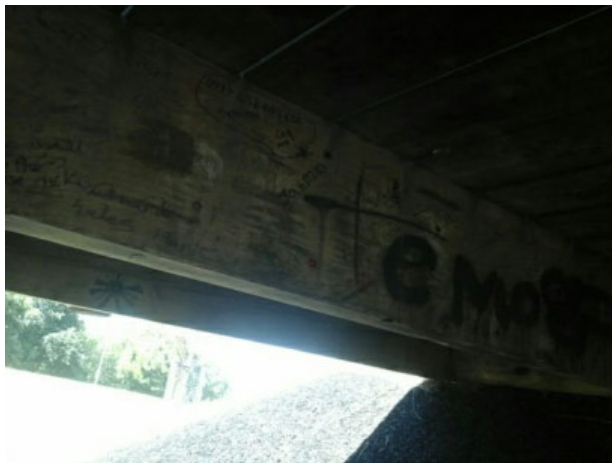
Item: Activity Equipment - Bridge
Manufacturer: Playdale Playgrounds Ltd

Finding: There is offensive graffiti present

Action: Remove as soon as practicable

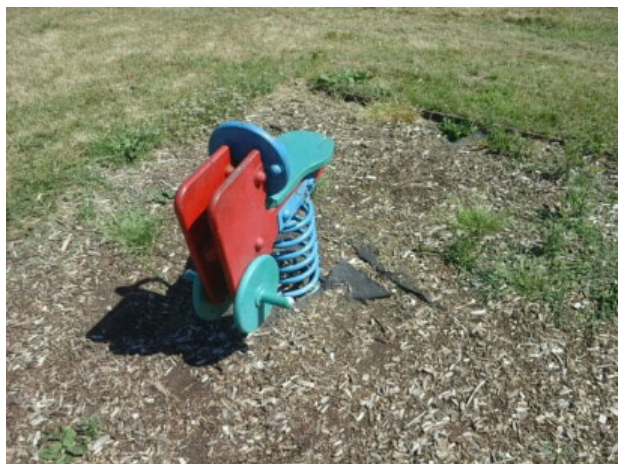
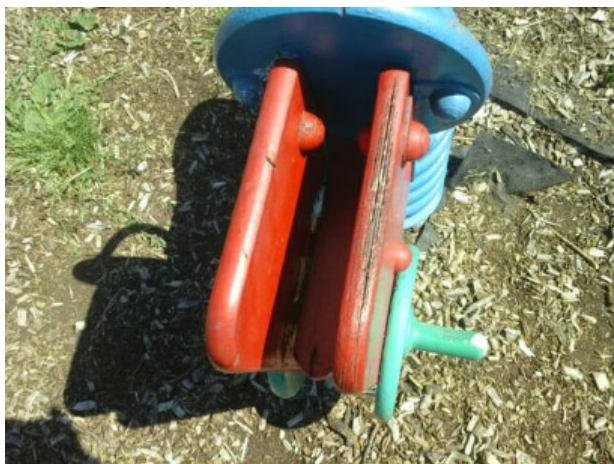
Item: Rocking Equipment - Spring Tractor
Manufacturer: Owner/Operator

Risk Level: L - Low Risk
Surface: Bark Mulch

Finding: The plywood has delaminated in some places

Action: Remove all rough or splintered edges.

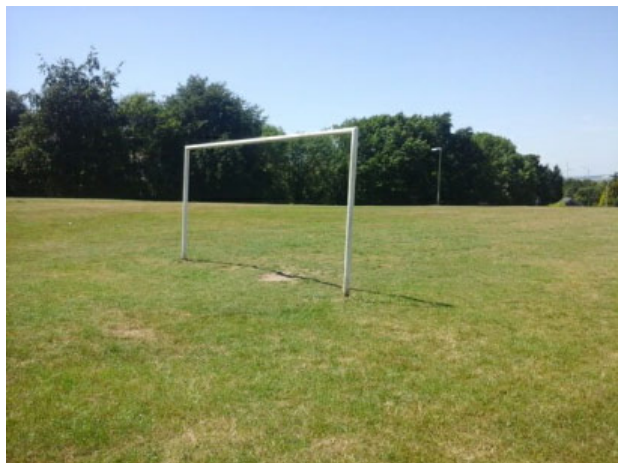
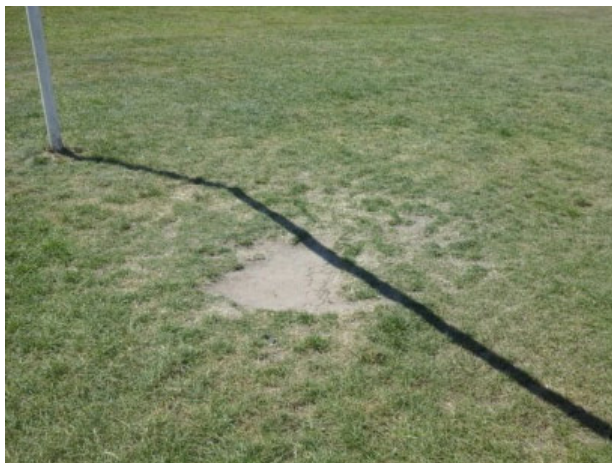
Item: Multi Use Games Area - Goal End
Manufacturer: Owner/Operator

Risk Level: L - Low Risk
Surface: Grass

Finding: The surface has eroded in some areas

Action: Reinstate the surface
