Annual Inspection

Frodsham Town Council

Townfield Lane

Annual Inspection - 02 July 2018 at 13:27 Inspector: Matt Hall RPII Annual Inspector (Outdoor)

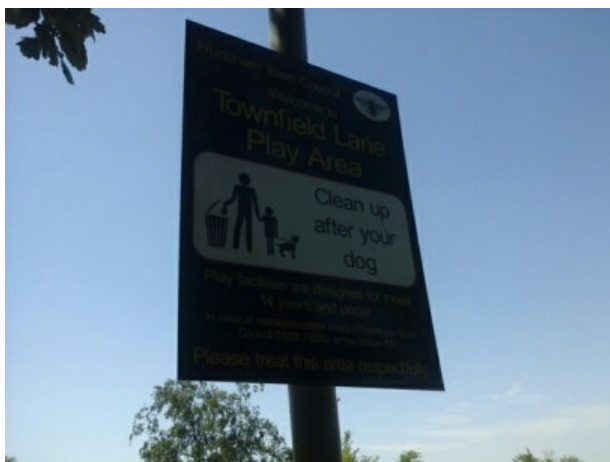
Item: Ancillary Items - Sign
Manufacturer: Owner/Operator
Surface Type: N/A
Equipment Compliance: N/A
Surface Area Compliance: N/A
Ref/Part Number:
Total Findings: 1

Finding 1

This item is satisfactory - no work required

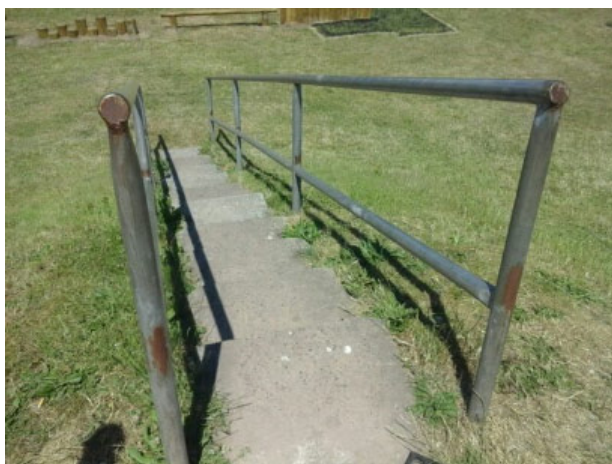
Item: Ancillary Items - Steps
Manufacturer: Owner/Operator
Surface Type: All Weather Surface
Equipment Compliance: N/A
Surface Area Compliance: N/A
Ref/Part Number:
Total Findings: 1

Finding 1

This item is satisfactory - no work required

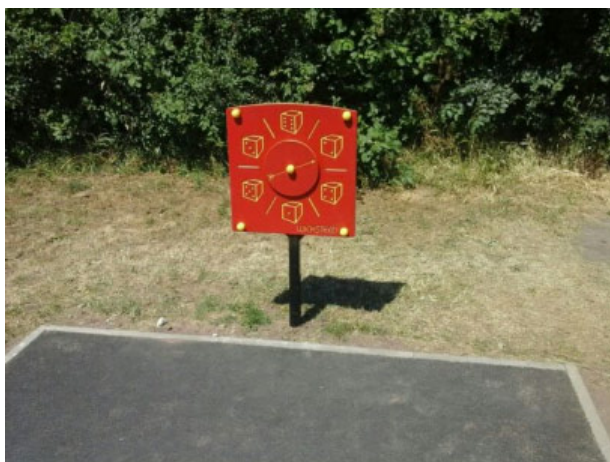
Item: Other - Play Panel
Manufacturer: Wicksteed Playgrounds
Surface Type: Bitmac
Equipment Compliance: Yes
Surface Area Compliance: N/A
Ref/Part Number:
Total Findings: 1

Finding 1

This item is satisfactory - no work required
