Annual Inspection

Frodsham Town Council

Park Lane

Annual Inspection - 02 July 2018 at 12:12 Inspector: Matt Hall RPII Annual Inspector (Outdoor)

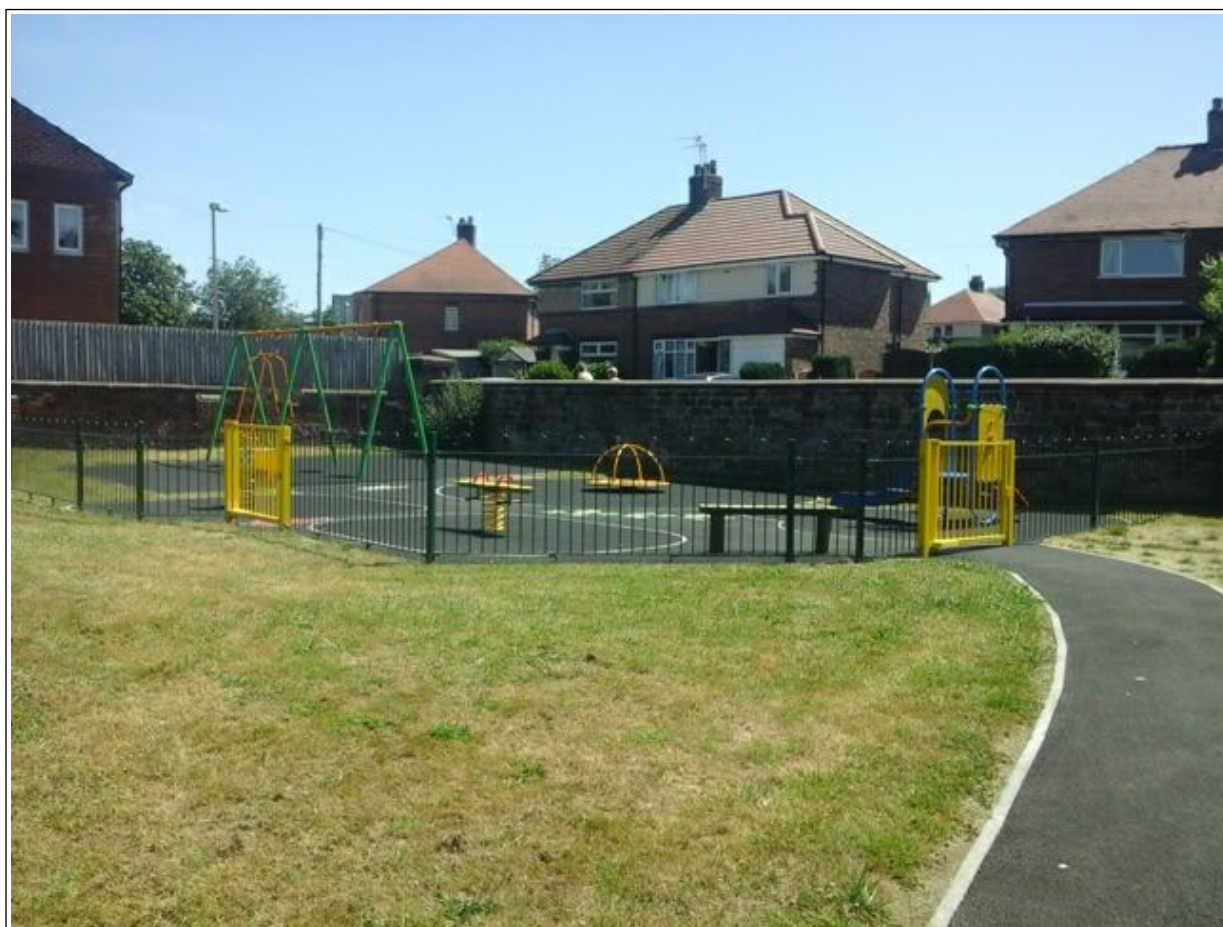
Risk Assessment: **10 - Low Risk**

Location: The site is located in an area of public open space and is overlooked by a number of properties in the local community.

Disabled Access: Generally accessible; an area accessible to most but not all people even when help is at hand.
