Annual Inspection

Frodsham Town Council

Park Lane

Inspection Ref: 1409107

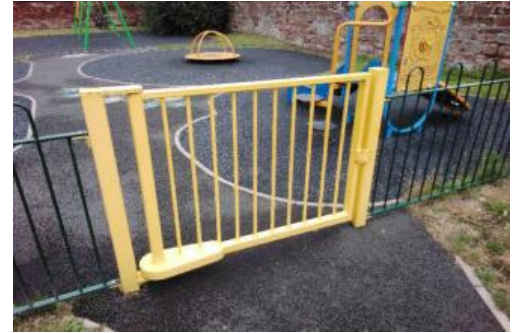
Item: Gate - Self Closing
Manufacturer: Owner/Operator
Surface Type: Bitmac
Surface Nominal Depth: 2mm
Item Quantity: 1
Equipment Compliance: N/A
Surface Area Compliance: N/A
Total Findings: 1

Finding 1

This item is satisfactory - no work required -
