## Annual Inspection

Frodsham Town Council

Townfield Lane

Inspection Ref: 1409106

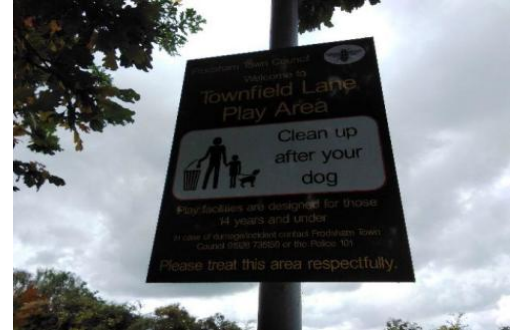
**Item:** Sign  
**Manufacturer:** Owner/Operator  
**Surface Type:** N/A  
**Item Quantity:** 1  
**Equipment Compliance:** N/A  
**Surface Area Compliance:** N/A

It is recommended that signage, with information including the site address, contact information for maintenance issues and emergency contact details are provided for the facility - Provide in accordance with the recommendations

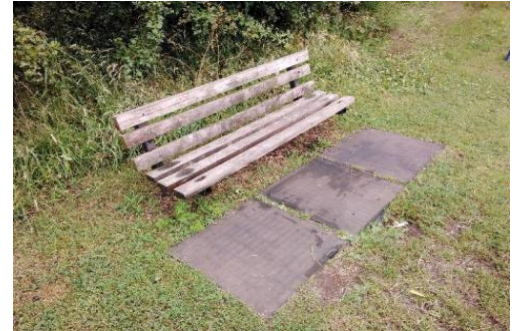
**Item:** Bench  
**Manufacturer:** Owner/Operator  
**Surface Type:** Grass  
**Item Part Number:**  
**Item Quantity:** 2  
**Equipment Compliance:** N/A  
**Surface Area Compliance:** N/A  
**Total Findings:** 3

There are trip hazards present - Reinstate surrounding surfaces to level to remove the trip points

There are post / end caps missing from the item - Replace missing post caps

The tube(s) on this item have corroded from the inside and split the steel - Replace all affected parts

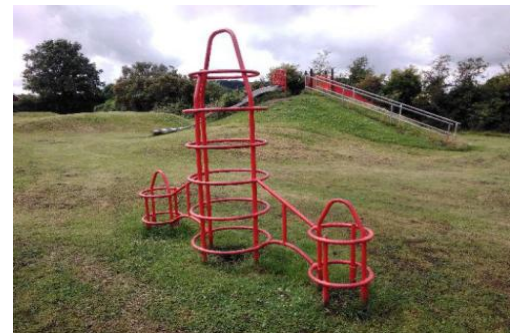
**Item:** Climbing Frame  
**Manufacturer:** Not Identified  
**Surface Type:** Grass Matrix Tiles  
**Item Quantity:** 1  
**Equipment Compliance:** No  
**Surface Area Compliance:** Yes  
**Total Findings:** 2

There are falls in excess of 600mm between adjacent components on the structure, in contravention of the recommendations set out in BS EN 1176 Part 1; 4.2.8.4 - Monitor - No remedial work recommended

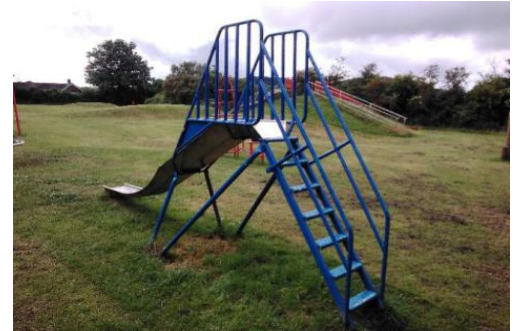
**Item:** Free Standing Slide  
**Manufacturer:** Wicksteed Playgrounds  
**Surface Type:** Grass  
**Item Quantity:** 1  
**Equipment Compliance:** No  
**Surface Area Compliance:** Yes

The item fails to meet the requirements of BS EN 1176 Part 1 4.2.7.2 for head and neck entrapment in the framework - Monitor - No remedial work recommended

There are a number of dents in the slide surface - Monitor for any further deterioration and repair as required

Parts of the steel on this item have corroded excessively and the metal has perforated in places - Ensure all affected areas are treated and repaired

There is surface corrosion present on the item - Consider treating the item

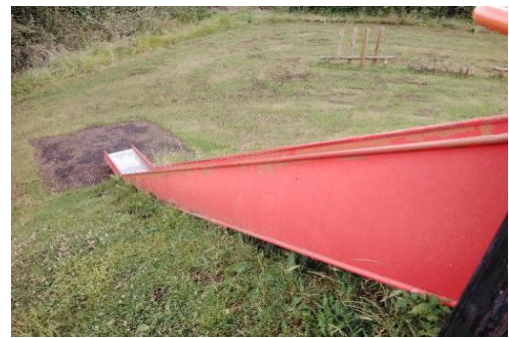
**Item:** Embankment Slide  
**Manufacturer:** Hags  
**Surface Type:** Wet Pour  
**Item Quantity:** 1  
**Equipment Compliance:** Yes  
**Surface Area Compliance:** Yes

- Finding 1**  
There are a number of dents in the slide surface - Monitor for any further deterioration and repair as required
- Finding 2**  
The surface has eroded in some areas - Reinststate the surface
- Finding 3**  
There is some minor damage to the surface - Monitor for any further deterioration and repair as required
- Finding 4**  
There is grass on the surface making for slippery conditions - Clean and maintain
- Finding 5**  
There is or are fixings missing on the item - Replace all missing fixings

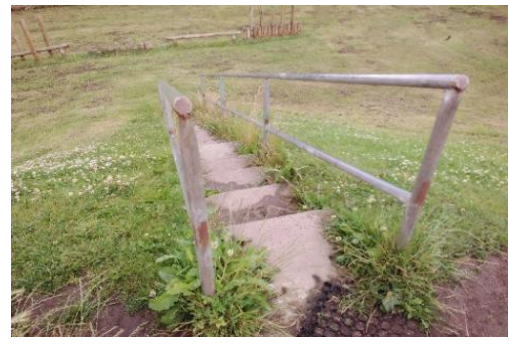
**Item:** Steps  
**Manufacturer:** Owner/Operator  
**Surface Type:** All Weather Surface  
**Item Quantity:** 1  
**Equipment Compliance:** N/A  
**Surface Area Compliance:** N/A

- Finding 1**  
The grass mat is a potential trip hazard - cut back grass mat away from the steps and tuck in edge

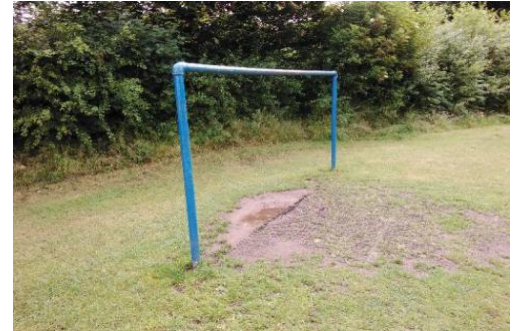
**Item:** Goal End  
**Manufacturer:** Owner/Operator  
**Surface Type:** All Weather Surface  
**Item Quantity:** 1  
**Equipment Compliance:** N/A  
**Surface Area Compliance:** N/A

The edges of the grass mat surface have not been installed in accordance with the API Code of Practice - Tuck in edges of grass mat to remove trip hazards

The item is slightly loose in its foundations - Monitor for any further deterioration and repair as required

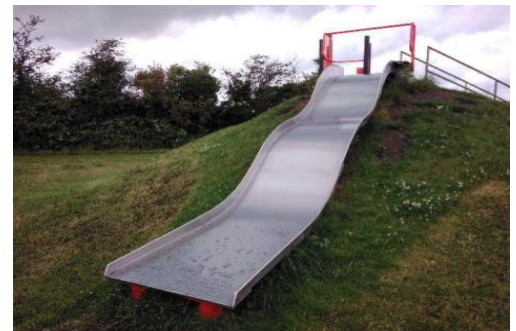
**Item:** Embankment Slide  
**Manufacturer:** Wicksteed Playgrounds  
**Surface Type:** Grass Matrix Tiles  
**Item Quantity:** 1  
**Equipment Compliance:** No  
**Surface Area Compliance:** Yes

The foundation forms a hard object within the falling space of the equipment in contravention of the requirements of BS EN 1176 Part 1 - Reinstate a grass surface

The edges of the grass mat surface have not been installed in accordance with the API Code of Practice - Tuck in edges of grass mat to remove trip hazards

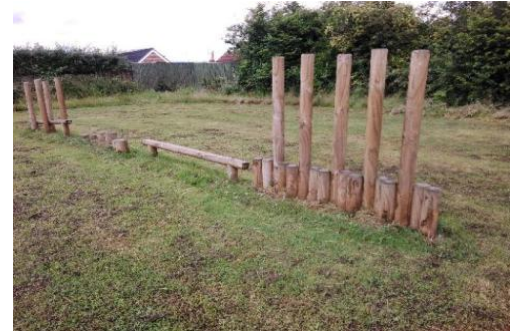
**Item:** Activity Trail  
**Manufacturer:** Wicksteed Playgrounds  
**Surface Type:** Grass  
**Item Quantity:** 1  
**Equipment Compliance:** Yes  
**Surface Area Compliance:** Yes

There is some strimmer / machinery damage apparent on the posts, this can penetrate the preservative applied to the timber and accelerate the rotting process - Monitor for any deterioration (rot) and replace as required

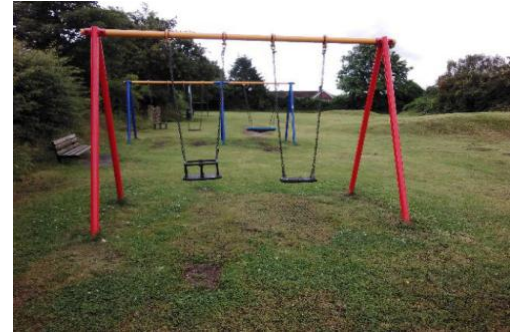
**Item:** 1 Bay 2 Seat Swing  
**Manufacturer:** Wicksteed Playgrounds  
**Surface Type:** Grass Matrix Tiles  
**Item Quantity:** 1  
**Equipment Compliance:** No  
**Surface Area Compliance:** Yes

The chain openings are in excess of the 8.6mm as recommended by BS EN 1176 - Monitor - No remedial work recommended

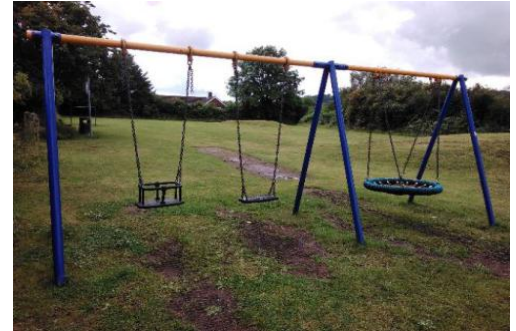
**Item:** 2 Bay 2 Cradle 1 Basket  
**Manufacturer:** Wicksteed Playgrounds  
**Surface Type:** Grass Matrix Tiles  
**Item Quantity:** 1  
**Equipment Compliance:** No  
**Surface Area Compliance:** Yes

There are excessive chain tails - Cut back excessive chain links

The chain openings are in excess of the 8.6mm as recommended by BS EN 1176 - Monitor - No remedial work recommended

The bushes are worn or missing - Replace worn or missing bushes

There is some notable evidence of chain wear - Monitor for any further deterioration and replace when 40% worn

The split pins are missing from the shackles - Insert split pins to secure the shackles

The seat has minor damage or wear - Monitor for any further deterioration and replace as required

The shackles have been overtightened or seized transferring wear to the chain links below - Loosen shackles to ensure free movement at the pivot

The seats are too close to the frame as defined in BS EN 1176 Part 2; this is a low risk failure and no remedial action is required - Monitor - No remedial work recommended

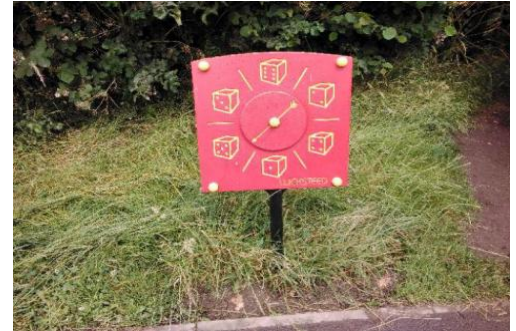
**Item:** Play Panel  
**Manufacturer:** Wicksteed Playgrounds  
**Surface Type:** Bitmac  
**Item Quantity:** 1  
**Equipment Compliance:** Yes  
**Surface Area Compliance:** N/A

The item is loose in its foundations - Reinstall item to secure

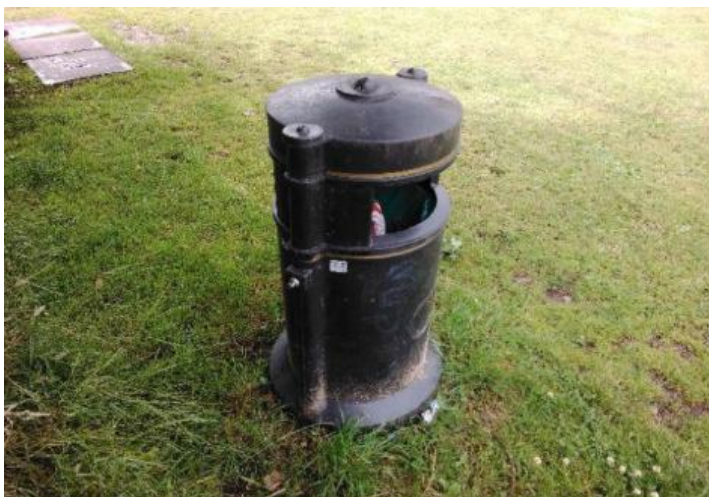
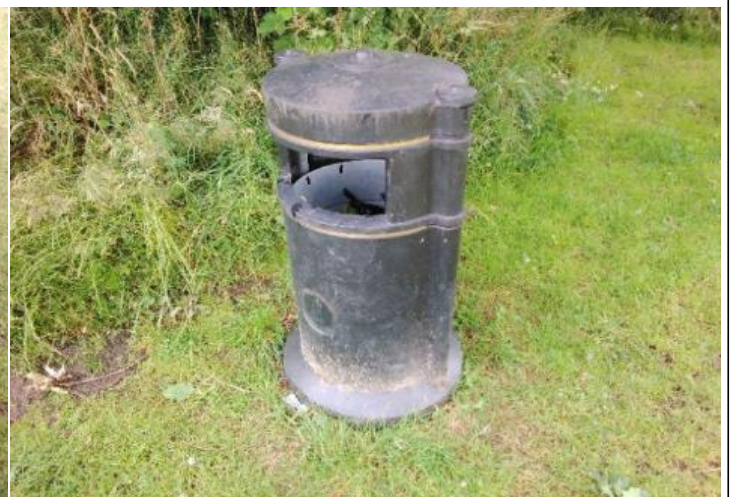
**Item:** Ancillary Items - Litter Bin  
**Manufacturer:** Owner/Operator

**Finding:** The lid or door of the litter bin is not secured

**Action:** Ensure the lid or door is kept locked

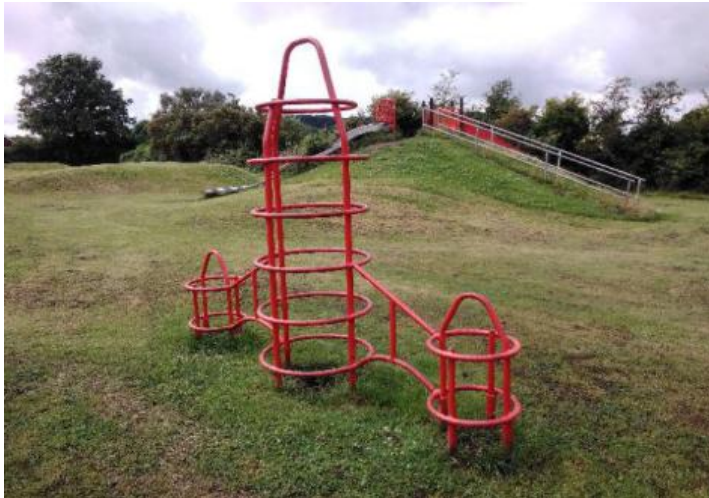
**Item:** Activity Equipment - Climbing Frame  
**Manufacturer:** Not Identified

**Finding:** The surface has eroded in some areas

**Action:** Reinststate the surface

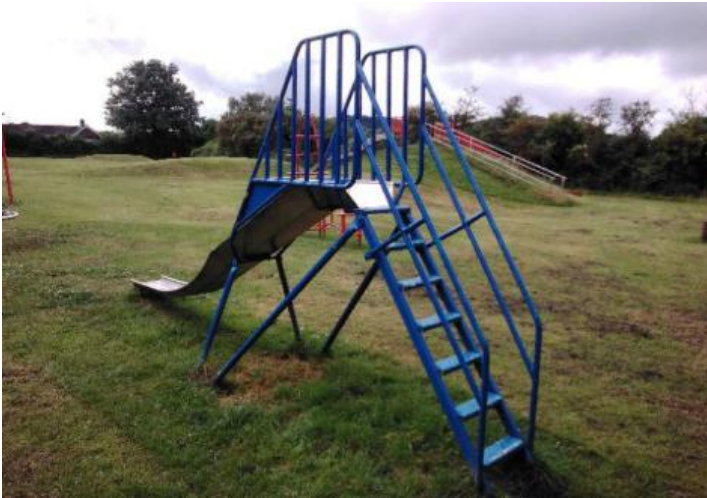
**Item:** Other - Free Standing Slide  
**Manufacturer:** Wicksteed Playgrounds

**Finding:** There are projecting bolt thread(s) present

**Action:** Remove excess thread length and deburr or provide cap

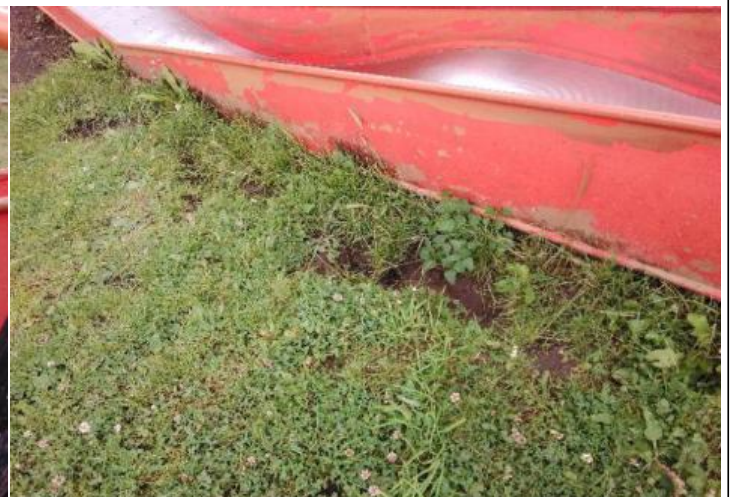
**Item:** Other - Embankment Slide  
**Manufacturer:** Hags

**Finding:** The surface has eroded in some areas

**Action:** Reinstate the surface

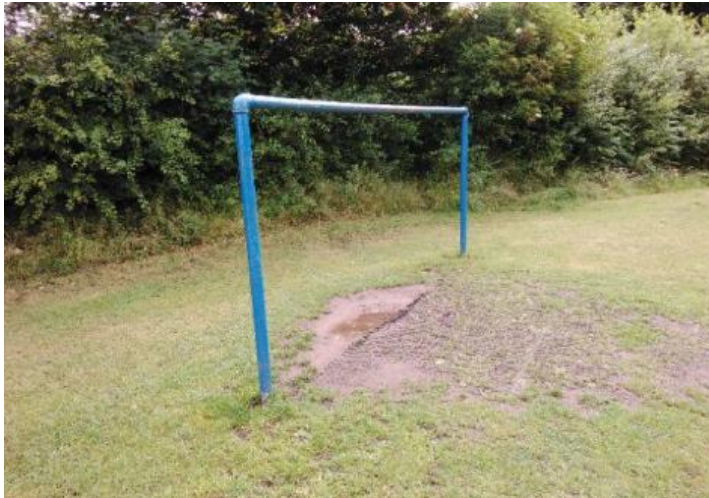
**Item:** Multi Use Games Area - Goal End  
**Manufacturer:** Owner/Operator

**Finding:** The grass mats are silted up, the soil is compacted and the area will become very slippery when the soil is wet. **Action:** Reinstate as required

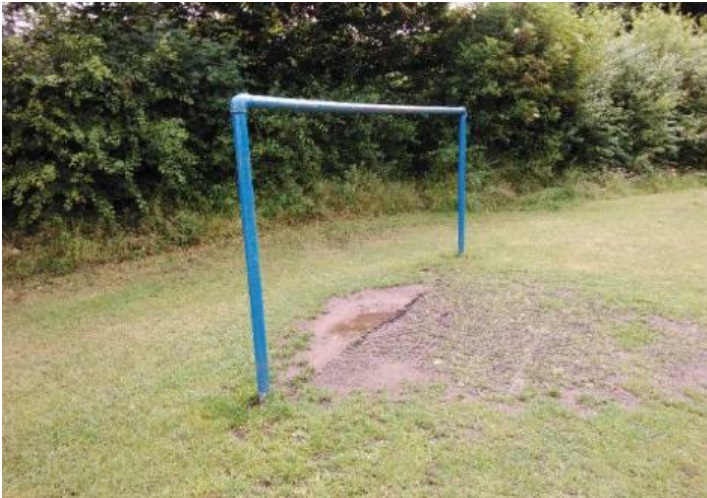
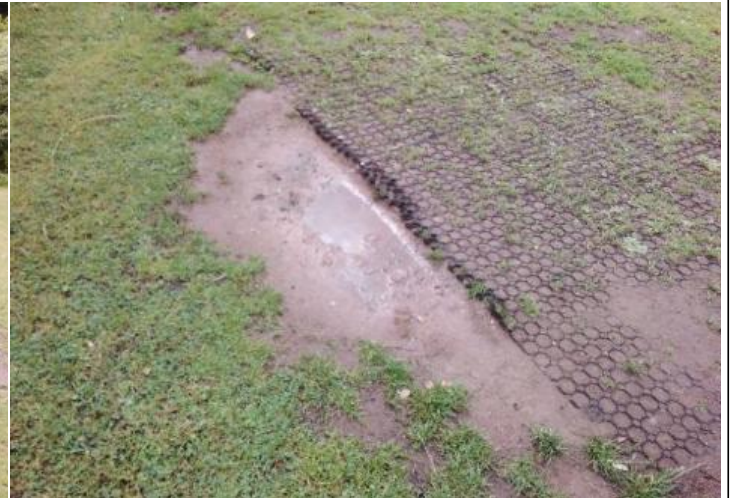
**Item:** Multi Use Games Area - Goal End  
**Manufacturer:** Owner/Operator

**Finding:** The surface has eroded in some areas

**Action:** Reinststate the surface

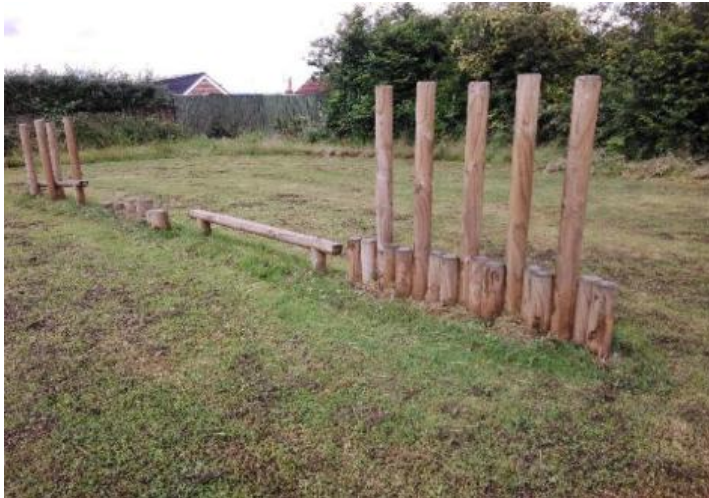
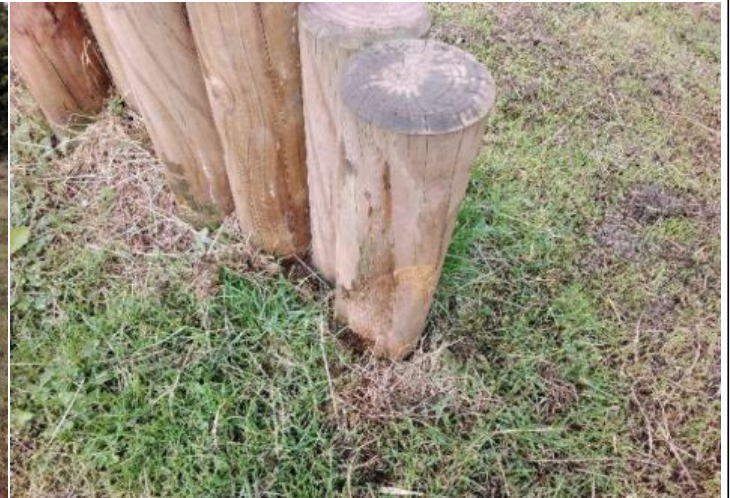
**Item:** Activity Equipment - Activity Trail  
**Manufacturer:** Wicksteed Playgrounds

**Finding:** Parts of the timber are rough or splintered

**Action:** Remove all rough or sharp edges

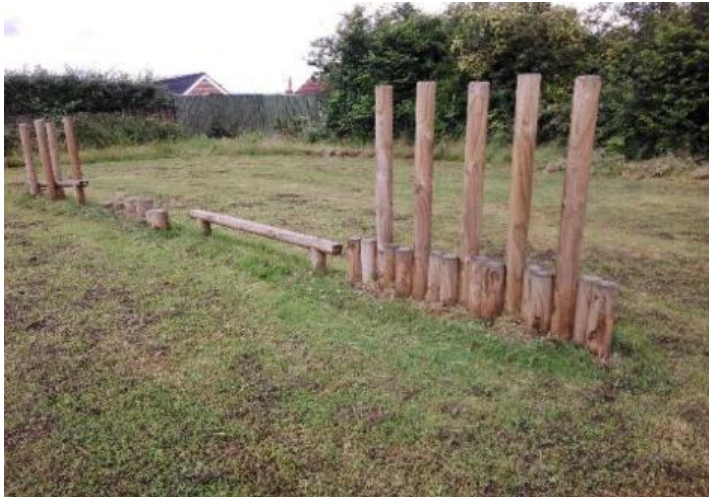
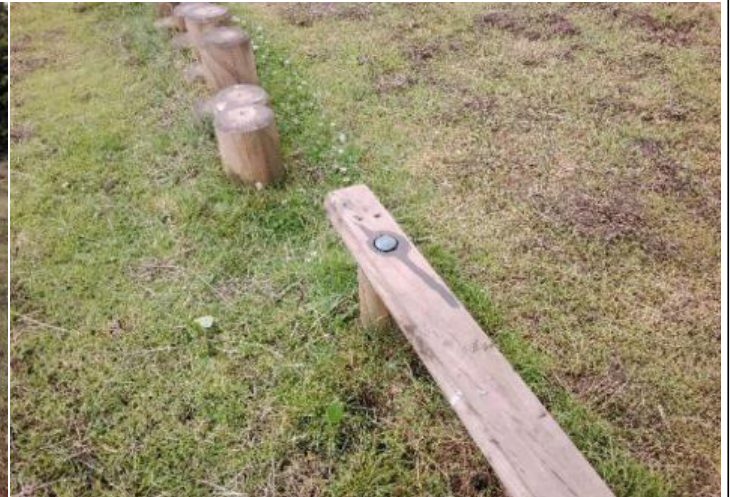
**Item:** Activity Equipment - Activity Trail  
**Manufacturer:** Wicksteed Playgrounds

**Finding:** There is algae or moss on the surface of the equipment

**Action:** Clean and treat appropriately

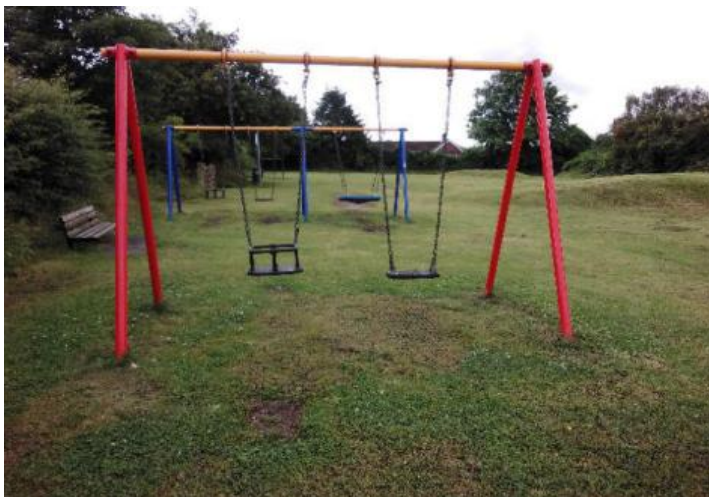
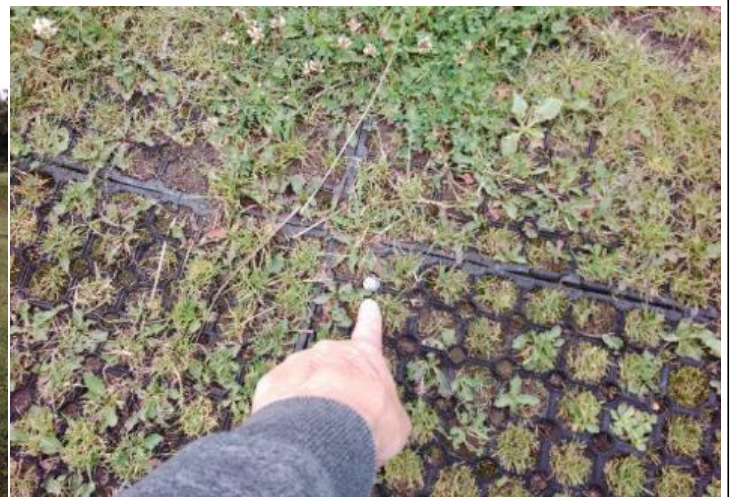
**Item:** Swings - 1 Bay 2 Seat Swing  
**Manufacturer:** Wicksteed Playgrounds

**Finding:** Fixing Pins have been installed in the impact areas of the grass mats **Action:** Remove pins from impact areas

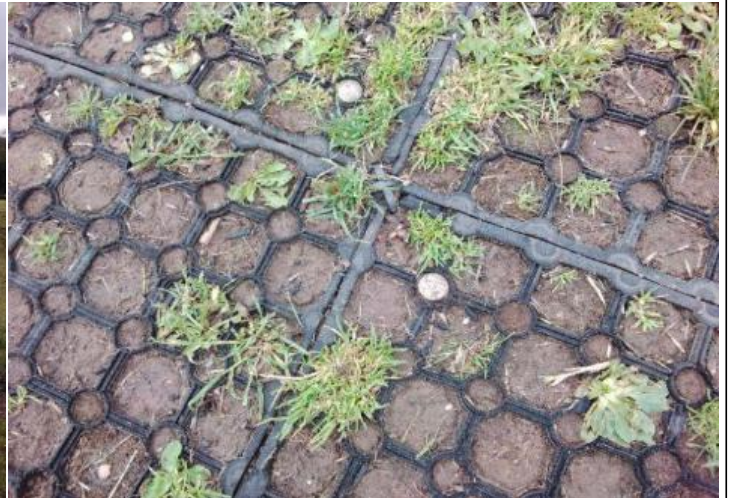
**Item:** Swings - 2 Bay 2 Cradle 1 Basket  
**Manufacturer:** Wicksteed Playgrounds

**Finding:** Fixing Pins have been installed in the impact areas **Action:** Remove pins from impact areas of the grass mats

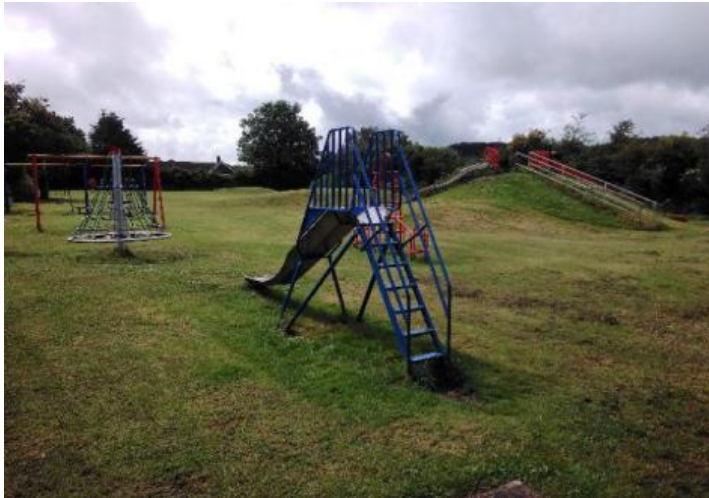
**Item:** Ancillary Items - Site General  
**Manufacturer:** Owner/Operator

**Finding:** The site is accessible to the public during the COVID 19 pandemic. The government have released guidelines for safely re-opening these types of facilities which is available on the government website.

**Action:** Ensure there is an appropriate risk assessment in place and review regularly

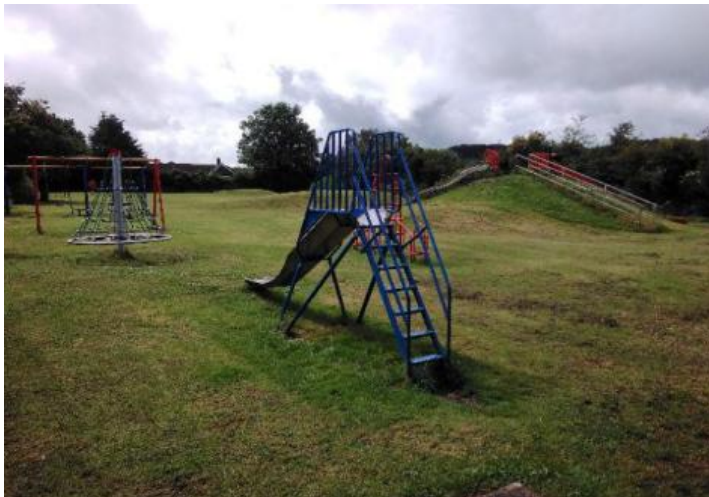
**Item:** Ancillary Items - Site General  
**Manufacturer:** Owner/Operator

**Finding:** There sharp projecting ties on the equipment

**Action:** Remove ties from equipment
