## **Tree Condition Survey and Management Work Recommendations**

Date – 10/04/2023

Site – Tarvin Road Cemetery, Frodsham

Client – Frodsham Town Council – [townclerk@frodsham.gov.uk](mailto:townclerk@frodsham.gov.uk)

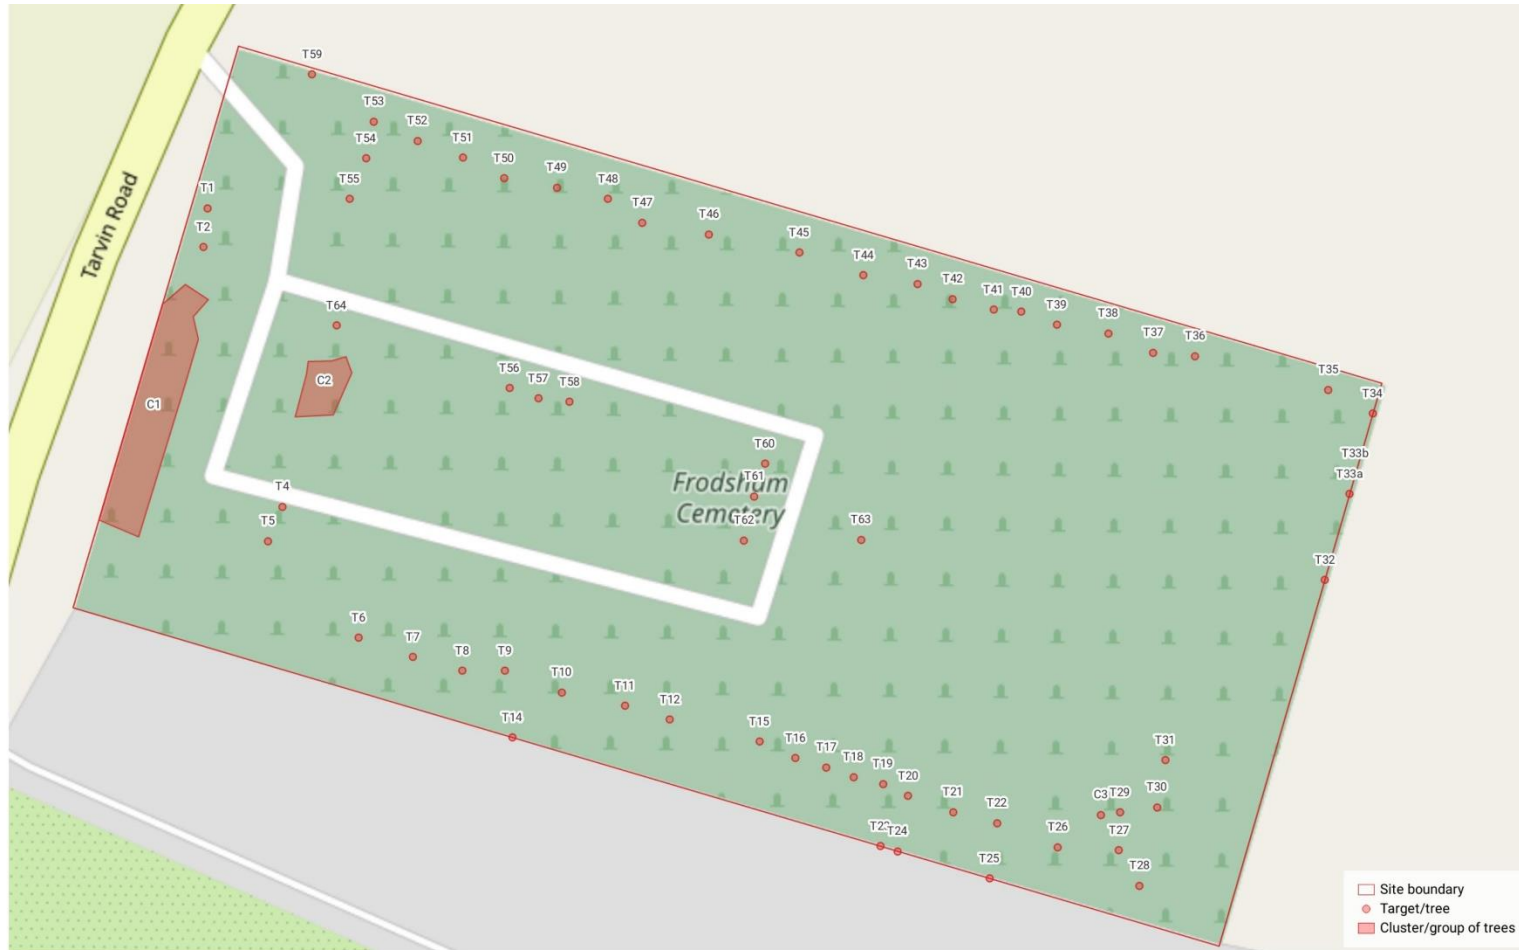
Map.1. Location of trees identified during tree condition survey. Target and Cluster trees relate to table in appendix 2.
